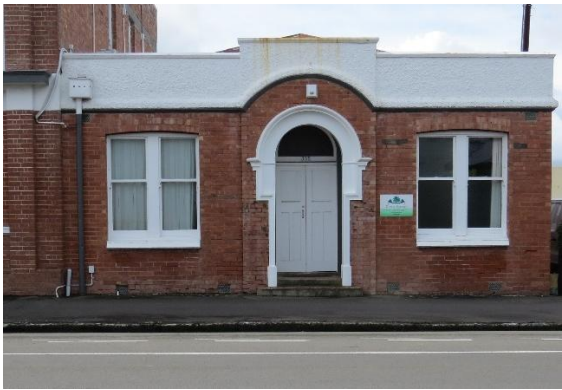
| <b>335 Broadway / Drover Surveys</b><br><br> | <b>Upper Façade</b><br>NA |

| | <b>Lower Façade</b><br>Traditional high-quality brick masonry. High visual interest. Well maintained. |
| | <b>Ground-Floor Fenestration</b><br>Small windows with high sill. |
| | <b>Signage</b><br>Small wall-mounted sign adjacent main entrance. |
| | <b>Activation</b><br>Little visual connectivity. Raised floor. |

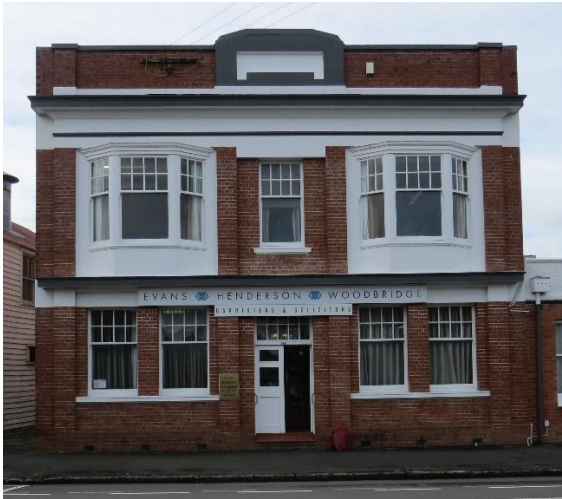
| <b>333 Broadway / Evans, Henderson, Woodbridge</b><br><br> | <b>Upper Façade</b><br>Traditional, high-quality brick masonry with rendered sections. High visual interest. Well maintained. |

| | <b>Lower Façade</b><br>Traditional, high-quality brick masonry consistent with upper facade. High visual interest. Well maintained. |
| | <b>Ground-Floor Fenestration</b><br>Small windows with high sill. |
| | <b>Signage</b><br>Single high-quality sign consistent with architecture. |
| | <b>Activation</b><br>Little connectivity at ground floor. Raised floor. First-floor bay windows suggest inhabitation. |

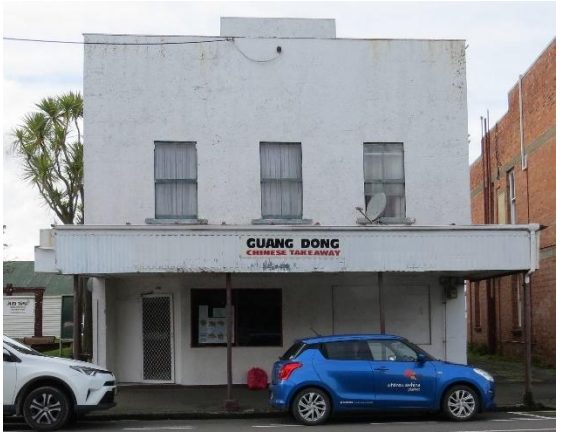
| <b>327 Broadway / Guang Dong Takeaway</b><br><br> | <b>Upper Façade</b><br>Modernised. Low-quality. Poor repair. |

| | <b>Lower Façade</b><br>Modernised. Low-quality. Poor repair. |
| | <b>Ground-Floor Fenestration</b><br>Inconsistent with upper level. Blanked off window. |
| | <b>Veranda</b><br>Poor quality. Poor repair. |
| | <b>Signage</b><br>Poor quality. |
| | <b>Activation</b><br>Limited connectivity (security mesh on door, blanked off window). Blank side elevation to park. |

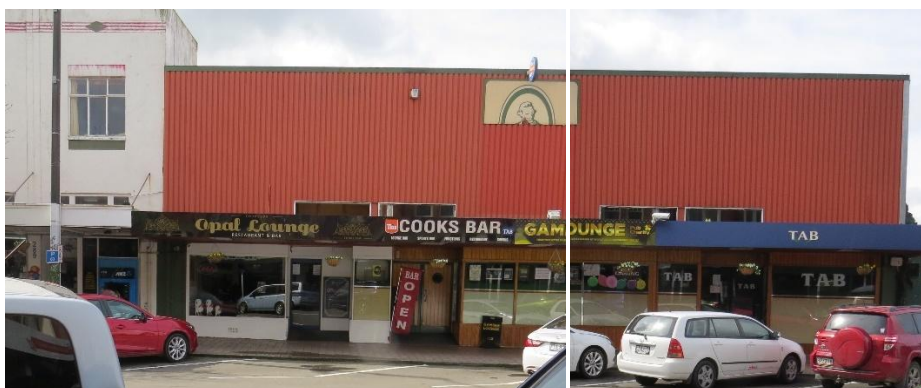
## 297 Broadway / Cooks Bar & Gaming Lounge

Modernised. Low quality. Very low visual interest.

Modernised. Low-moderate quality.

Fully glazed. Most doors/windows obscured.

Modernised. Consistent treatment. Well maintained.

Partially missing upper-façade sign. Fair veranda signs.

Opal Lounge provides only visual connectivity. Remaining windows are covered with opaque film. Degraded finish on timber cladding. Some street-facing signs on ground-floor windows. Upper façade has no openings or other architectural detail. Upper façade masks pitched roof. So, no first-floor inhabitation. Hanging baskets provide additional detail and signal custodial care.

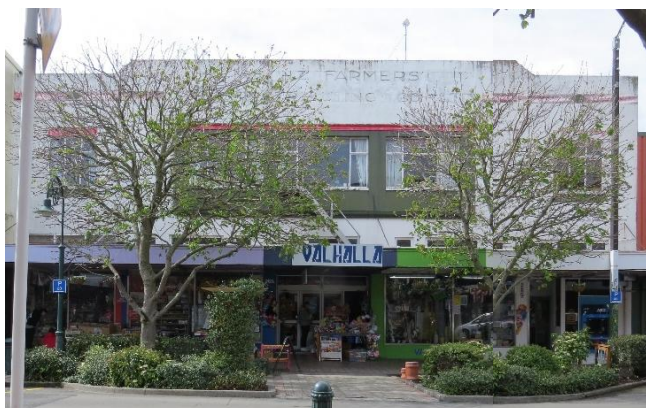
## 289 Broadway / The N.Z. Farmers Distributing Co.

Original art deco. Poor repair. Unflattering colours.

Modernised. Distinct from upper façade. Good repair.

Fully glazed. High connectivity. High visual interest.

Original clerestory windows above. Fire escape added.

Original upper façade inscription. Single veranda sign.

Window displays and on-street merchandise create a highly activated retail frontage. This combines with planting and street furniture to make a virtue of discontinuity (deeper setback) in building line. When in leaf, street trees conceal upper façade. Large first-floor windows provide sense of inhabitation. Mid-block pedestrian crossing aligned with centre of building.

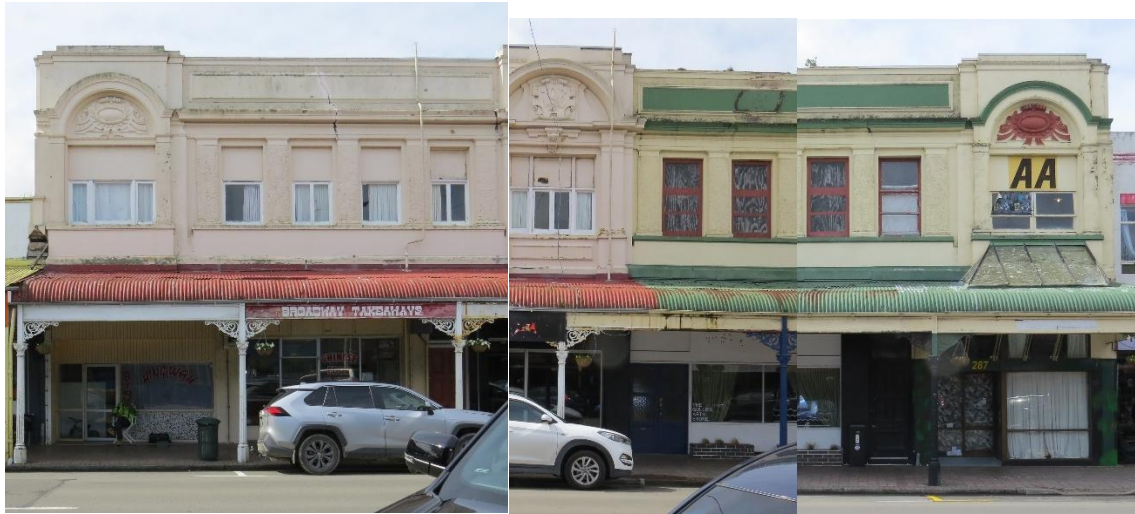
## 281-287 Broadway

Original (except some windows). High-quality masonry. Poor repair. Inconsistent colour scheme.

Modernised. Fragmented. Poor quality. Poor repair.

Extensive glazing (partially obscured).

Original. Ornate. Veranda posts. Very poor repair.

Unsympathetic AA sign. Single discrete veranda sign.

Impressive 1908 façade anchors centre of block in terms of scale and architectural quality. Let down by poorly maintained fabric. Limited indoor/outdoor connectivity owing to obscured openings. Ground-floor tenancies vacant or occupied with low-intensity activities that fail to engage street. Little sense of first-floor inhabitation owing to curtains and the fact that some windows have been reduced in size.

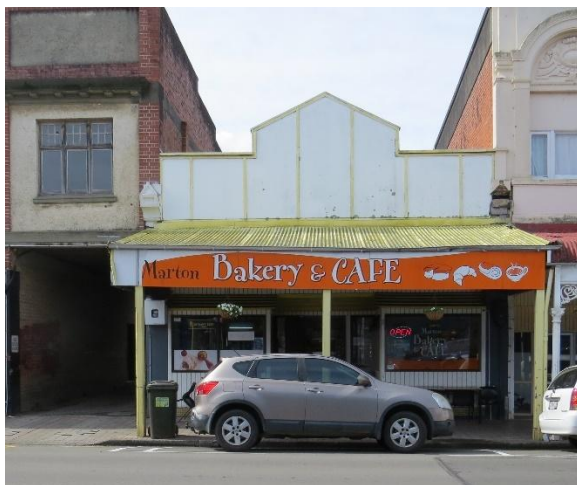
## 277 Broadway / Marton Bakery & Cafe

Modernised. Poor quality. Poor repair.

Modernised. Inconsistent with upper façade. Moderate quality. Moderate repair.

Extensive glazing. Raised sill.

Modernised. Possibly original veranda posts.

Medium quality. Strong appeal to street.

Outdoor seating. Upper façade conceals pitched roof. Diminutive vertical / horizontal scale. Hanging flower baskets add detail and signal care.

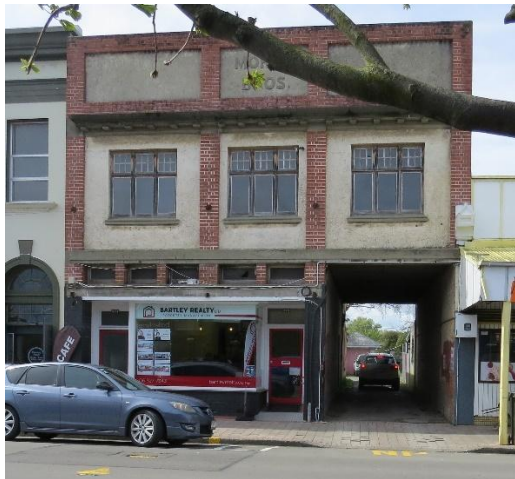
### 273 Broadway / Moral Bros.

Original. High-quality. Fair repair.

Partially modernised. Unsympathetic colours. Moderate quality.

Fully glazed. Good connectivity.

Original upper façade inscription. Bartley Realty high-quality window signage.

Good visual connectivity. Two entrances. Passage to rear of lot. Real estate office provides relatively little engagement with street. Little sense of first-floor inhabitation despite large windows.

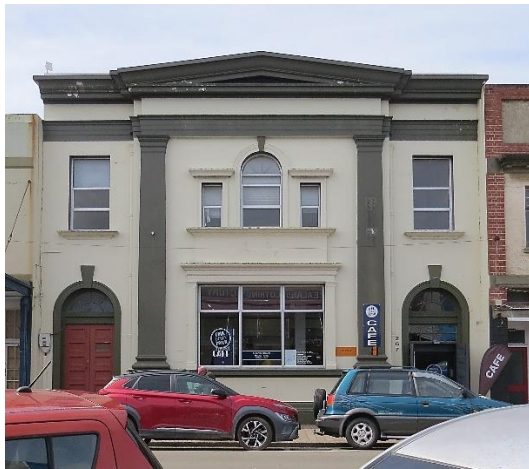
### 267 Broadway / Four Doors Down Cafe

High-quality plastered masonry. Original. Good repair.

Single large window. Raised sill. One entrance glazed.

Discrete signage. Sympathetic to architecture.

No outdoor seating. Little visual connectivity with interior. Raised ground floor limits indoor-outdoor exchange. Some signs of first-floor inhabitation. Parallel parking allows better cross-street visibility.

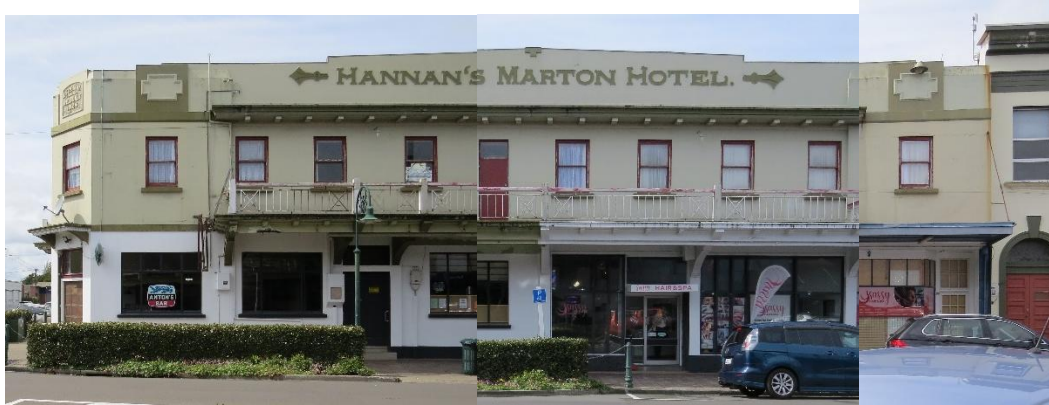
## 255-265 Broadway / Hannan's Marton Hotel

Original. High-quality. Fair condition.

Partially modernised. Fragmented incl. colours. Fair.

Partial-full glazing (some obscured). Some raised sills.

Original. Ornate. Unusual balcony / veranda design. Not full length. Inconsistent colour scheme.

Original upper-façade inscription. Varied at ground.

Limited indoor / outdoor connectivity owing to raised sills and obscured windows. Hair salon and spa has good signage. Antons bar on corner is closed. Little sense of first-floor inhabitation. Variety of poor-quality window coverings on upper level – suggestive of vacancy / neglect.

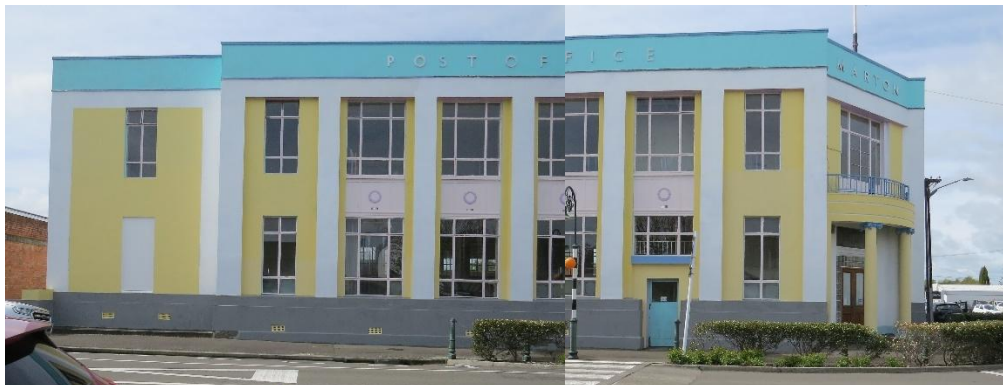
## 249-253 Broadway / Marton Post Office

Original (transition style). High quality. Good condition.

As for upper façade. Addresses corner.

Large windows. Original condition. Raised sills.

Original lettering on parapet. Mural to entry alcove.

Scale and quality ensure strong spatial definition at intersection. Main (corner) entrance is closed. No other access point evident. Vacant or low-intensity ground-floor use. Solid plinth and raised windows prevent eye-level visual contact with interior. Pastel colour scheme promotes art deco reading of architecture.

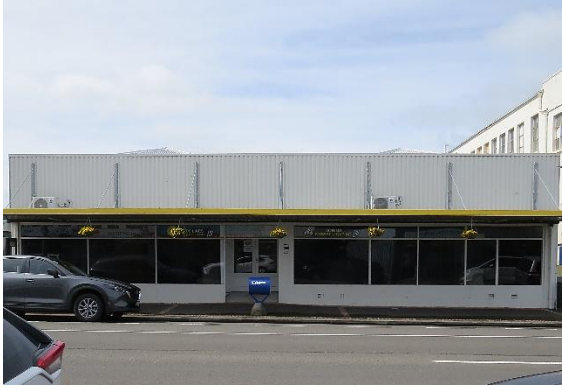
| <b>237 Broadway / ADS Lines etc.</b><br><br> | <b>Upper Façade</b><br>Modernised. Poor quality. Good condition. |

| | <b>Lower Façade</b><br>Modernised. Fair quality. Good condition. |
| | <b>Ground-Floor Fenestration</b><br>Near fully glazed. Dark glass prevents connectivity. |
| | <b>Veranda</b><br>Modern. Fair quality. Good condition. |
| | <b>Signage</b><br>Small signs on windows. Matched to fenestration. |
| | <b>Activation</b><br>Deeply recessed entry. Little sense of internal activity. |

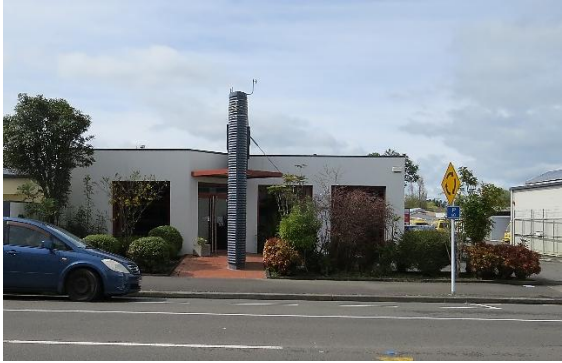
| <b>225 Broadway / Downs Group</b><br><br> | <b>Upper Façade</b><br>NA |

| | <b>Lower Façade</b><br>Contemporary. High quality. Good condition. |
| | <b>Ground-Floor Fenestration</b><br>Extensive glazing. Dark glass prevents connectivity. |
| | <b>Signage</b><br>High quality. Integrated with building. |
| | <b>Activation</b><br>Set back behind vegetation, vehicle circulation. |

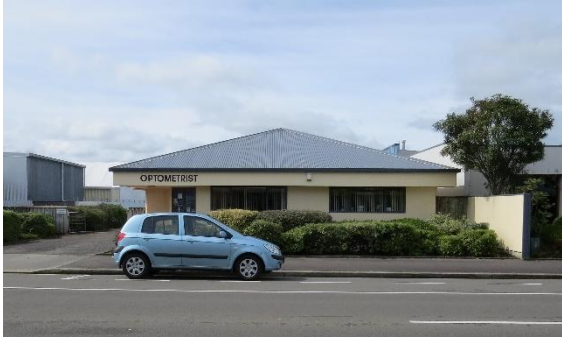
| <b>223 Broadway / Vision Experience</b><br><br> | <b>Upper Façade</b><br>NA |

| | <b>Lower Façade</b><br>Domestic style. Visible hip roof. Good condition. |
| | <b>Ground-Floor Fenestration</b><br>Domestic scale. Raised sills. Little connectivity. Recessed corner entrance addresses street. |
| | <b>Signage</b><br>Single street-facing sign. Integrated with building. |
| | <b>Activation</b><br>Set back behind vegetation. Little connectivity. |

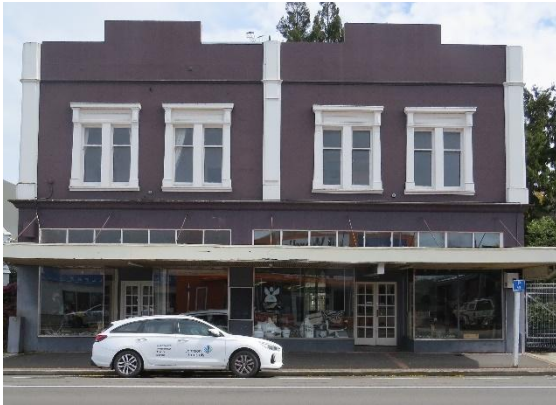
### 194-224 Broadway

Original. High quality. Fair condition.

Modernised. Inconsistent with upper façade.

Fully glazed.

Original. Medium quality. Poor-fair condition.

Occupied but closed. Sense upper-level inhabitation.

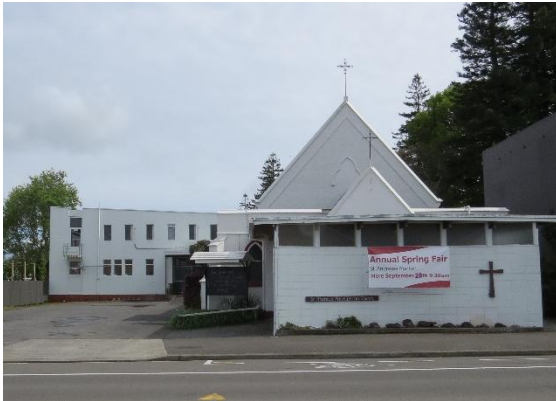
### 204 Broadway / St Andrews Church

Modernised. Poor-medium quality. Poor-fair condition.

Minimal. Discrete. Non-commercial.

Set back. Little presence. Original church concealed. Large parking lot. Concealed or remote entrances.

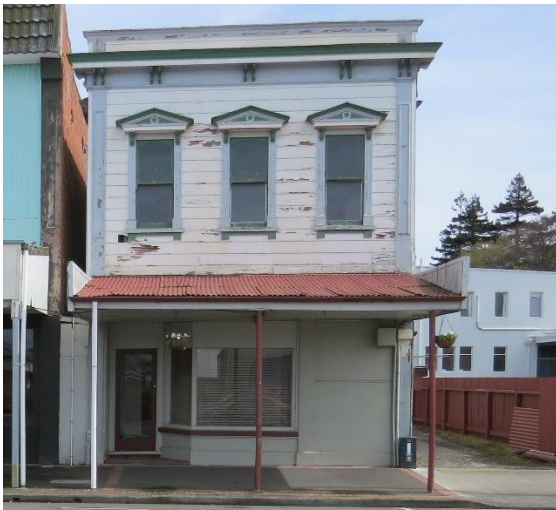
### 212 Broadway

Original. Ornate. High quality. Poor condition.

Modified original. Medium quality. Poor condition.

Partially glazed. One section blanked off.

Modified original. Poor quality. Poor condition.

Little connectivity at ground. Vacant or low-intensity use. No sense upper-level inhabitation.

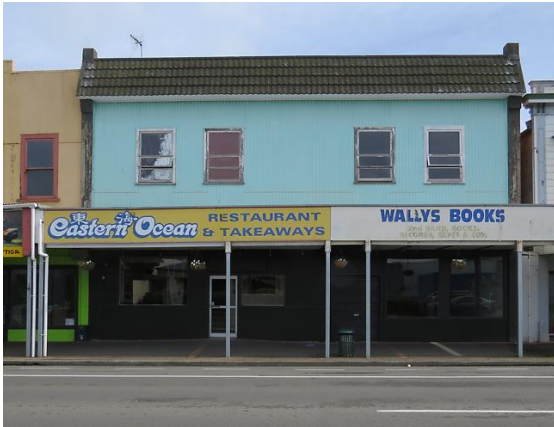
**216-218 Broadway / Wallys Books etc.**

Modernised. Poor quality. Very poor condition.

Modernised. Poor-medium quality. Fair condition.

Modernised.

Matched to veranda fascia. Poor condition.

Vacant ground level. Sense of vacant upper level.

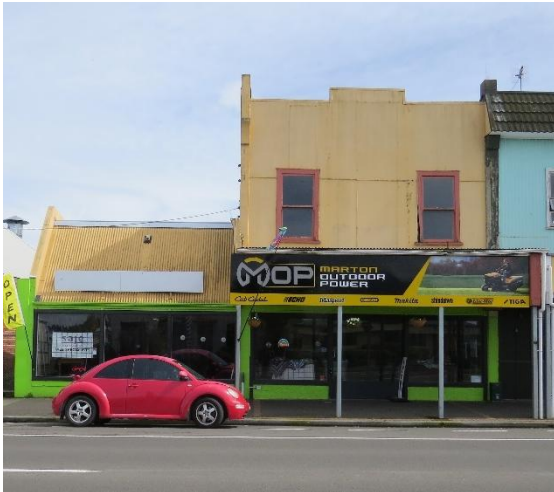
**222-226 Broadway / MOP**

Modernised. Poor quality. Very poor condition.

Modernised. Poor-medium quality. Fair condition.

Fully glazed. Window display behind security mesh.

Modernised. Partial.

Disproportionately large. Modern. Veranda fascia. Good condition.

Dimly lit interior. Sense of vacant upper level.

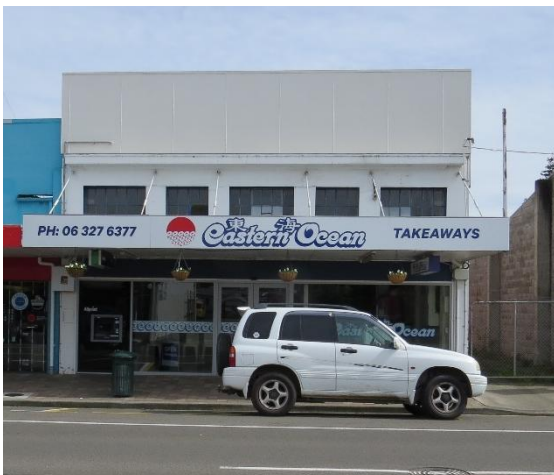
**230 Broadway / Eastern Ocean**

Parapet only. Modernised. Poor quality. Fair condition.

Modernised. Poor-medium quality. Fair-good condition.

Fully glazed. Clerestory windows remain.

Modernised. Over-scaled fascia. Fair condition.

Modern. Co-ordinated fascia and window signs.

Takeaway business closed mornings. Good indoor / outdoor connectivity. ATM.

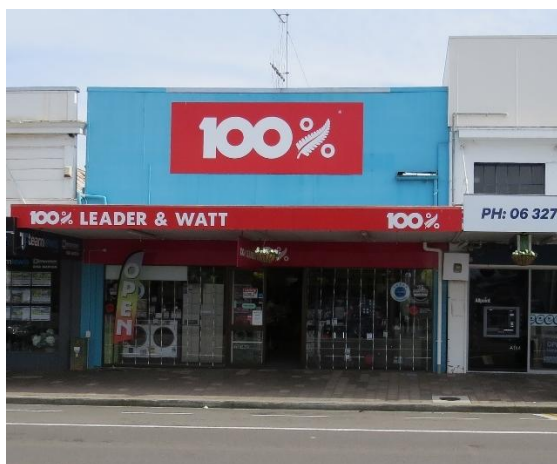
### 234 Broadway / Leader & Watt

Parapet. Modernised. Poor quality. Good repair.

Modernised. Medium quality. Good repair.

Fully glazed. Window display. Security mesh.

Modernised. Med-fair quality. Good repair.

Modern. Co-ordinated. Over-scaled parapet sign.

Large appliances in window. Little indoor / outdoor connectivity.

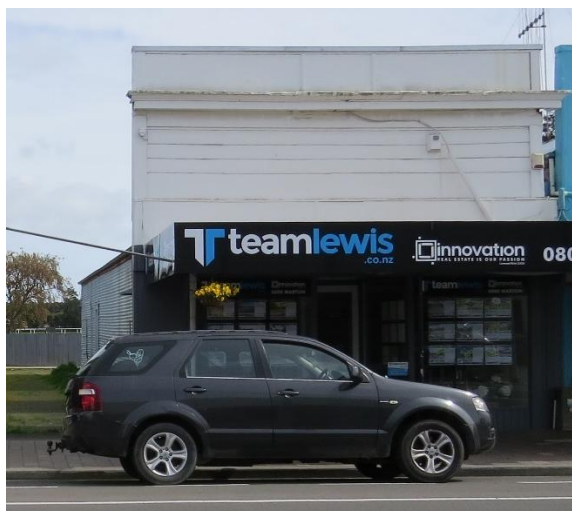
### 236 Broadway / Team Lewis

Original timber. Modified parapet?

Modernised. Fair quality. Fair condition.

Fully glazed.

Modernised. Posts. Over-scaled fascia. Fair condition.

Real estate window display limits indoor / outdoor connectivity. Deeply recessed entry.

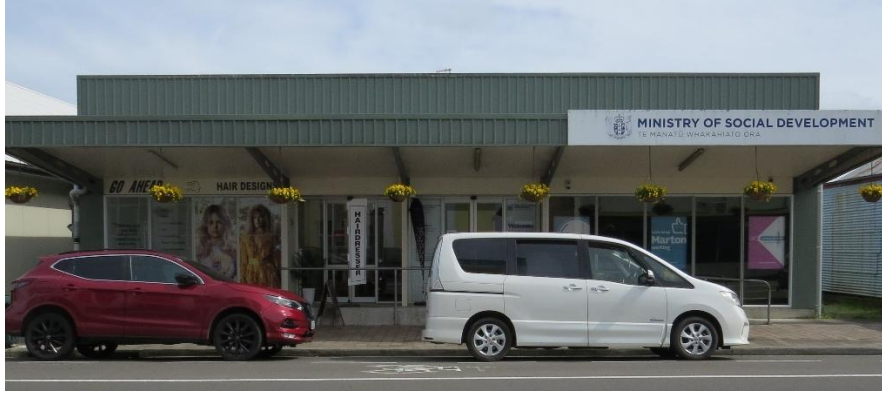
## 238-248 Broadway / Ministry of Social Development / Go Ahead Hair Designs

| <b>Upper Façade</b><br>Parapet only. Modern. Low quality. Good repair. | <b>Activation</b><br>Non-typical development. Raised floor level. Deep setback to accommodate ramped access. Balustrade and change in datum reduces contact with street edge. Window signage greatly reduces indoor / outdoor visual connectivity. |
| <b>Lower Façade</b><br>Modern. Medium quality. Good repair. Raised floor. | |
| <b>Ground-Floor Fenestration</b><br>Fully glazed. | |
| <b>Veranda</b><br>Modern. Over-scaled cantilever. Shallow pitch on soffit. Exposed steep structure. | |
| <b>Signage</b><br>Modern. MSD fascia sign. | |

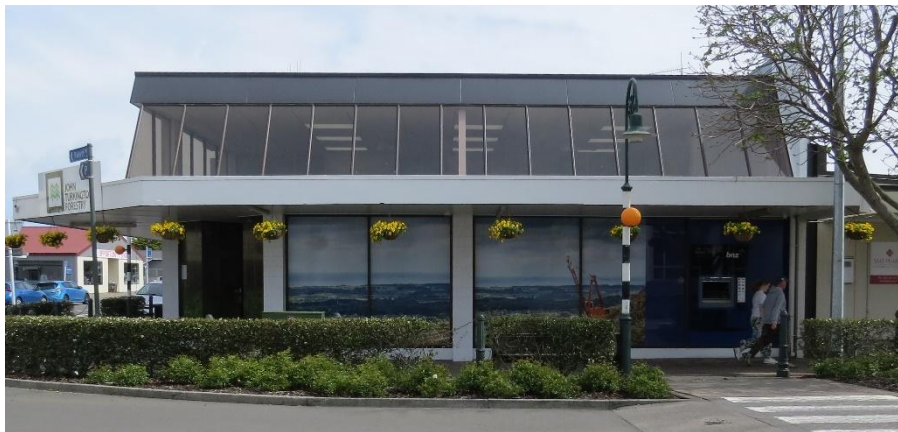
## 252 Broadway / John Turkington Forestry

| <b>Upper Façade</b><br>Modern. Fair quality. Good condition. | <b>Activation</b><br>Entrance addresses corner. Contemporary commercial architecture offers low-moderate visual interest. Images on windows prevent indoor / outdoor connectivity. Tinted glass limits sense of first-floor occupation. ATM. |
| <b>Lower Façade</b><br>Modern. Fair quality. Good condition. | |
| <b>Ground-Floor Fenestration</b><br>Fully glazed. | |
| <b>Veranda</b><br>Modern. Fair quality. Good condition. | |
| <b>Signage</b><br>Modern. Single fascia-mounted sign at corner. | |

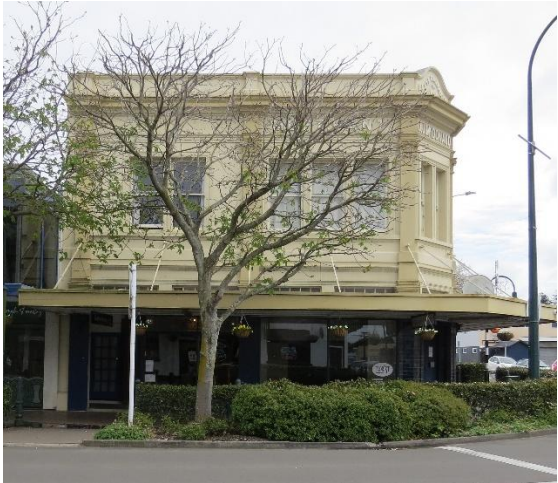
| <p><b>256-258 Broadway / J.J.McDonald</b></p> | <p><b>Upper Façade</b><br/>Original. High quality. Very good repair.</p> |

| | <p><b>Lower Façade</b><br/>Some original. Good quality. Very good repair.</p> |
| | <p><b>Ground-Floor Fenestration</b><br/>Fully glazed both frontages.</p> |
| | <p><b>Veranda</b><br/>Original. Good repair.</p> |
| | <p><b>Signage</b><br/>Discrete window signs. Original façade inscription.</p> |
| | <p><b>Activation</b><br/>Corner entrance. Good indoor / outdoor connectivity. Some window displays. Vacant corner tenancy. Sense of inhabitation on upper level.</p> |

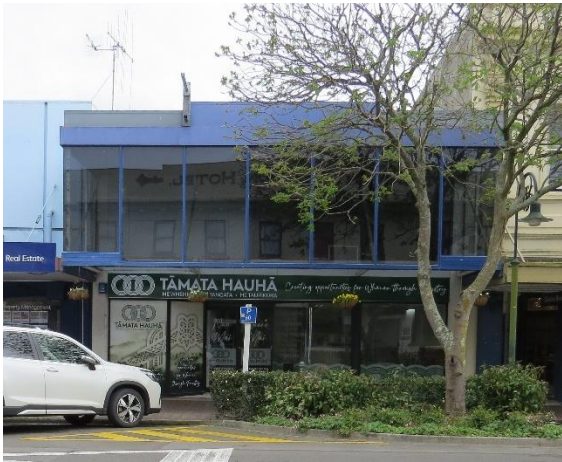
| <p><b>262 Broadway / Tāmata Hauhā</b></p> | <p><b>Upper Façade</b><br/>Modern construction. Consistent scale. Average quality. Low-medium visual interest. Well maintained.</p> |

| | <p><b>Lower Façade</b><br/>Modern. Average quality. Well maintained.</p> |
| | <p><b>Ground-Floor Fenestration</b><br/>Fully glazed. Partially screened by graphics.</p> |
| | <p><b>Veranda</b><br/>Projecting, glazed box. Conceals upper façade.</p> |
| | <p><b>Signage</b><br/>High quality, integrated.</p> |
| | <p><b>Activation</b><br/>Office reception. Limited connectivity. Little activity.</p> |

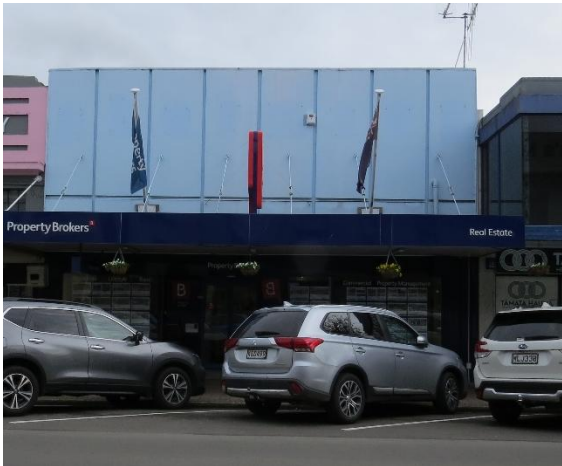
| <p><b>266 Broadway / Property Brokers</b></p> | <p><b>Upper Façade</b><br/>Modernised. Consistent scale. Fair quality. Low visual interest. Well maintained.</p> |

| | <p><b>Lower Façade</b><br/>Modernised. Fair quality. Well maintained.</p> |
| | <p><b>Ground-Floor Fenestration</b><br/>Fully glazed. Mostly screened by advertising.</p> |
| | <p><b>Veranda</b><br/>Modernised. Well maintained.</p> |
| | <p><b>Signage</b><br/>Façade sign removed. High-quality awning sign / flags.</p> |
| | <p><b>Activation</b><br/>Real estate office. Curated window display. Limited internal / external connectivity. Little visible activity.</p> |

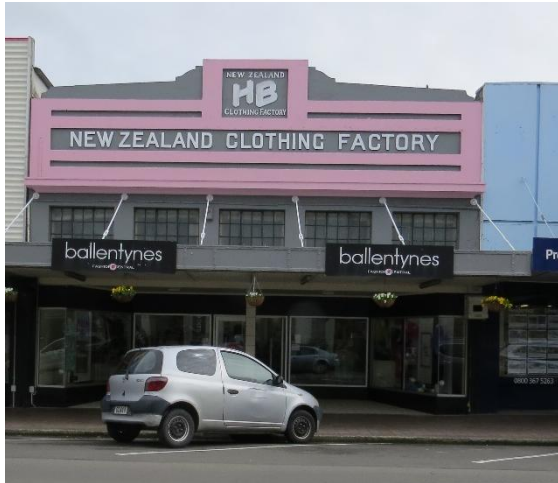
## 268 Broadway / Ballentynes

Early 20<sup>th</sup> century. High-quality. High visual interest. Well maintained.

Modernised. Fair quality. Well maintained.

Fully glazed. Retail displays. Recessed entry.

Original. Partially modernised. Fully integrated.

High-quality. Integrated. Original above. Modern below.

Good internal / external connectivity.

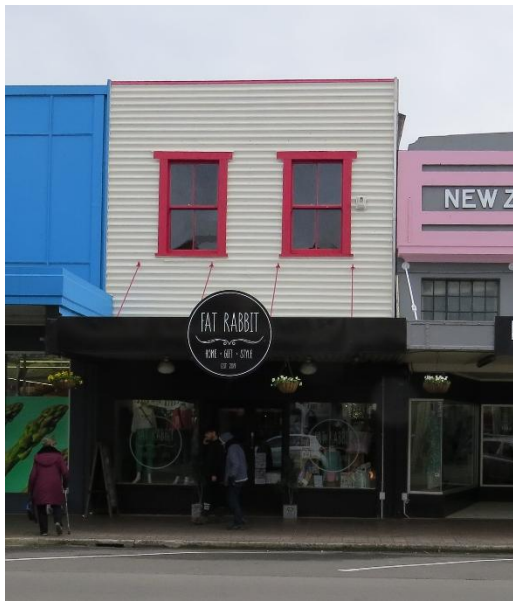
## 272 Broadway / Fat Rabbit

Modernised. Poor-medium quality. Fair condition.

Modernised. Medium quality. Good repair.

Fully glazed.

Modified original.

Modern. High quality. Co-ordinated.

Good indoor / outdoor connectivity. Attractive window displays.

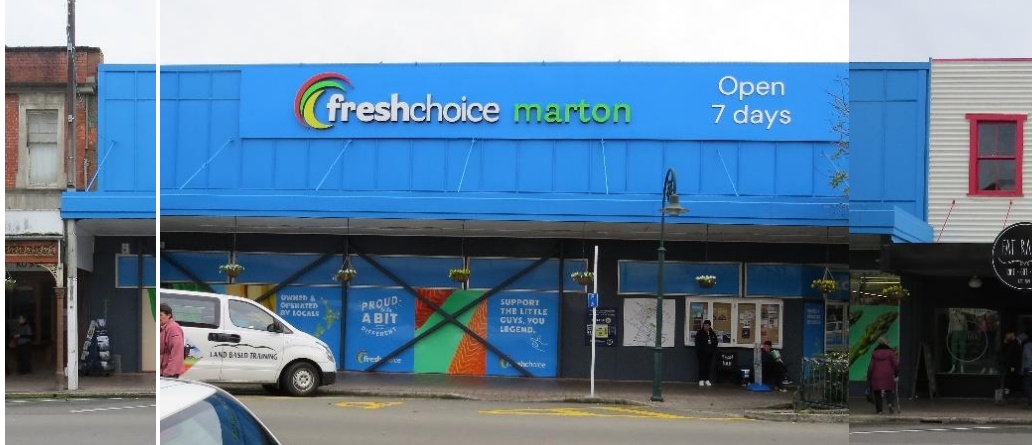
## 276 Broadway / Freshchoice

Parapet only. Modern. Poor quality. Good repair.

Modern. Poor quality. Good repair.

Glazing at entrance (blocked). Clerestory windows (blocked).

Modern. Fair condition. Poor lighting.

Parapet. Modern. High-quality. Corporate livery.

Long frontage with little activation or visual interest. Applied graphics block already limited glazing. Structural cross-bracing contributes to perception of barrier at street edge. Corporate livery is intrusive.

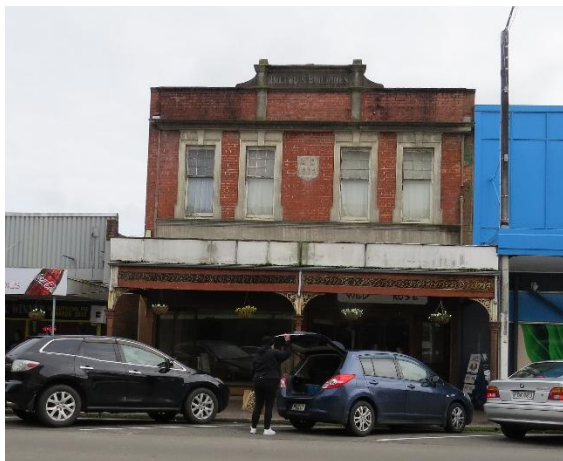
## 286 Broadway / Hilton's Buildings

Original. High quality. Poor condition.

Modernised. Medium quality. Partly sympathetic.

Fully glazed. Recessed door.

Original with posts. Ornate. Very poor condition.

Original inscriptions. Redundant ground-floor sign.

Vacant ground floor. Little sense inhabitation above.

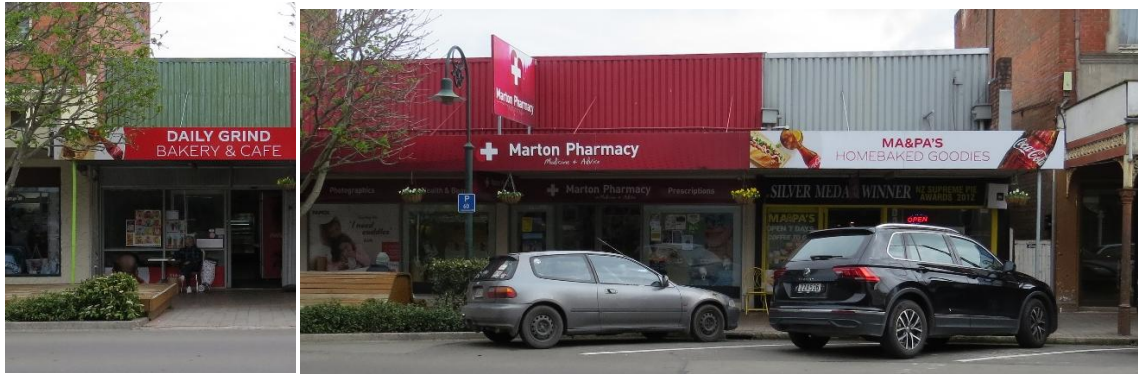
## 288-294 Broadway / Ma & Pa's / Marton Pharmacy / Daily Grind

Modern parapet. Low-medium quality. Fair condition.

Modern. Good quality. Good condition.

Fully glazed.

Modern. Fair quality. Good condition.

Modern. Medium-high quality. Co-ordinated.

Three buildings present as single long façade. Horizontal emphasis almost as stark as that of Freshchoice supermarket. Pharmacy window displays add interest but limit indoor / outdoor connectivity to entrance. Café outdoor seating.

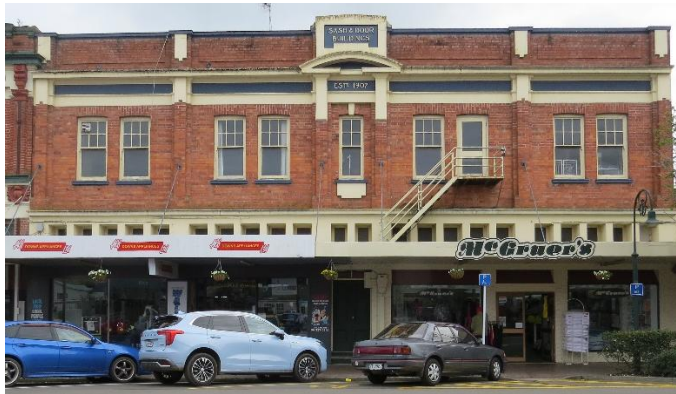
## 296-298 Broadway / Sash & Door Buildings

Original. High-quality brick. Good repair.

Modernised. Medium quality. Good repair.

Fully glazed.

Modernised suspended cantilever. Medium quality. Good condition.

Good signage. Co-ordinated. Original inscriptions.

Historically significant connection to prominent Marton business. Ground-floor window displays. Some on-street merchandise (McGruer's). Little sense of inhabitation above. Part of sequence of four high-quality original facades.

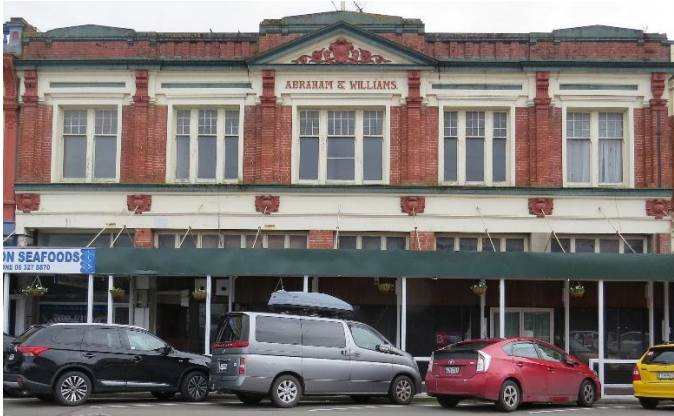
### 302-304 Broadway / Abraham & Williams

Original. Very high quality. Good condition.

Modernised. Poor quality. Poor-fair condition.

Original suspended cantilever. Partly modernised. Poor condition (temporary timber props).

Redundant Marton Seafoods signs. Original inscriptions.

Vacant ground floor. Screened windows. Temporary props to veranda contribute to separation from street. Little sense of inhabitation above. Part of sequence of four high-quality original facades.

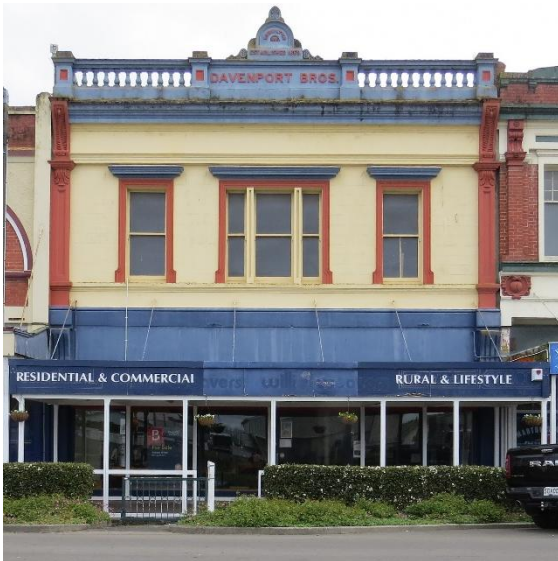
### 310-314 Broadway / Davenport Bros.

Original. High quality. Fair-good condition.

Modernised. Fair quality. Sympathetic. Fair-good condition.

Fully glazed.

Modernised suspended cantilever. Temporary props.

Remnant signs on veranda fascia. Original inscriptions.

Passive display of historic farm machinery. Poorly illuminated. Veranda props and planting increase separation from street. Part of sequence of four high-quality original facades.

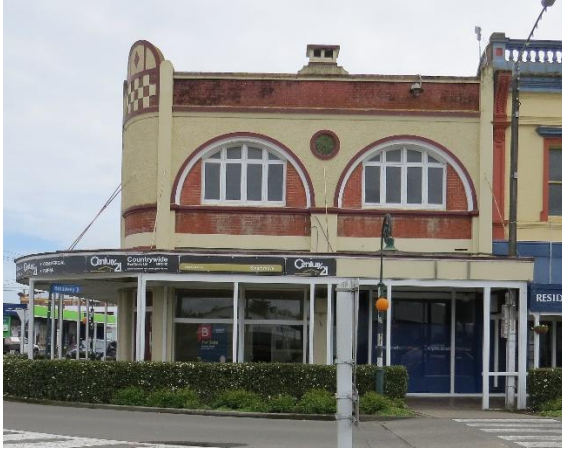
### 318 Broadway / Century 21

Original. High quality. Good condition.

Modernised. Various treatments on two frontages. Partly sympathetic. Good condition.

Fully glazed. Partially screened (Kip McGrath office).

Modernised suspended cantilever. Temporary props. Fair condition.

Redundant veranda fascia signs.

Kip McGrath office (still tenanted?). Otherwise vacant. Part of sequence of four high-quality original facades.

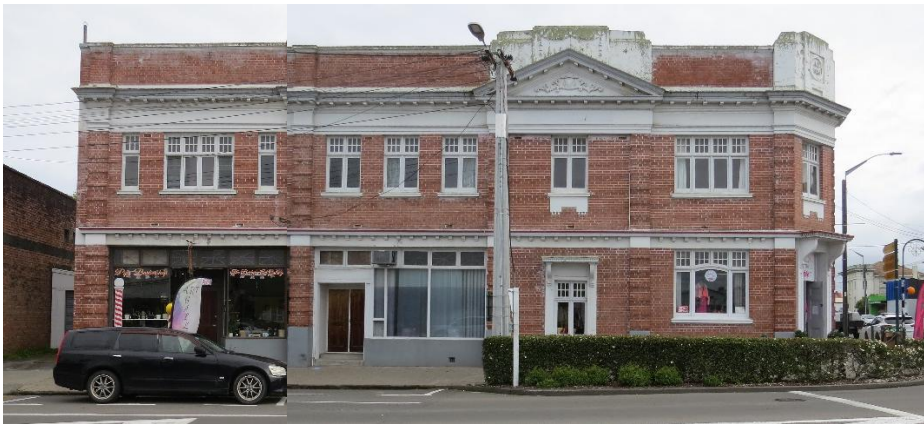
### 1 High Street / RAWR / Pip's Barbers

Original. High quality. Good condition.

Original. Fair condition.

Applied to glazing. Some free-standing signs on footpath. High quality. Sympathetic.

Two fully glazed shop fronts (one screened). Otherwise, small windows with raised sills (possibly raised ground floor) limit indoor / outdoor connectivity. Strong corner entrance. Pip's Barbers makes strong address to street (window display, planters, free-standing signs).

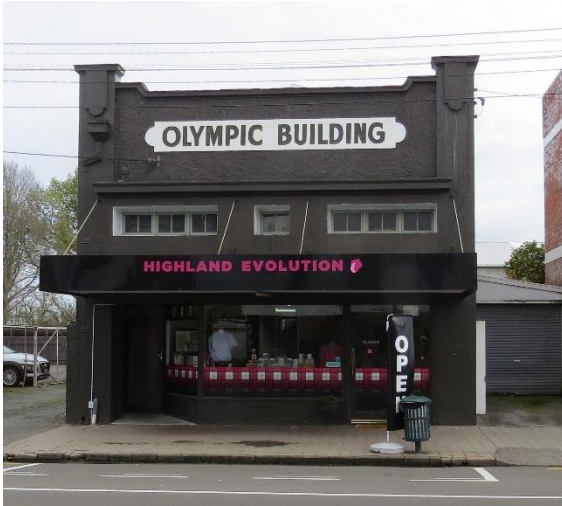
### 328 Broadway / Olympic Building

Original. High quality. Good condition.

Modernised. Medium quality. Good condition. Sympathetic.

Fully glazed.

Modernised suspended cantilever. Overly deep fascia.

Original parapet sign? Excessive contrast. High-quality co-ordinated veranda / window signs / livery.

Window display with strong street appeal. Good indoor / outdoor connectivity. Dark colour partially conceals façade detail.

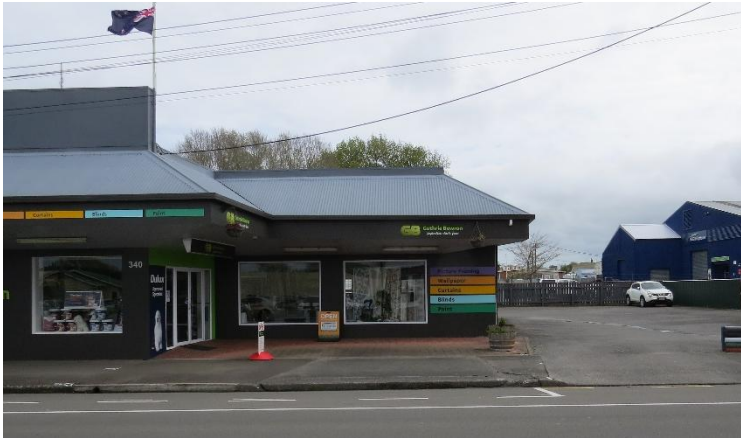
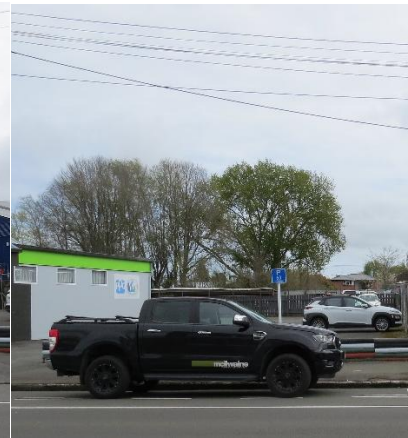
### 340 Broadway / Guthrie Bowron

Modern. Parapet with pitched roof over veranda. Fair quality. Good condition. Out of character.

Modern. Fair quality. Good condition. Partly set back from street edge. Detached building in the round.

Partially glazed. Some blank elevation at street edge.

Reads as roof rather than veranda. Out of character.

High quality. Coordinated.

Carpark and forecourt contribute to detachment from street edge. Hybrid character represents shift towards vehicle-oriented retail format.
