Subject: **Upgrading Amenities for Taihape Memorial Park – further report**

TAIHAPE MEMORIAL PARK GRANDSTAND FEASIBILITY REPORT

Rangitikei District Council

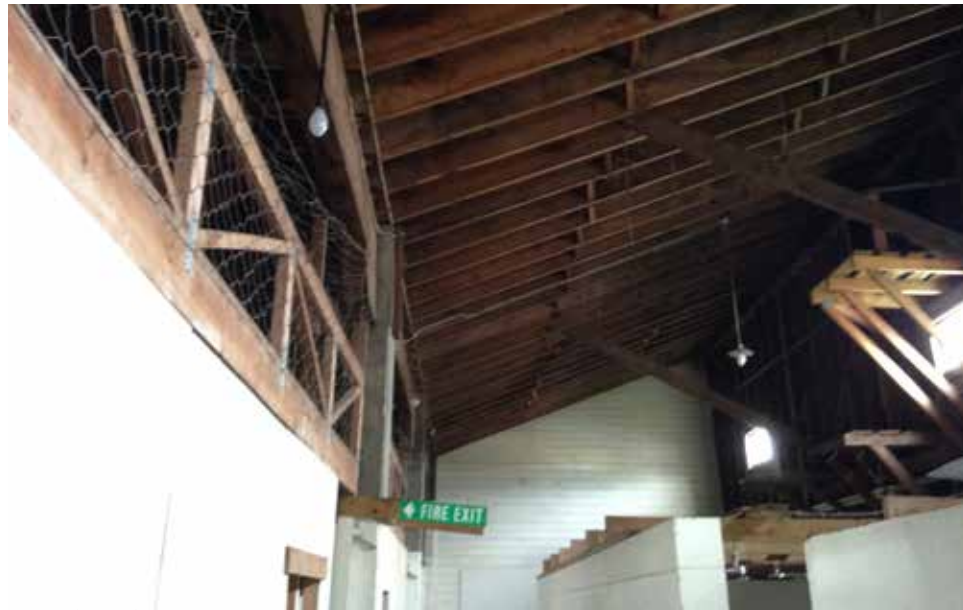
Grandstand Interior

The building appears to be in a generally run-down condition, not only in the changing and shower room areas on the ground floor, but also inside the roof canopy over the seating. This is dark and dirty, and stained and littered with bird droppings. An attempt to control birds has been made with the installation of light netting below the roof trusses. This is damaged and broken and now accommodates, as well as birds nests, many empty bottles which have been thrown there by people from below. This needs to be cleaned up, consideration given to decorative treatment of the timber, and effective new bird control installed.

The changing rooms and showers are now so dilapidated that they appear beyond maintenance and repair and need to be removed and supplanted by new facilities.

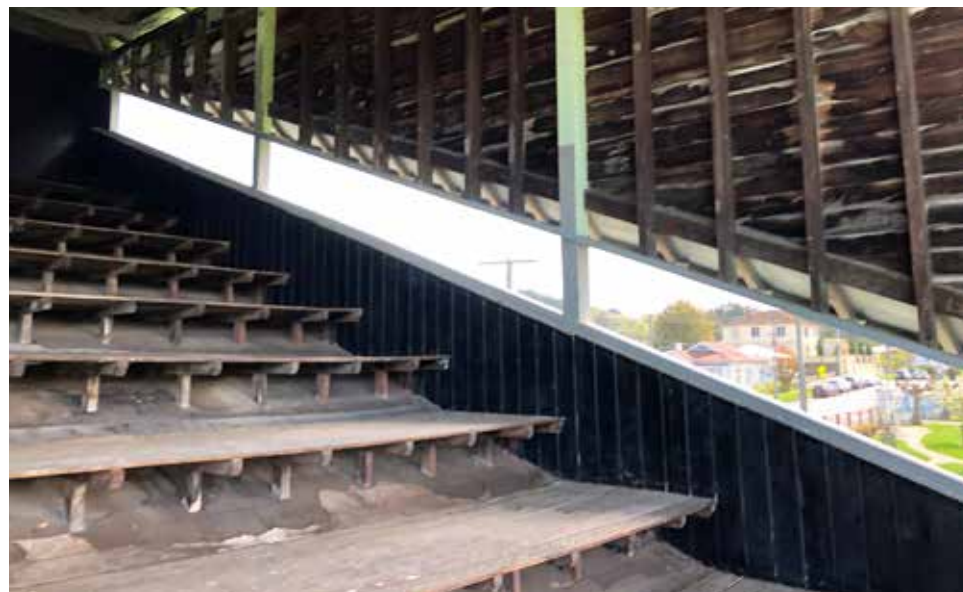
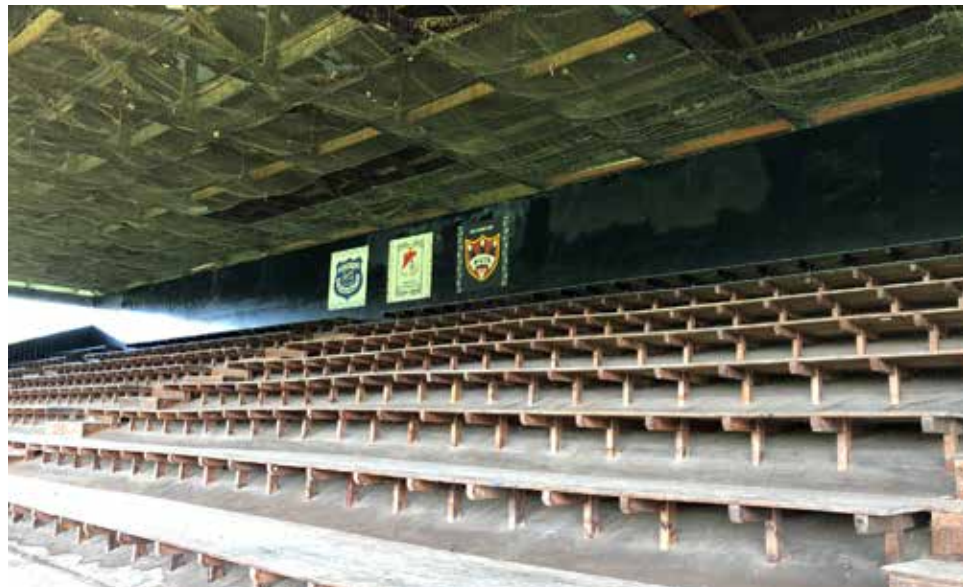
Grandstand seating detail

It is noted that the KOA report did not consider the structural capacity of the seating in their report. The main beam supporting the sloping ramp has been identified as rimu. There is some springiness. It is not stated what timber the rest of the seating assembly is made of. The timber of the seat benches looks to be hardwood possibly totara. Despite its worn condition the timber may have much life left, however the structural system of its support needs to be assessed by an engineer.

Further structural investigation is recommended. All timber seating members should be inspected and the whole seating assembly tested to determine its structural capacity. This detailed work is needed before the restoration can be accurately costed and compared with the cost of replacement with modern construction.

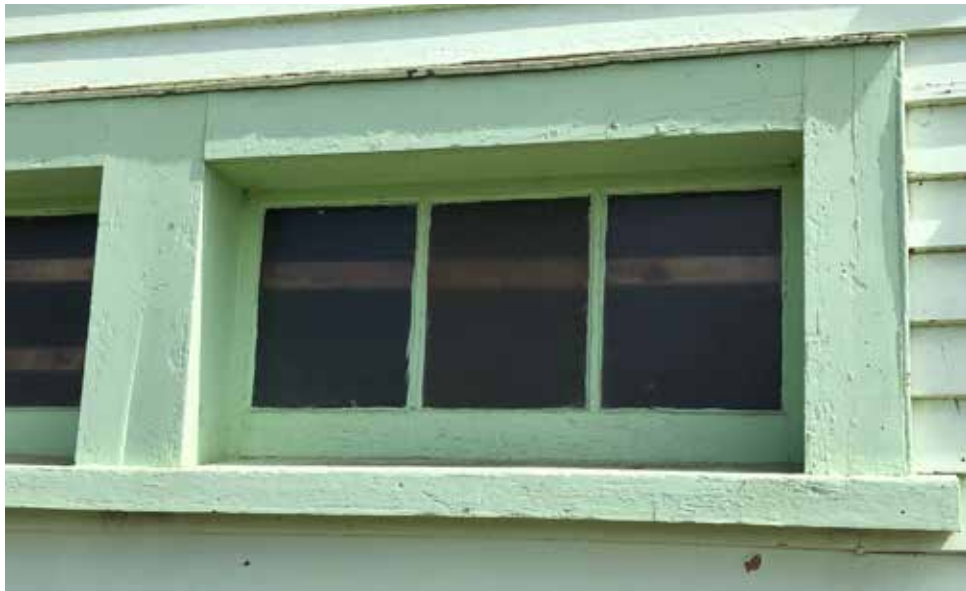
Typical existing window jammed in closed position

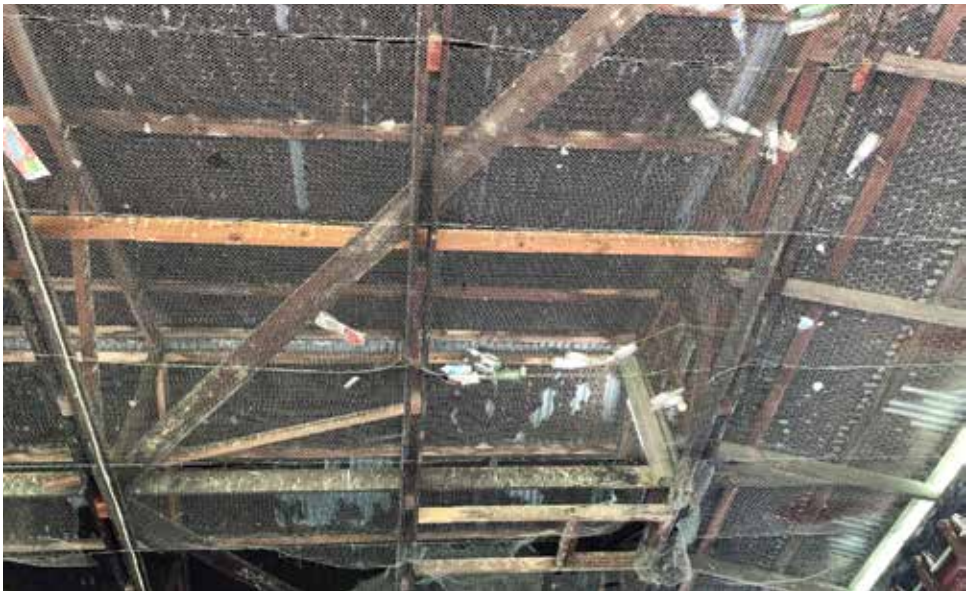
As noted in the Proarch report of 2017: 'The roof is clad in short sheet lengths overlapped (painted) not long run, the roof has not been recently inspected and we have not viewed it, its condition is therefore unknown.' The replacement of the roof, including replacement flashings, gutters and downpipes to current standards, has been assumed as an essential component of the refurbishment of the building.

Condition of roof above seating

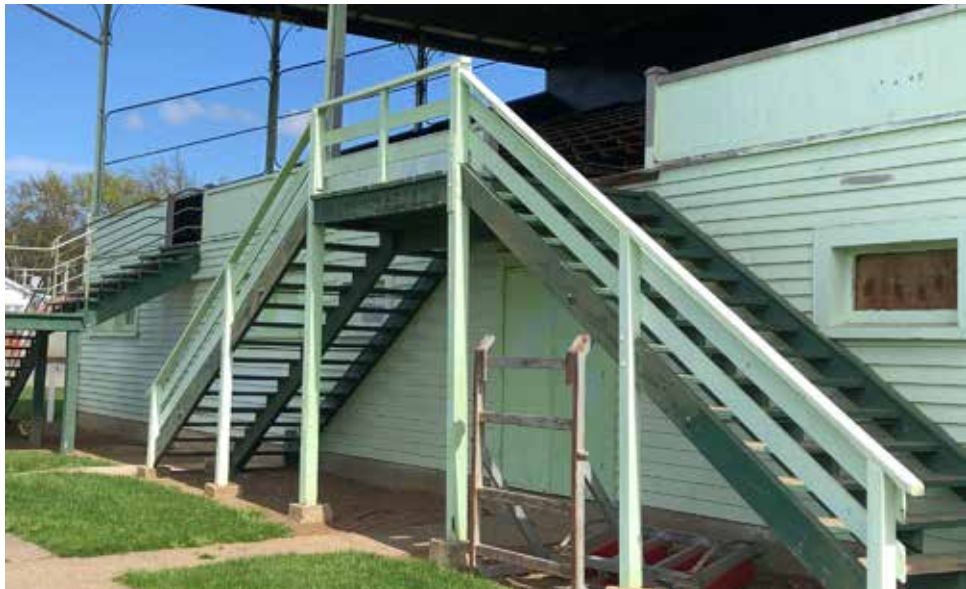
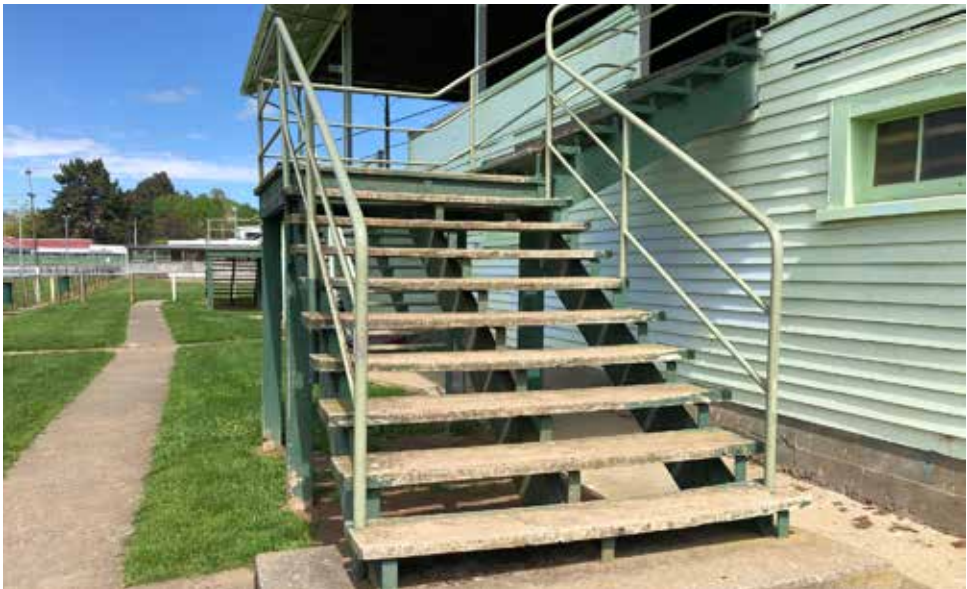
Existing open tread stair

The means of access to the grandstand seating is significantly short of current standards. There is no wheelchair access (either by ramp or lift) to the upper level. The stairs have open treads and handrails which do not meet the current standards for accessible stairs. The KOA 2009 report also identified serious structural deficiencies with the stairs (which since may have been fixed to some extent). Escape distances and pathways potentially will not comply with regulatory requirements. Barriers also exist in excess of 20mm high at the door thresholds at ground floor level, thus inhibiting wheelchair movement.

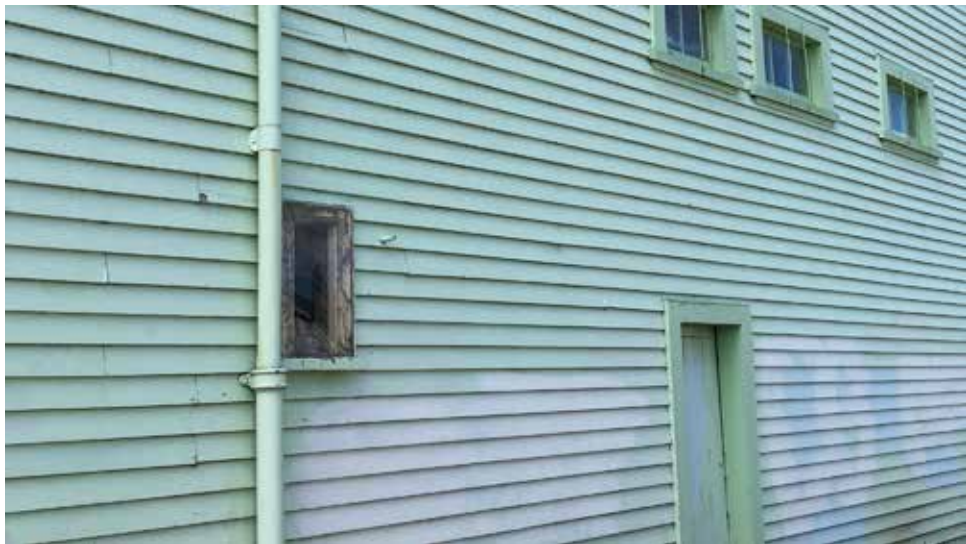
Original weatherboard cladding

To cursory visual inspection, the external walls generally appear to be straight and true, without major signs of seismic movement or damage over the years. It is unlikely that there is any insulation in the building, and perhaps no building paper – this is not of great concern because there are no internal linings to the external walls and it would be the assumption to retain this status quo.

The Proarch Report assumes replacement of existing cladding where rotten (although the extent of this is not known), repaint of external painted surfaces, internal demolition, seal off wastes and water supplies, new internal linings and bracing elements in plywood where identified in the KOA Report 2009. This appears to be appropriate.

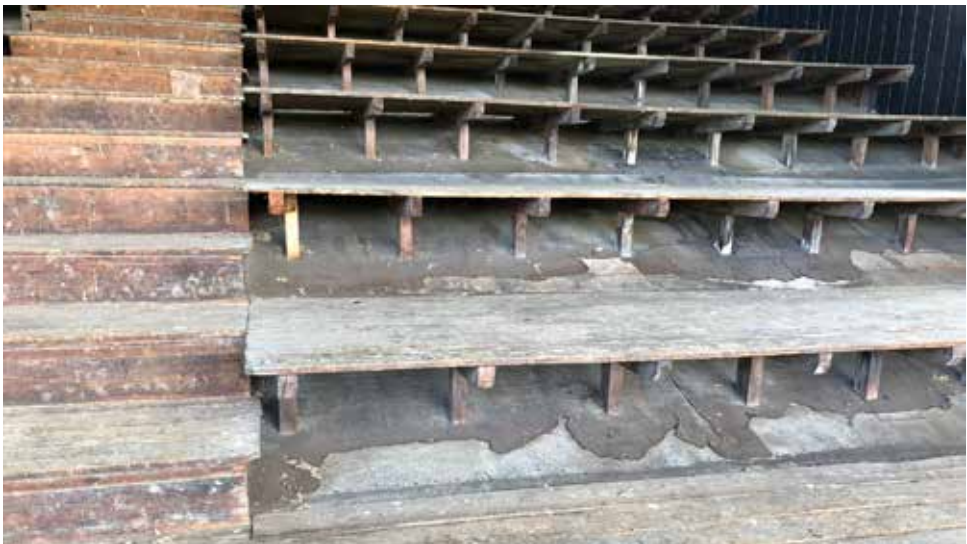
In 2009, Stephen Pinkney noted: *'Whilst it appears that a waterproofing membrane has been applied to the upper surface of the sloping floor, this is unlikely to be 100% effective at keeping water out from the rooms below. Therefore, if dry areas and linings such as Gib Board are envisaged below, then at least some areas of the waterproofing will require remedial work. This may be problematic as it is also a wearing surface and has seats framed off it.'* From visual recent inspection, it is evident that the waterproofing issue has got worse since the 2009 report was prepared. It would be a major task to replace the top applied membrane and make it totally effective from a waterproofing viewpoint, and this may not be practicable. However, the finish to the top side of the ramped floor could be replaced by a new wearing surface. For the purposes of this report it is assumed that any fit-out work below the bleachers will be waterproofed independently from the sloping soffit.

Damaged waterproofing under seating
