# DETAILED SEISMIC ASSESSMENT

## ASSESTS BUILDING

### 46 HIGH STREET, MARTON

18 FEBRUARY 2022

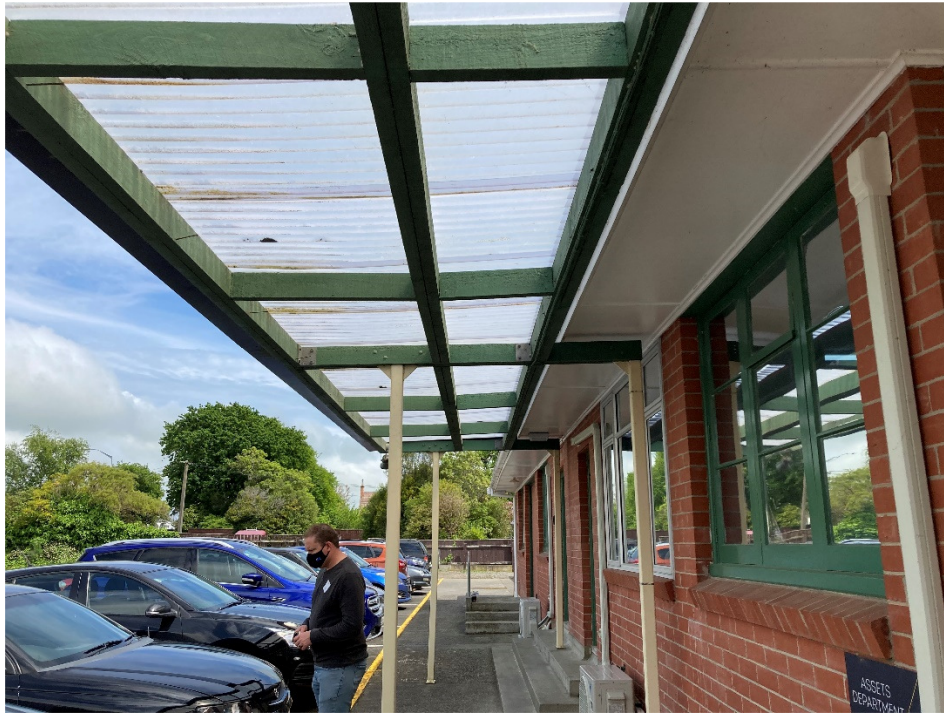
Figure 3: Front elevation indicating masonry veneer and covered walkway

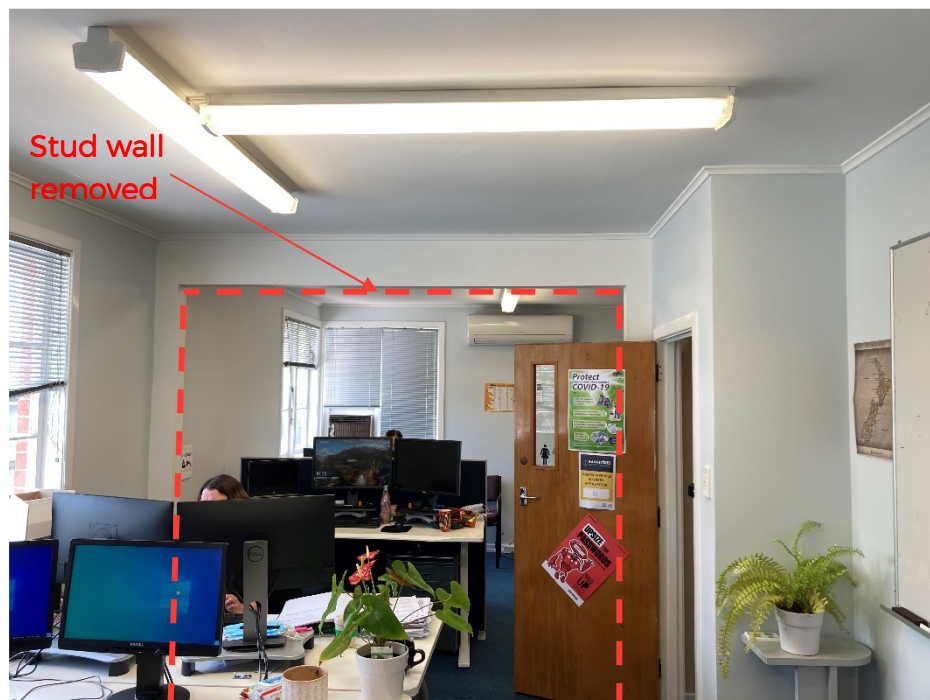
Figure 4: Office with new Gib lining and internal wall removed

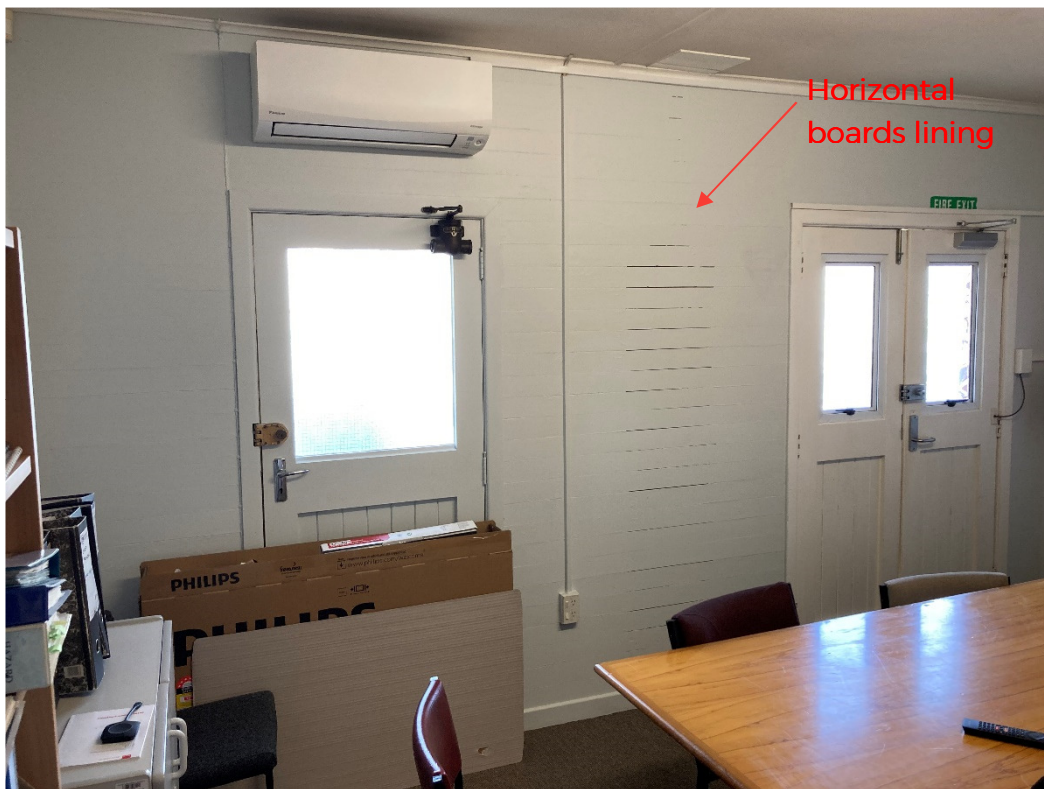
Figure 5: Original horizontal sheathing (Rata Room)

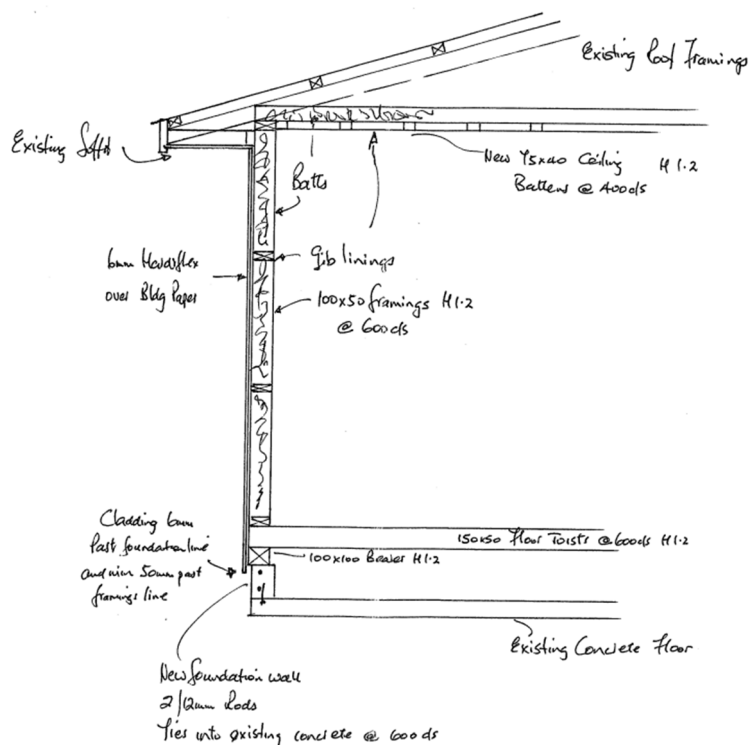
Figure 7: Typical section (across)

The gravity and lateral load resisting system comprises of lightweight timber frame wall construction as can be seen in Figure 7. Seismic loads are transferred via the ceiling diaphragm into the bracing walls (plasterboard linings to walls) and down into the perimeter footing. BRANZ report no. 134 notes that roof bracing is not a requirement where structural ceiling diaphragms are directly connected to trusses/rafters (in accordance with NZS3604 clause 13.5). It is therefore accepted that the ceiling diaphragm in the Assets Building is sufficiently connected to meet the requirements.

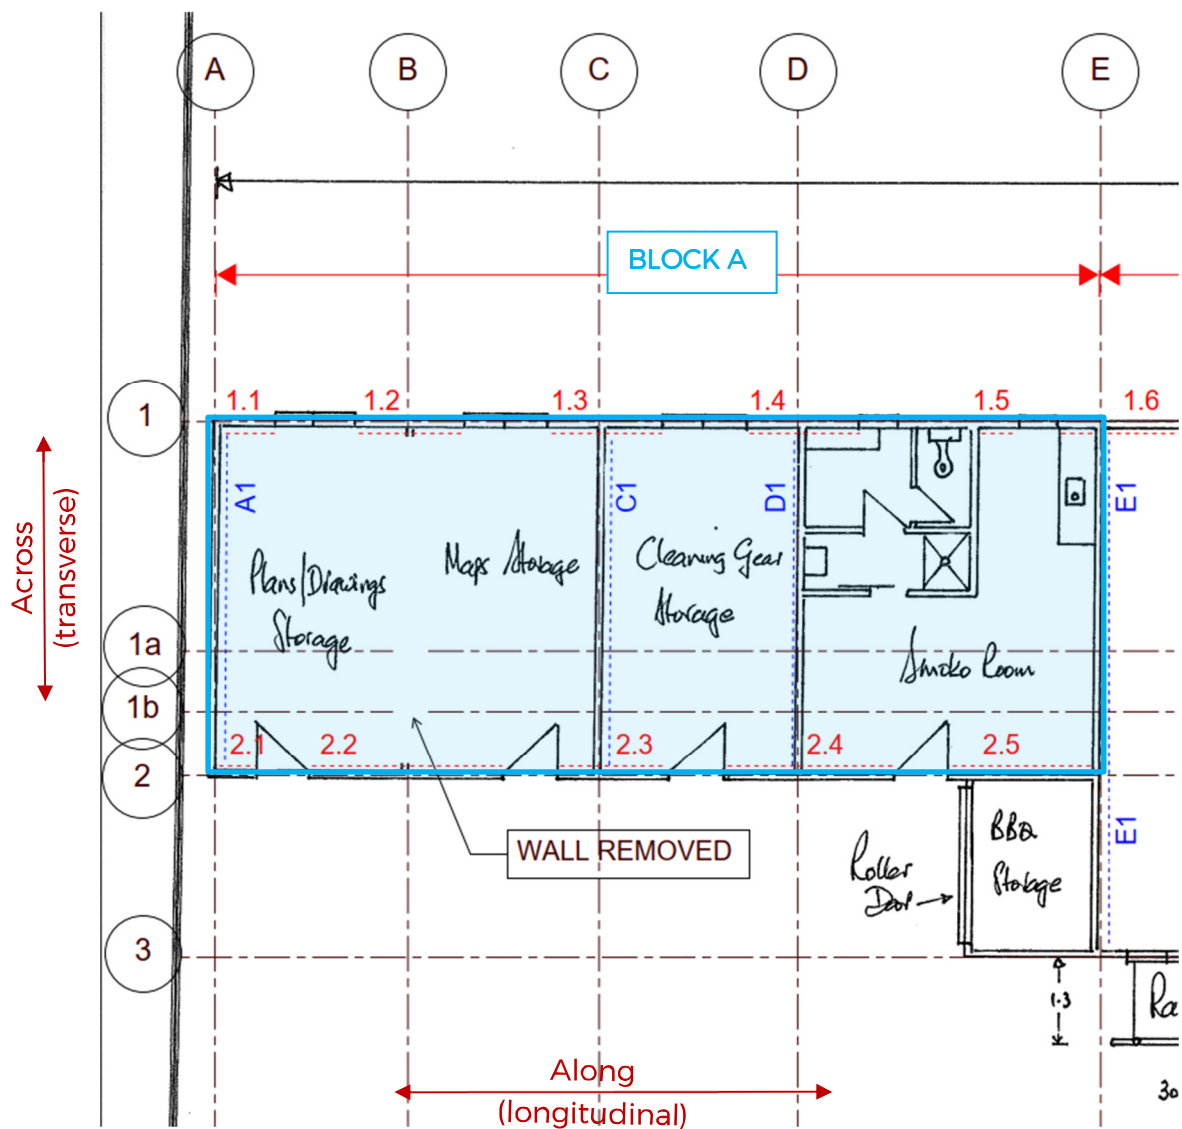
Figure 9: Block A bracing wall layout

On-site investigation confirmed that bracing walls have been re-lined with plasterboard during the 2006 alterations. In some areas, the original horizontal boards have not been replaced, therefore dependable strengths for this type of sheathing have been used in determining bracing capacity of the walls. Bracing wall layouts are shown for Block A and Block B in Figure 9 & 10 respectively.
