Detailed Seismic Assessment

Marton Civic Centre

Corner of Broadway and High Street, Marton

Date: 11-07-2019
Reference: 5-WT489.01
Status: Issue 1

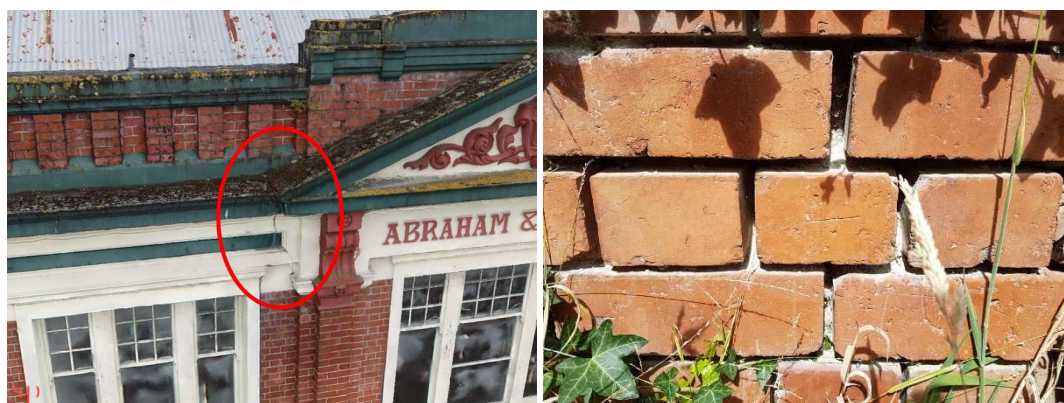
The façade of Abraham and Williams has large diagonal cracks at the top corners of the window spandrels. These cracks travel up into the parapet section of the façade. The cracking pattern significantly limits the shear capacity of the walls and may lead to the URM walls becoming more susceptible to out-of-plane failure.

Sections of the URM walls at the rear of the buildings contain washed out areas of mortar in the joints. There are signs of cracking in the concrete bond beams, bricks and mortar joints in all of the buildings. This can negatively affect the in-plane performance of the walls. Several areas of rear walls have water damage due to broken drain pipes. There is corrosion observed in the bond beams reinforced with steel rail sections causing large splitting cracks.

Figure 6. Cracks in Abraham and Williams façade and washed out mortar joints

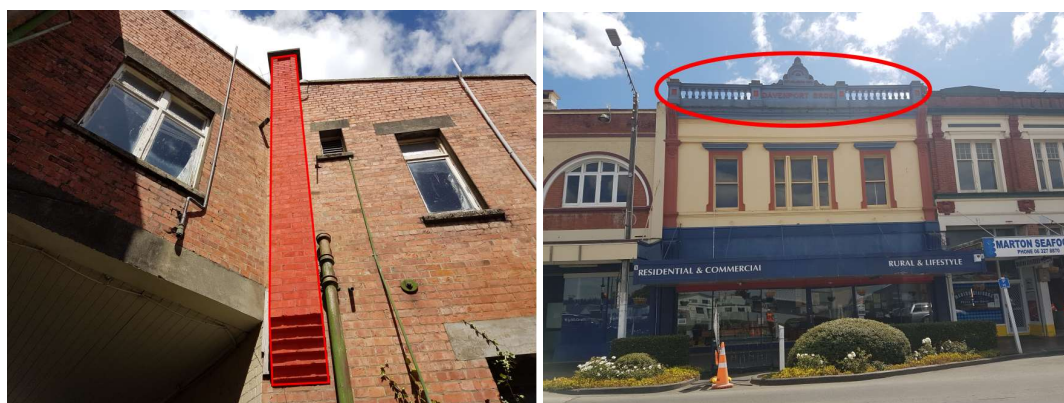
Heavy URM parts have been observed behaving poorly in past earthquakes. Parts such as parapets, ornaments and chimneys are vulnerable to collapse under small movements and pose a hazard to neighbouring properties and footpaths. The buildings in the Marton Civic Centre contain these URM parts as is seen below on the Cobbler and Davenport buildings

Figure 7. Protruding URM chimneys that extend pass the roofline and heavy ornaments/parapets at the top of Davenport's façade

| Element | Cobblers A and B | Davenport Brothers | Abraham and Williams |
|---|---|---|---|
| Chimneys above the roof | High 15% - Stability Intrusive Strengthening • Remove and replace with light weight replica OR • Repoint bricks, concrete fill within and tie existing bricks | Not Applicable | High 15% - Stability Intrusive Strengthening • Remove and replace with light weight replica OR • Repoint bricks, concrete fill within and tie existing bricks |

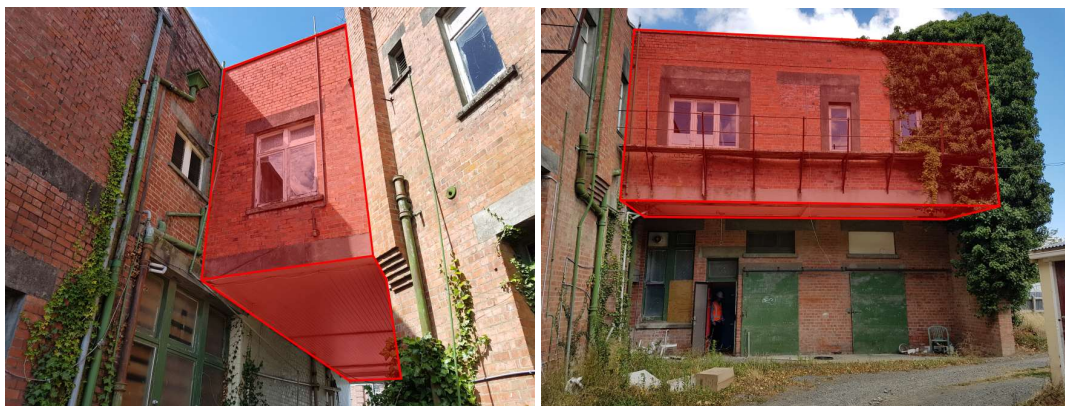
The connection between the two Cobbler buildings is provided at the upper level by means of a link structure with open corridor access underneath, as shown below, creating an area of potential weakness due to the absence of structural walls, which is vulnerable to damage from the independent movement of the two buildings to which it rigidly connects.

The rear section of Cobbler A contains a 400 mm deep cantilevered steel beam that provides support to a two course URM wall. The concrete bond beam that supports the brick is displaying signs of deterioration with cracks spread the length of the member.

Figure 8. Link between Cobblers and cantilevered Cobbler A wall

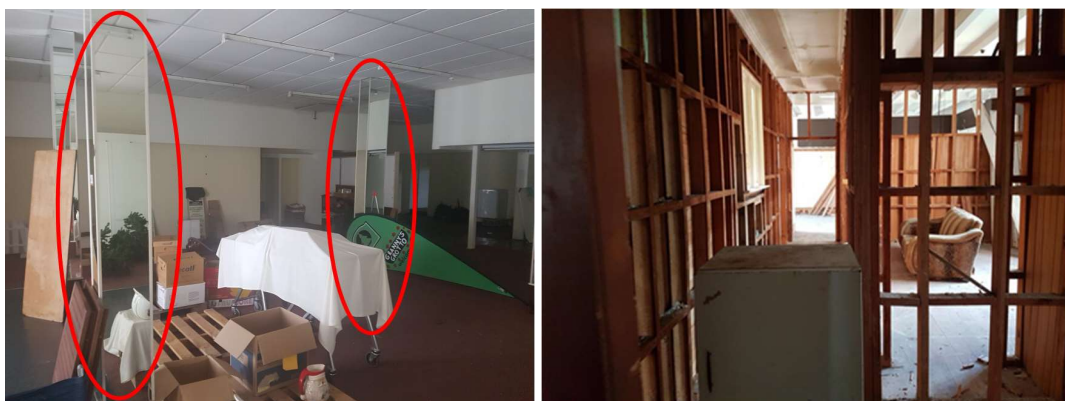
The ground floor of Abraham and Williams originally contained internal walls, which provided gravity support to the upper-level timber floor. The structure has undergone significant modifications to the layout of the URM walls at the ground floor, which now contains boxed out columns and is open plan. Remaining sections of the walls/beams above the ground floor were observed within the ceiling cavity, which span between these new columns. Large sections of internal timber partition walls have been stripped off their linings or removed completely.

Figure 9. Removed walls in Abraham and Williams and significant modification in Cobbler A

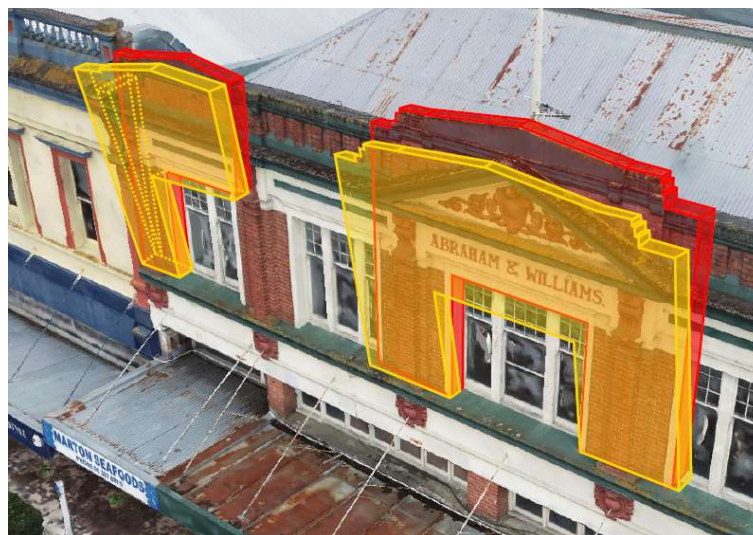
A local failure analysis was completed to determine any areas of the buildings vulnerable to failure due to the condition, layout, or position of elements. The analysis was completed with reference to both the displacement compatibility and the accelerations required to cause instability of the element². Sections such as the façade of Abraham and Williams, which contained cracks at the upper corners of the windows were highlighted as potential local failures and treated as block elements shown in the figure below.

Figure 12. Local failure mechanism analysis for Abraham and Williams' front façade

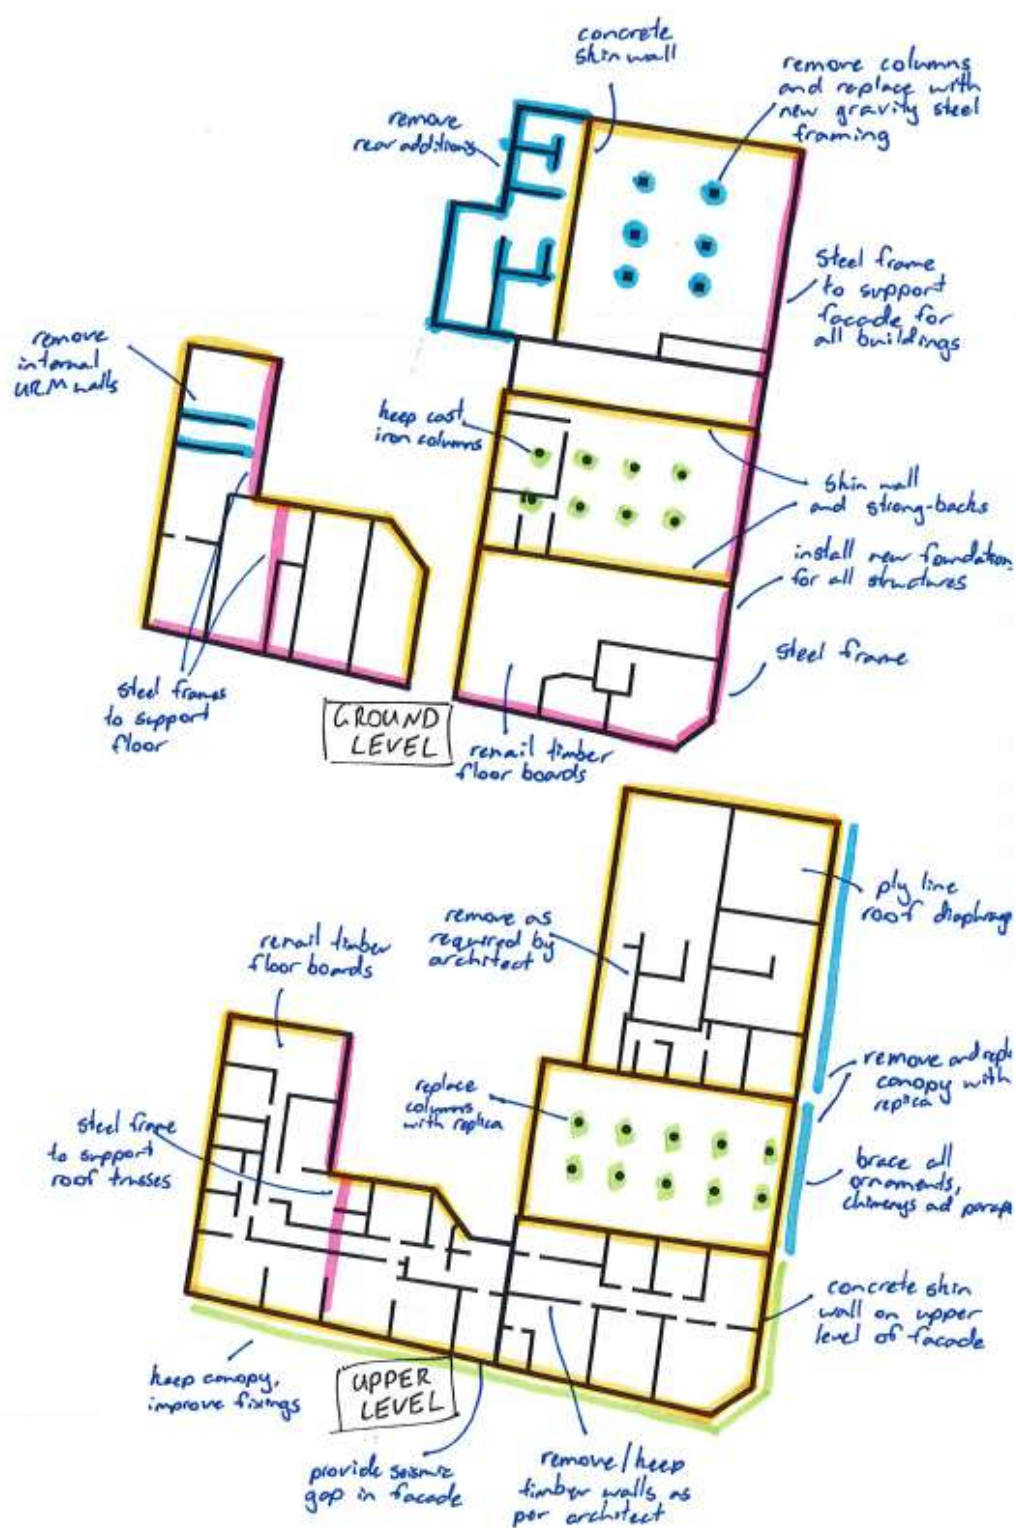
Figure 14. Concept strengthening

Our work is in progress for the concept strengthening design to bring the building to 100 %NBS as part of a separate stage of the project. The primary components of the structural strengthening are presented in Figure 14.
