Rangitikei District Council

DETAILED SEISMIC ASSESSMENT

46 HIGH STREET, MARTON

30 NOVEMBER 2021

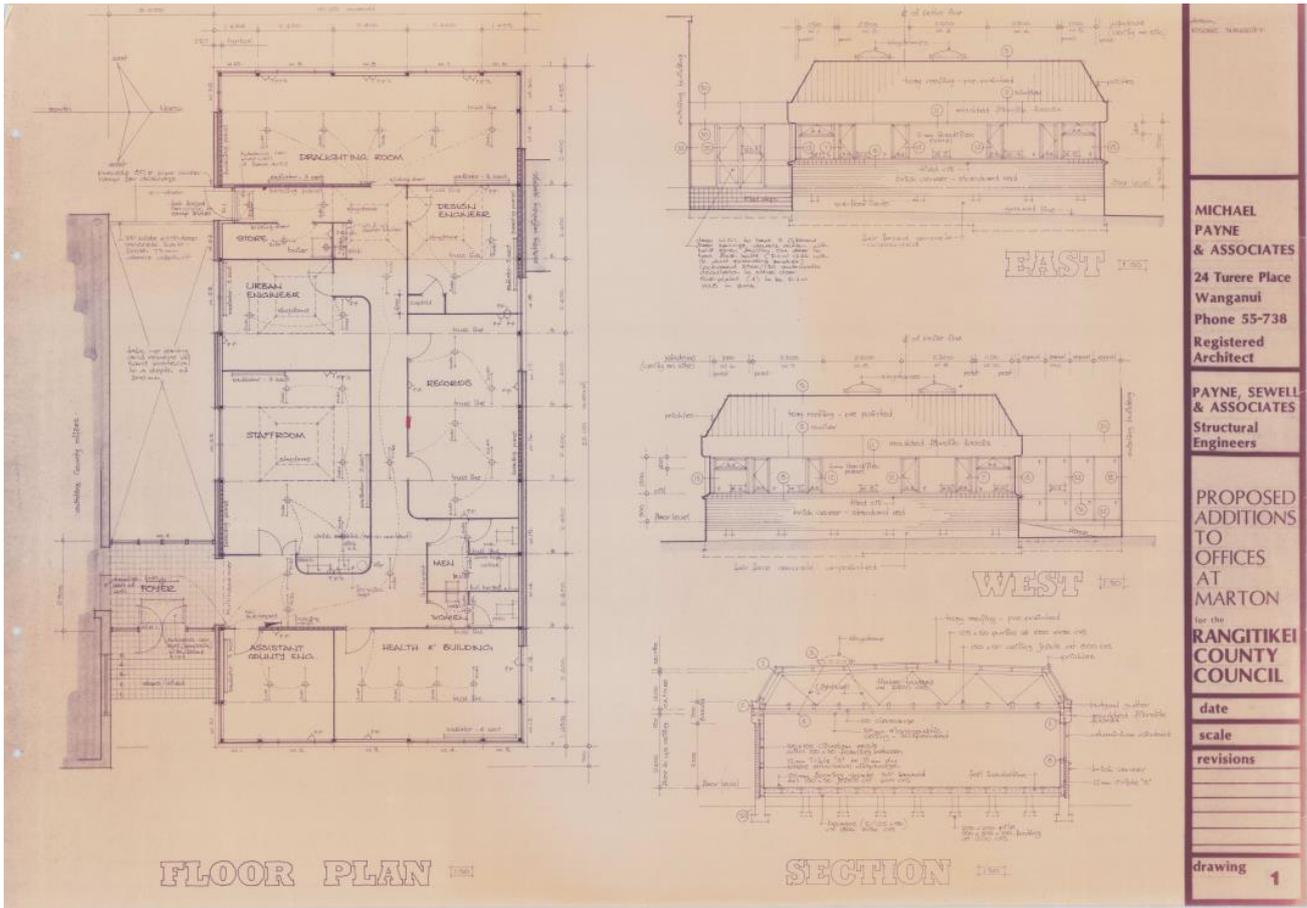
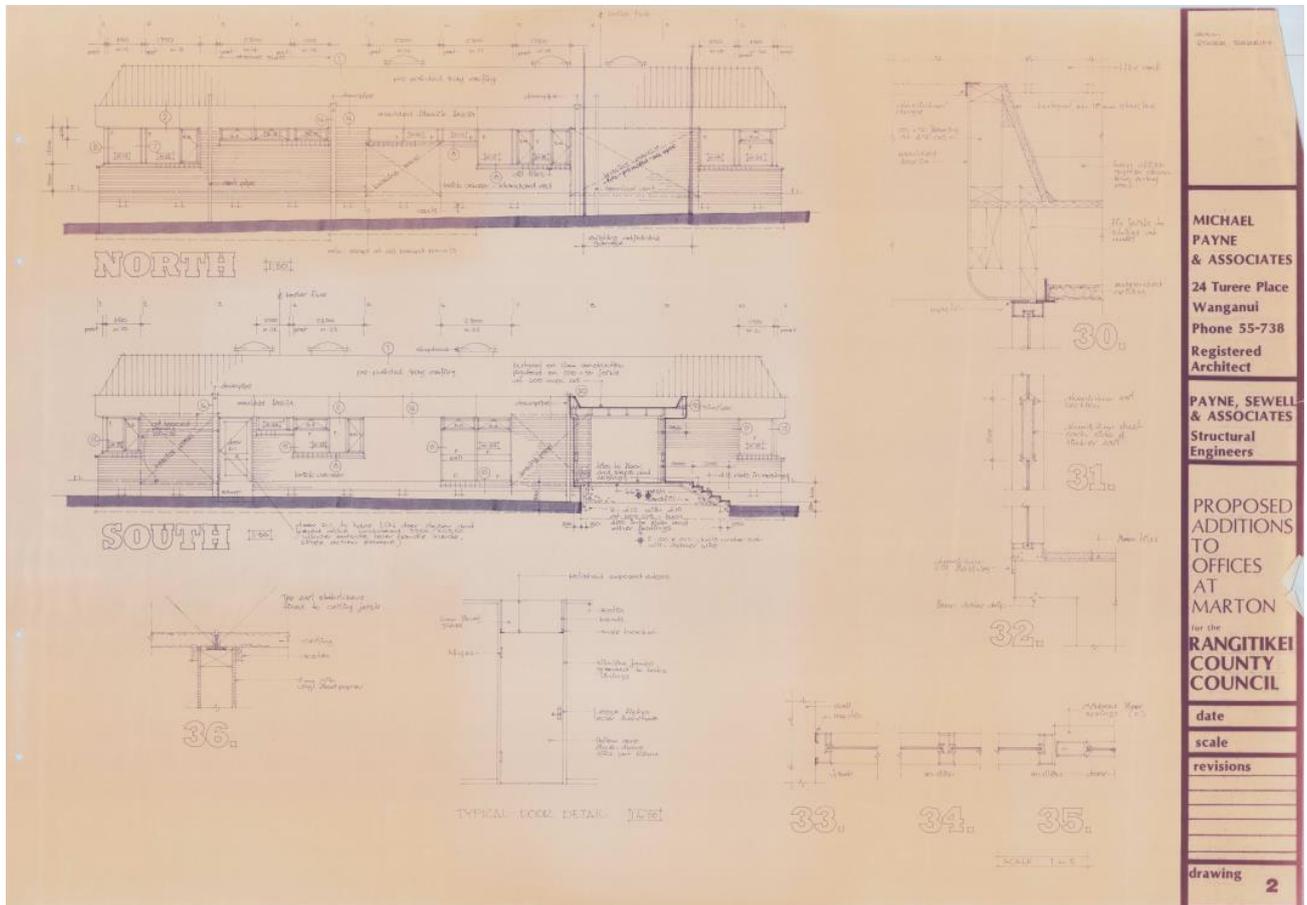
The single storey structure comprises of timber roof trusses supported on timber framed walls. Lateral loads are transferred to plywood lined bracing panels through the use of steel strap roof cross bracing. The plywood shear walls have reinforced concrete strip foundations. The building floor is constructed of timber flooring over timber joists, supported by timber bearer on piles footings.

The assessment shows that the performance of the building is limited by the lack of a sufficient load path in the roof bracing layout. Lateral loads at the roof level are then transferred through the GIB lining in the skylight domes. This score can be improved significantly by installing a new roof cross brace to complete the load path within the roof system.

Although the legal minimum requirement for strengthening works is 34%NBS, we would strongly recommend strengthening to at least 67%NBS.
