# Proposed Plan Change - Rezoning Rural to Industrial, Marton

Preliminary Geotechnical Appraisal

Date: February 2020  
Reference: 5-WT628.00  
Status: Issue 2

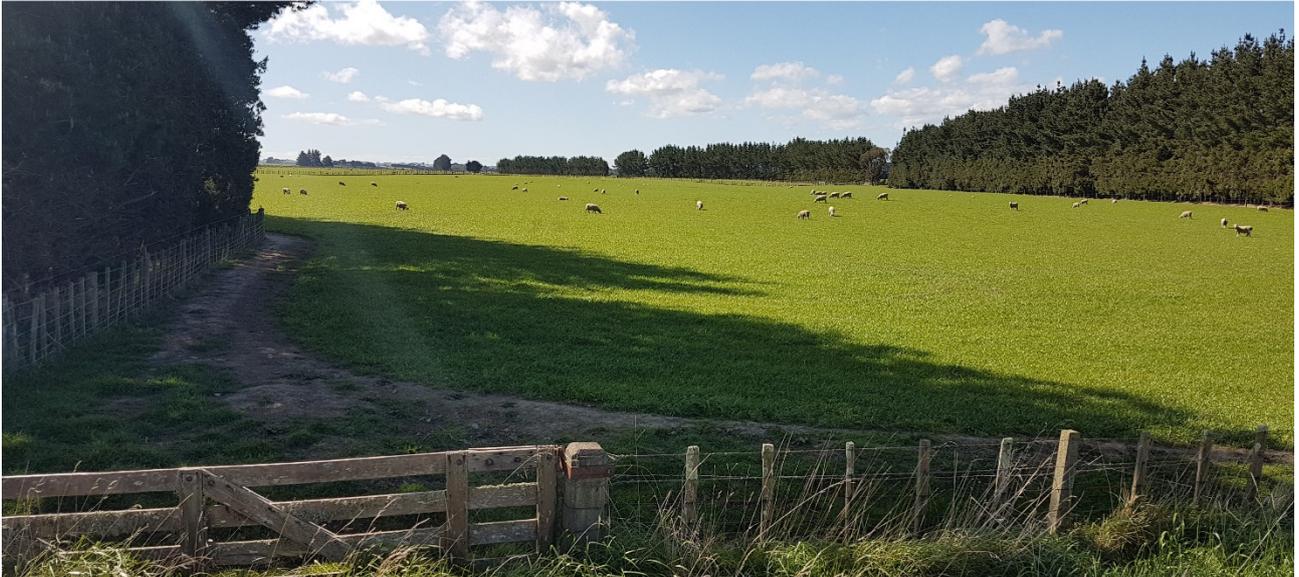
Photograph 1 : Study area from Makirikiri Road, looking north.

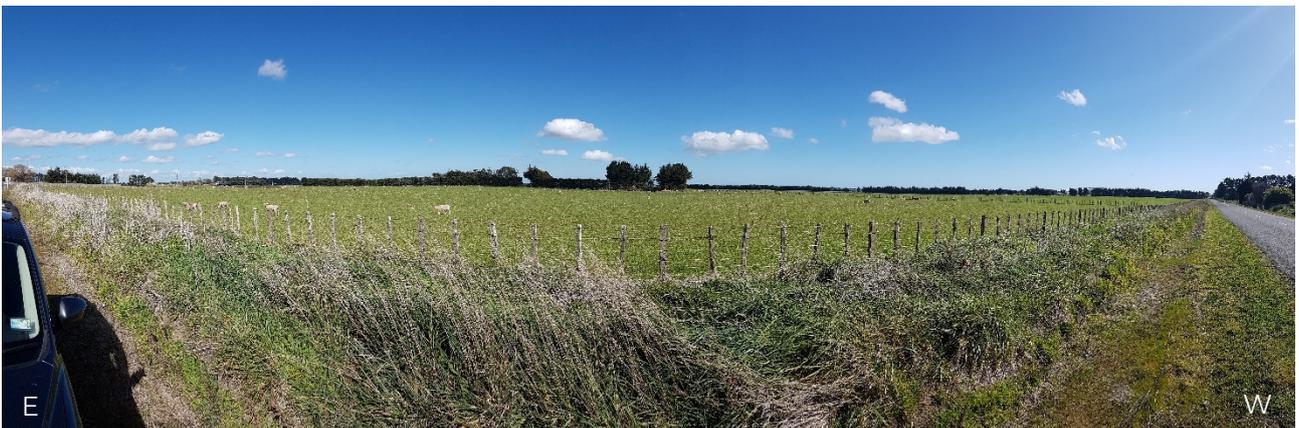
Photograph 2 : Looking south from Wings Line - SH1 on left

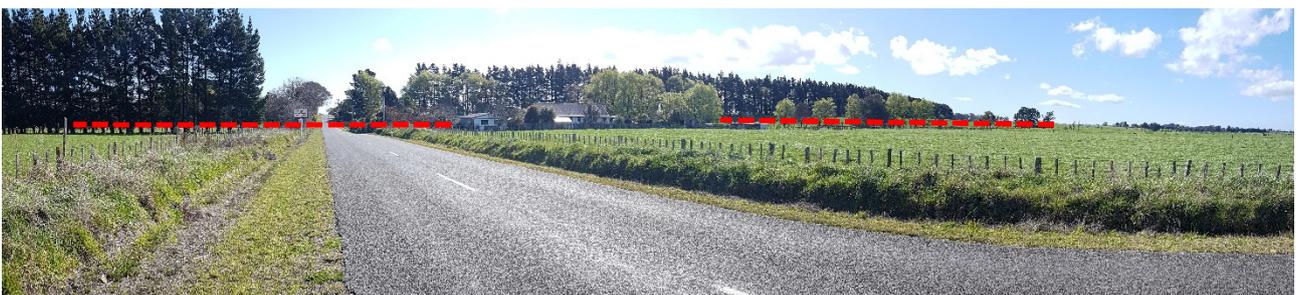
The area comprises flat pasture situated on a large raised river terrace surface. A number of small streams and watercourses cross the area. These are incised 2 – 3m into the terrace surface. The general drainage pattern appears to be towards the south across the area. Near the north west corner of the proposed re-zoning area on Wings Line there is a noticeable small rise to a higher surface level to the west. This linear escarpment running north-south is inferred to be the Leedstown Fault trace, with the eastern side down-thrown by up to 4 to 5 metres.

Photograph 3 : Inferred fault trace from Wings Line, looking west. Study area to left of road.

As the fault is inferred to cross the north west corner of the area, incorporating a fault avoidance zone into the plan change rezoning should be undertaken. Further work would be required at the southern extent of the fault through the study area to confirm its location.

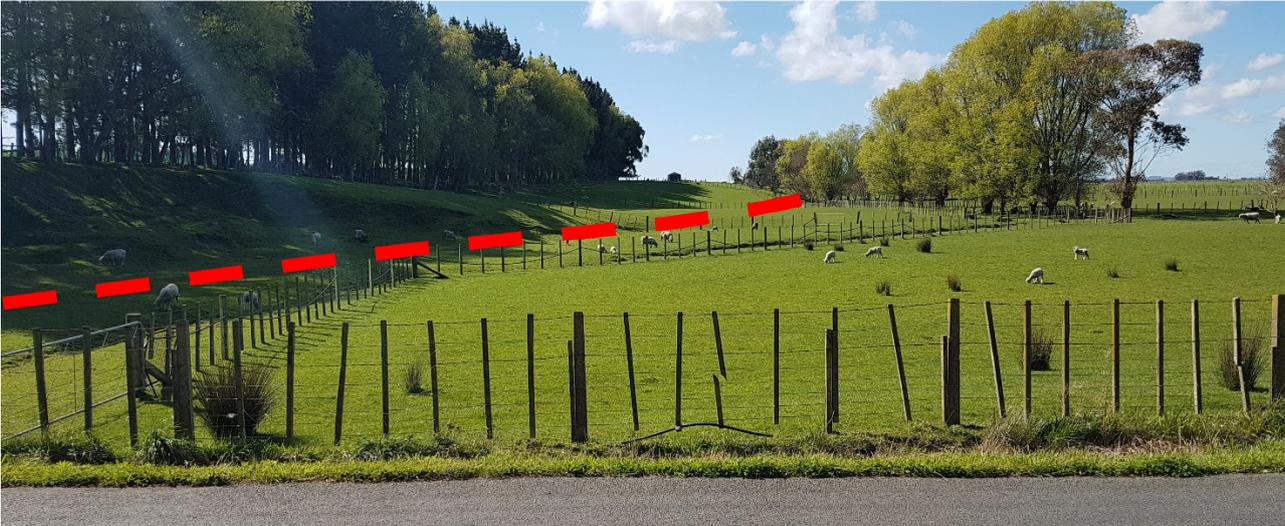
Photograph 4 : Inferred fault trace north of Wings Line

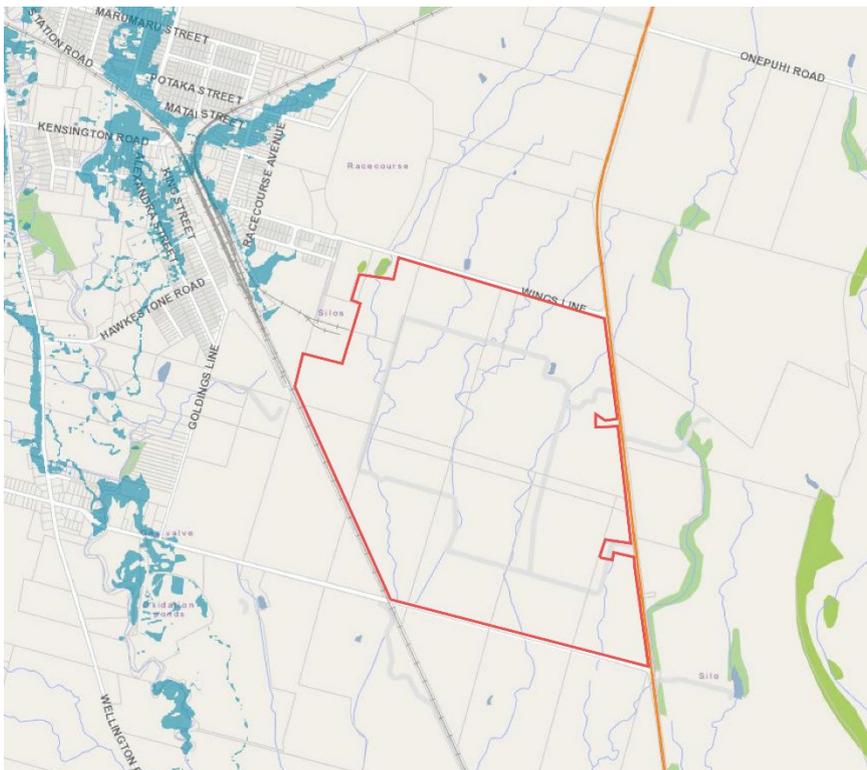
Figure 3 below presents an image from the web portal and indicates no flooding areas identified in the study area.

Figure 3 : AEP 0.5% flood event, showing areas of inundation (after (Horizons Regional Council, 2019))

The mapping is confirmed by site observations, which indicate only small streams and watercourses crossing the study area. Localised ponding may occur near the streams in a flood event, but widespread inundation by flood water appears unlikely.
