BRIDGE INSPECTION REPORT 2016/2017

Prepared for Manawatu and Rangitikei District Councils May 2017

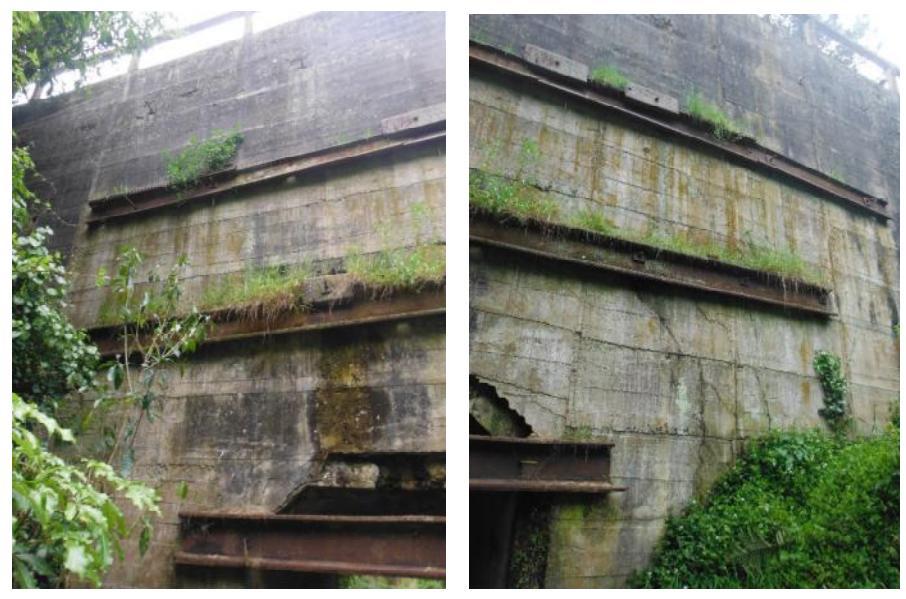
The 10m high concrete headwall of this cast in situ box culvert is exhibiting signs of bulging on the downstream side with cracks forming in the headwall face. Steel cross bracing has been installed to prevent further movement however it is unclear whether this is performing as intended. In addition to this, there are previously grout injected cracks within the culvert walls/soffit and translational cracking on the downstream concrete kerb.

Figure 4-1: Downstream wall of bridge S5A

It is recommended that bridge S5A be surveyed and tell tales installed to monitor for any further movement.

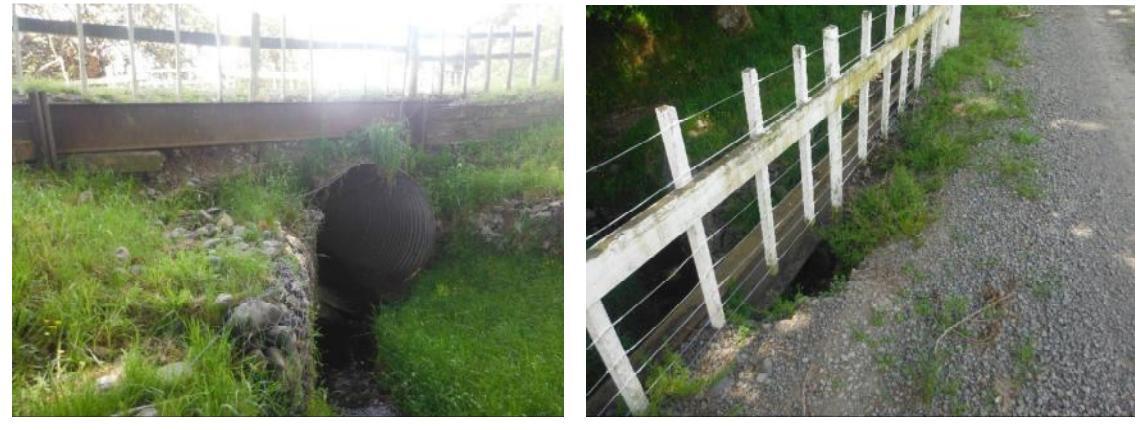
The headwall on the upstream side of this helical spun culvert is formed by a single steel beam. The gravel road is at risk of washing out as it is currently not retained. In addition to this, water is passing below the culvert structure at the upstream side, this will eventually undermine the culvert and create settlement issues.

Figure 4-2: Upstream side of bridge S141

It is recommended that an earth retaining headwall and concrete apron with cut-off wall be installed on the upstream side of bridge S141.

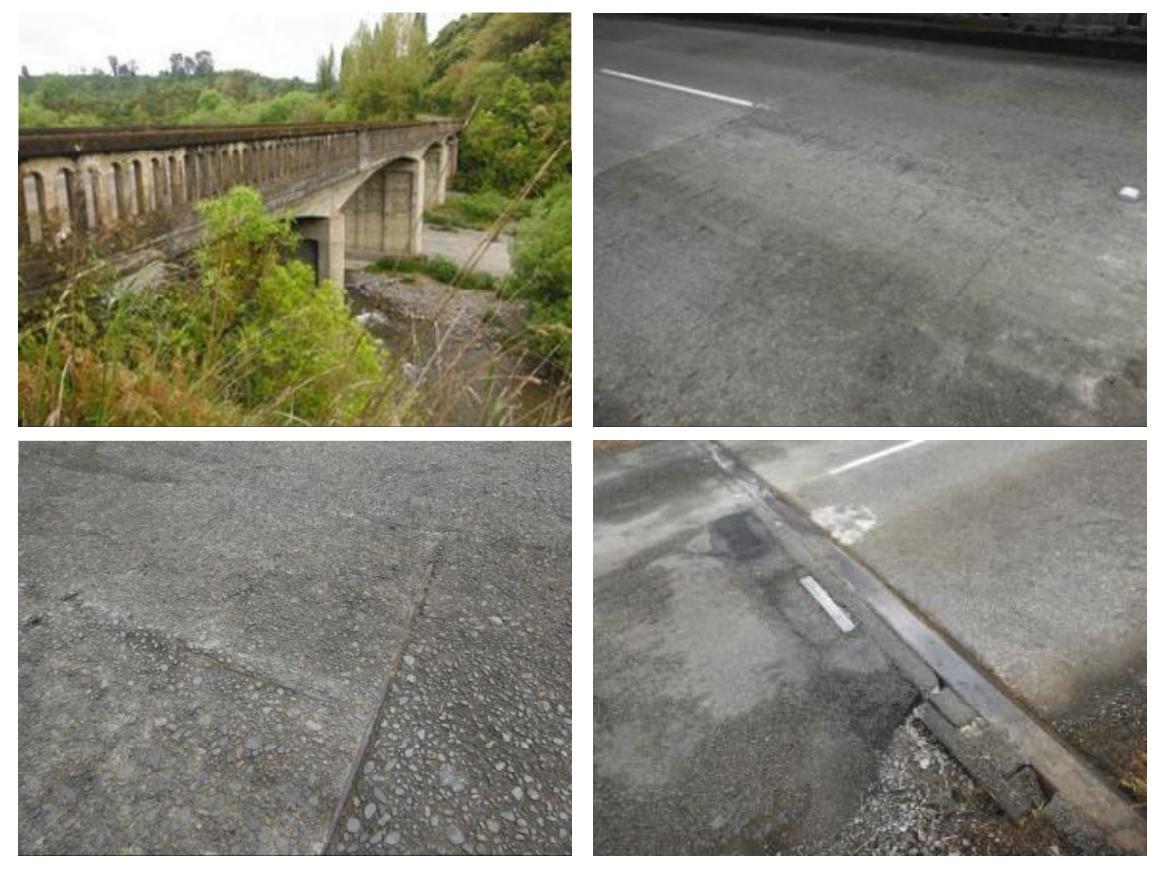
The deck joint and nosing at the true left abutment has failed, resulting in water ingress at the abutment face.

Figure 4-3: Bridge deck and expansion joints at bridge S170

It is recommended that NDT scanning be carried out on the deck of bridge S170 to confirm cover depths to reinforcing steel, deck capacity factor confirmed, posting/rating assessment of the bridge be undertaken with recommendations for deck strengthening.

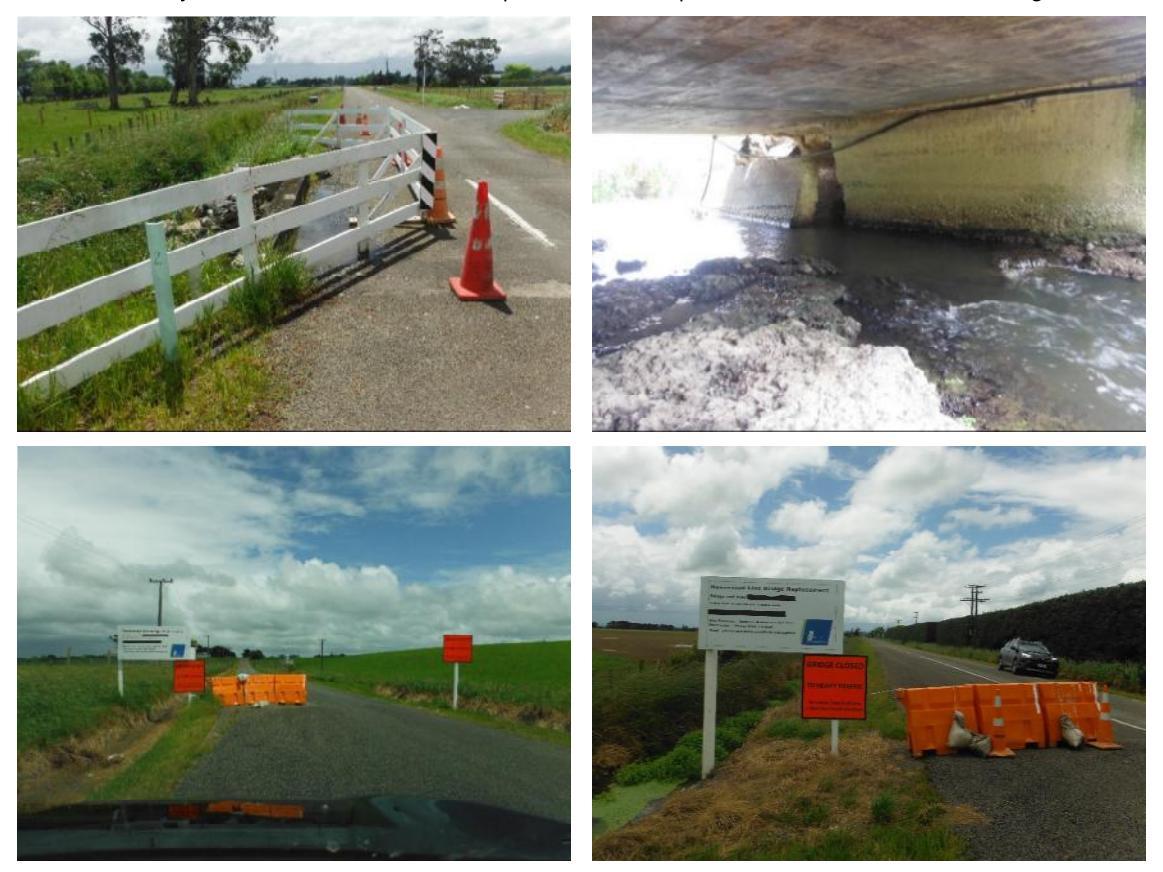
Signage on both ends of Nannestad Road has been erected warning motorists of that the bridge is closed to heavy traffic, however there is no posted limit or speed restriction stated on the signs.

Figure 4-4: Temporary road closure and affected abutment at bridge S161

It is recommended that bridge S161 be propped, fill behind the abutment temporarily retained, weight restrictions advertised and speed restrictions applied to mitigate the risk of further collapse and improve road safety. Propping should be re-inspected following extreme weather events and following severe seismic activity.

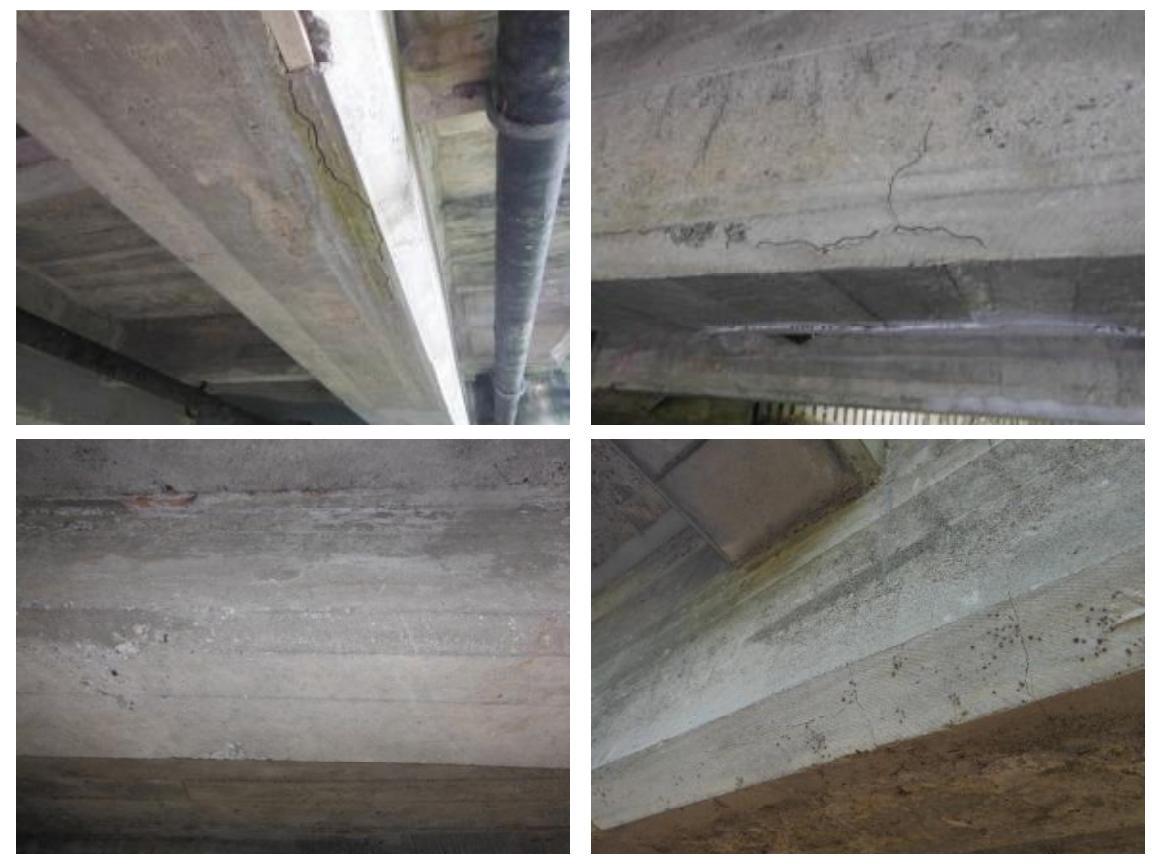
The cast in situ concrete beam soffits on bridges S404, S405, S408B & S409B have longitudinal and transverse cracking throughout. Previous concrete repairs appear to have been carried out on the soffits of the concrete beams however, the repairs do not appear to have been carried particularly well. Due to the bridge's location in urban Fielding, it is possible that this is frequented by 50MAX and HPMV vehicles, thus increasing the live loading and potentially damaging the beams further.

Figure 4-5: Previous concrete repairs and longitudinal cracking on beam soffits of bridges S404, S405, S408B & S409B (Clockwise from top left)

It is recommended that a Special Inspection be undertaken at bridges S404, S405, S408B & S409B to measure up all bridge elements and map cracking to allow for a posting assessment to determine the capacity of each structure. The results of the posting assessment will provide recommendations for grout injection, concrete repairs and/or strengthening.

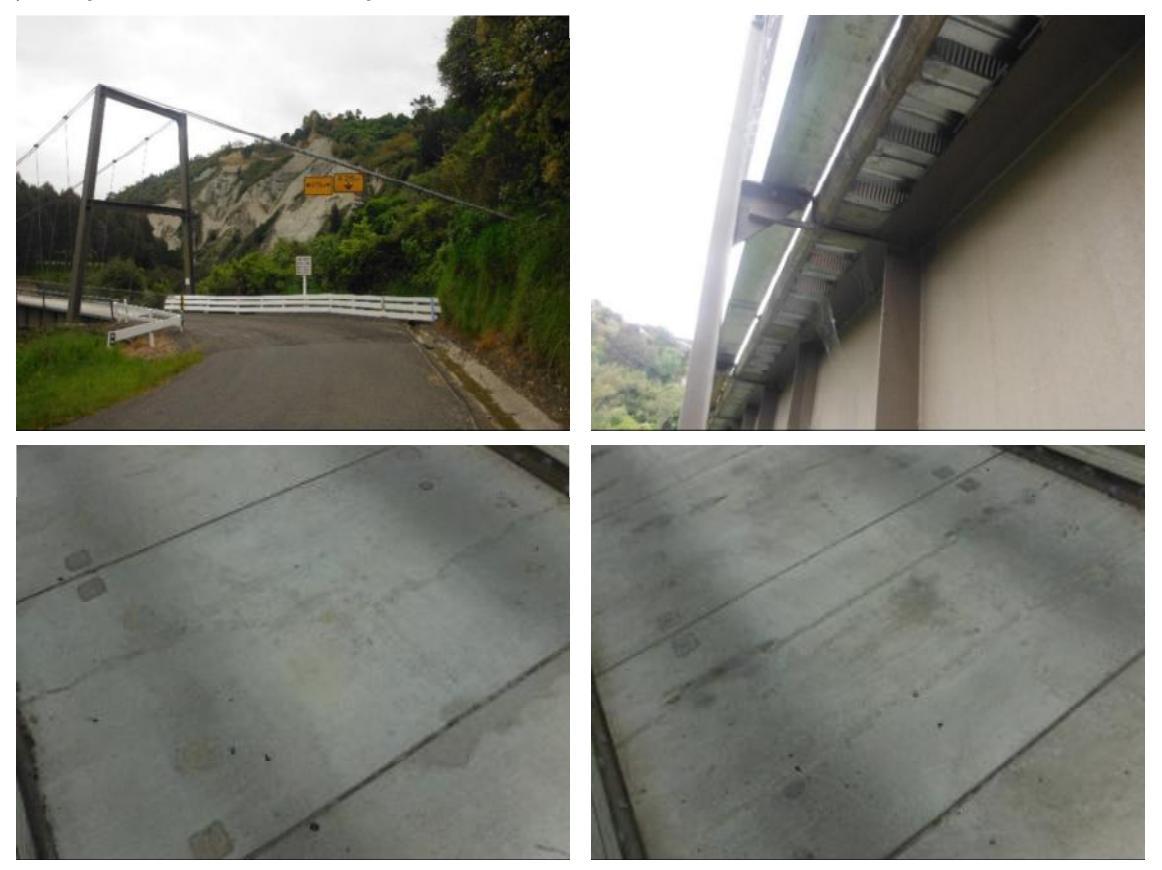
The deck slabs have an unusual ribbed aluminium permanent formwork which forms the deck soffit. The result is a deck thickness which varies between 130-60mm and may be a contributing factor in the posting assessment of this bridge.

Figure 4-6: Transverse cracking on deck slabs, ribbed deck soffit detail and previous concrete repairs to deck on bridge S142A

It is recommended that transverse cracking on bridge S142A be sealed with a flexible sealant to prevent water ingress and mitigate damage to the deck reinforcement. A posting and rating reassessment of this structure should be carried out annually with specific focus on the deck capacity factor due to the slender slab design and transverse cracking.

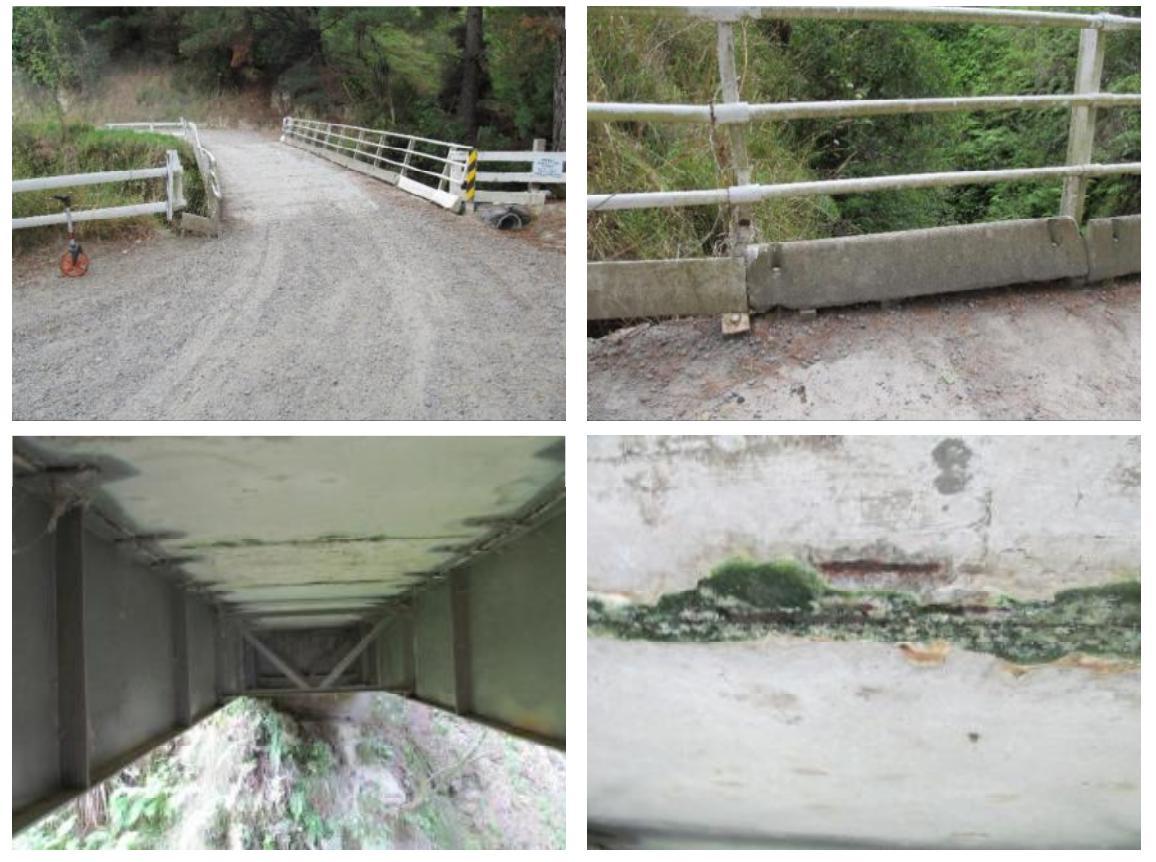
There are a number of bridges within MDC which comprise the details shown in Figure 4-7 below. The tapered precast kerb detail appears to be frequently impacted and often damaged and/or moved out of alignment. The geometric shape of the kerb is also unlikely to be commonly available in standard moulds and would be expensive to cast replacement units. The precast deck units are all leaking at the joints and staining the deck soffit. This leakage and subsequent repeated wetting of the concrete soffit increases the rate of carbonation and deterioration of the concrete in this local area. Eventually this leads to corroded rebar and potential reduction in in structural capacity of the element. The leakage through the deck joints is due to deterioration of the sealant which is accelerated by gravel accumulating on the deck surface as a result of unsealed approaches.

Figure 4-7: Precast kerb detail damage and precast deck soffit deterioration at location of the joint

- 8. The approaches for S144 are sealed and the deck kept clean. An appropriate joint sealant should be installed. Areas of the deck soffit where there is exposed rebar should be repaired with an appropriate cementitious repair product such as Sika Monotop. Unless there is a standard mould available for kerb units an alternative kerb detail should be considered which is simple and cost effective to replace when damaged, such as timber.

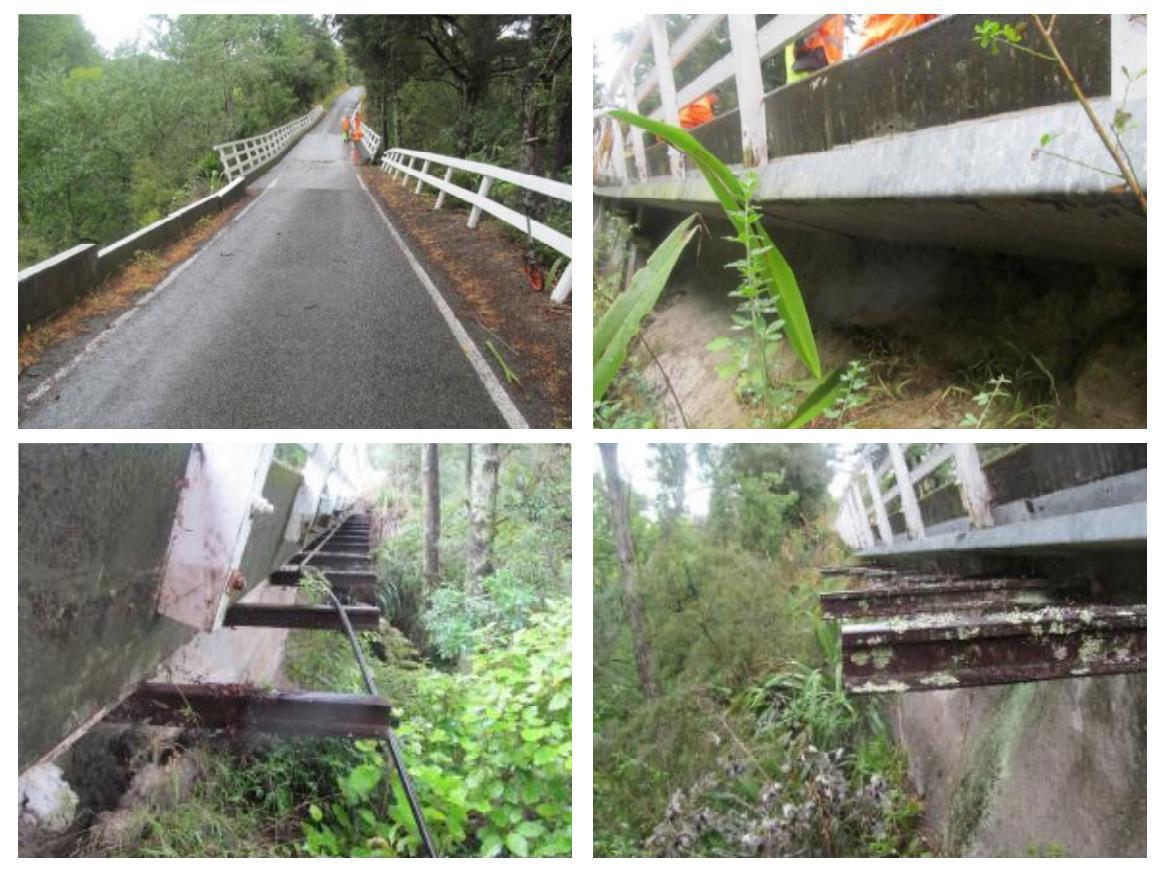
Bridge S030 is a half bridge that supports the carriageway on a steep embankment which is heavily vegetated. The structure, as observed, consisted of concrete wall elements which have steel railway irons cantilevering from the top of them and appear to have once supported a utility. The railway irons are corroding and do not appear to have any form of coating system. It is also unclear how far the wall elements extend below the ground. The bank is steep and potentially prone to ongoing erosion. Should the toe of the wall elements be exposed it could have a destabilising effect on the structure and embankment.

Figure 4-8: Precast kerb detail damage and precast deck soffit deterioration at location of the joint

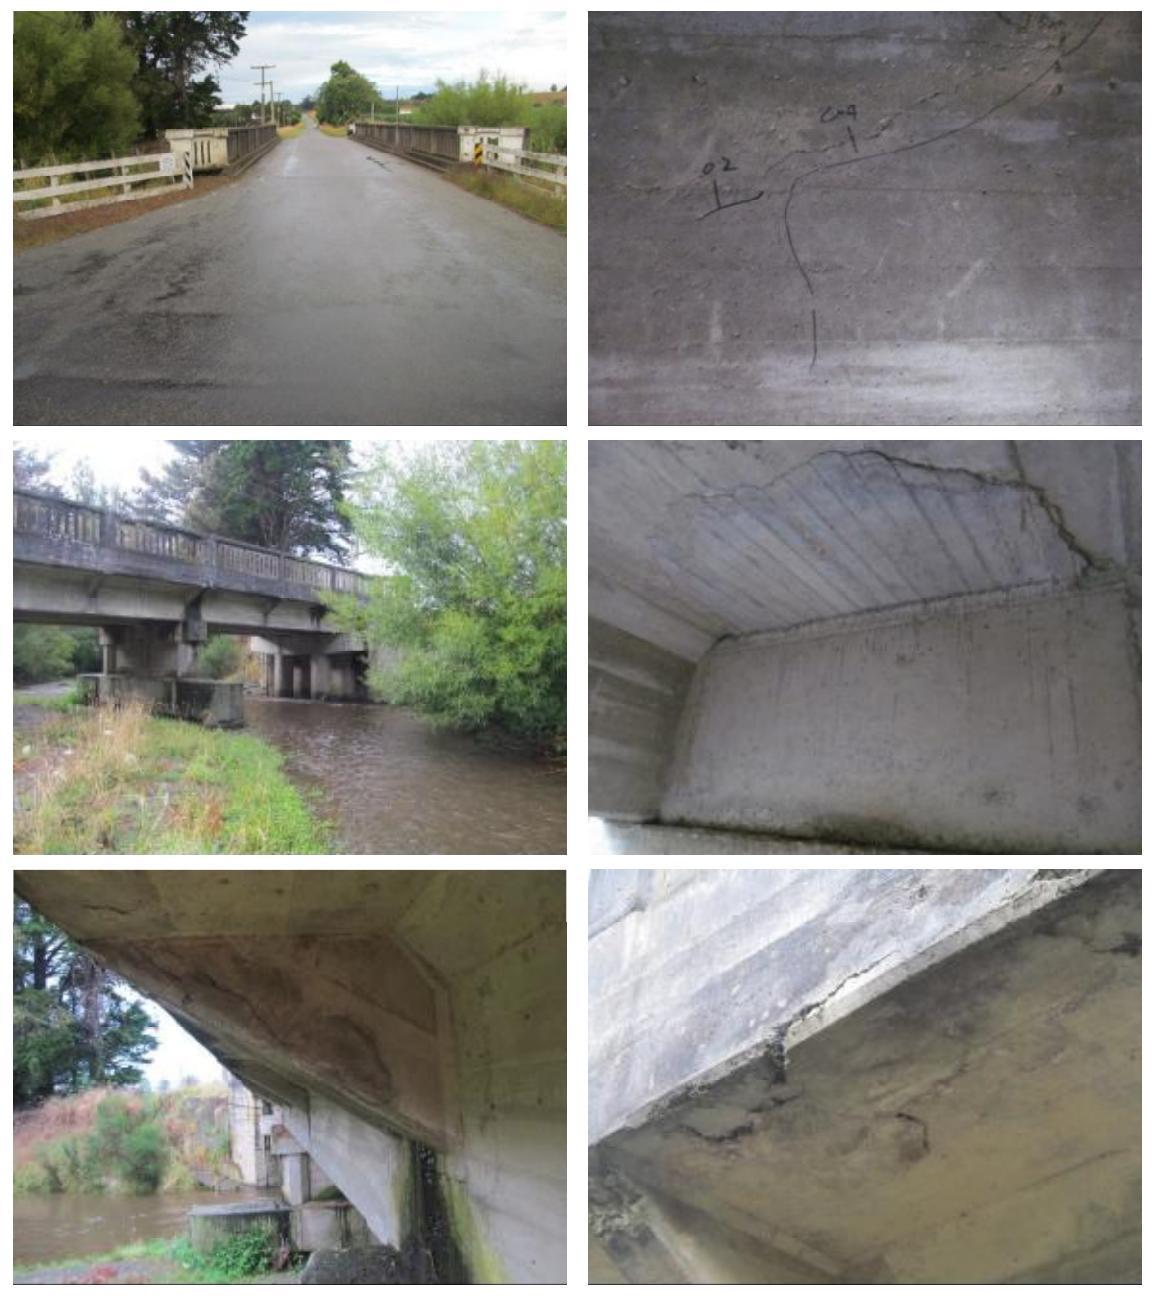
Bridge S008 has multiple defects on the insitu concrete superstructure. The beams display regular diagonal cracking along their length approx. 0.2mm to 0.4mm wide. Areas of the deck soffit show spalling defects including areas where the concrete has delaminated. The majority of outriggers on the edge beams are in very poor condition with sections of concrete coming loose from light prying. It should be noted that the beams at true right abutment, which should be integral with the abutment, are no longer connected and a new abutment on piles has been formed.

Figure 4-9: Multiple defects on concrete superstructure including cracking on beams and spalling on beam elements.

- 10. For bridge S008, that a series of concrete tests be carried out including phenolphthalein (to test for carbonation), chloride and electrochemical potential tests. The results of these tests will enable the selection of an appropriate concrete repair system.

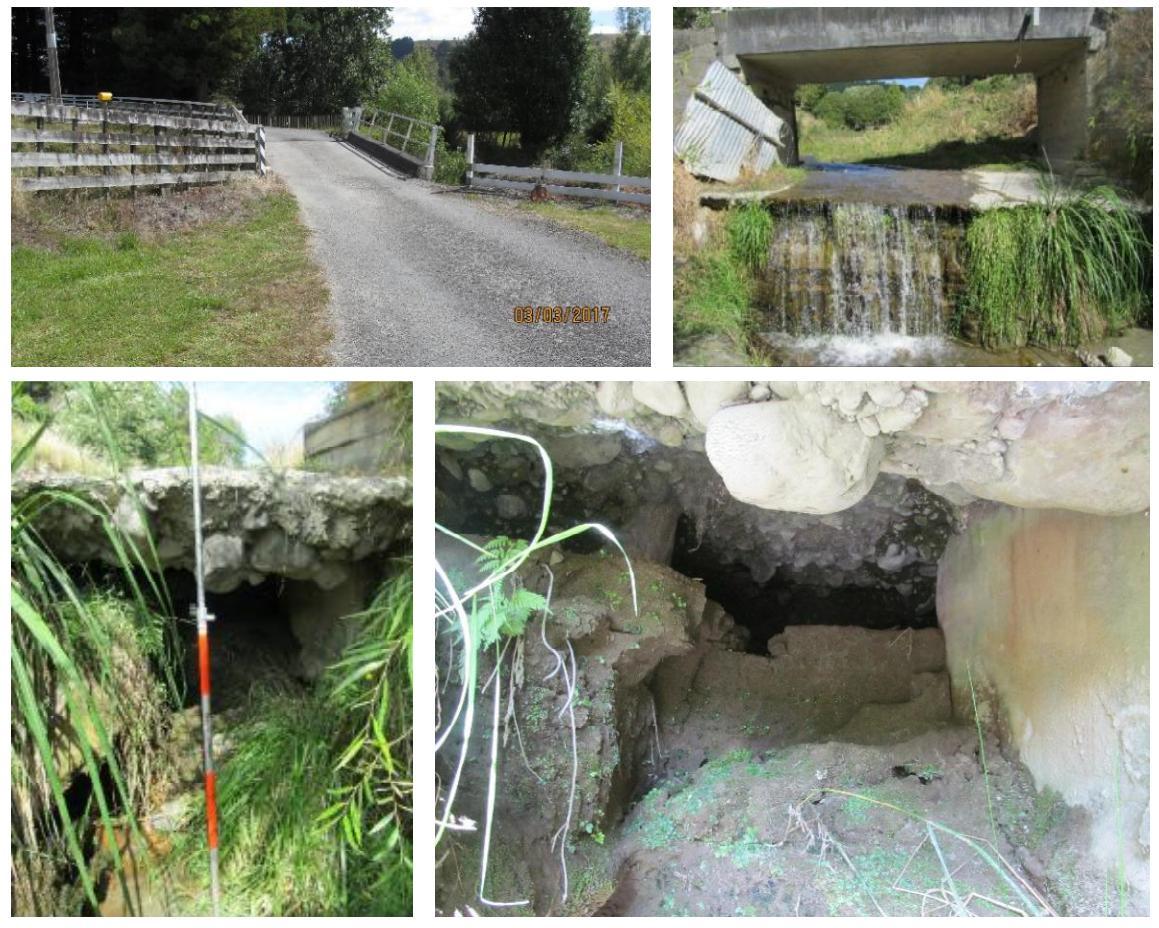
Bridge S288B has a cavity forming below the outlet apron as a result of ongoing scour erosion. The cavity is near the true left abutment and appears to migrating towards the abutment. Unless the abutment is on piles or has a secondary wall along the toe the cavity could undermine the abutment resulting in collapse.

Figure 4-10: Cavity forming below outlet apron migrating towards the true left abutment

It is recommended that the cavity be filled with a flowable grout or concrete mix to underpin the apron and rock armour be placed at the outlet to dissipate energy.

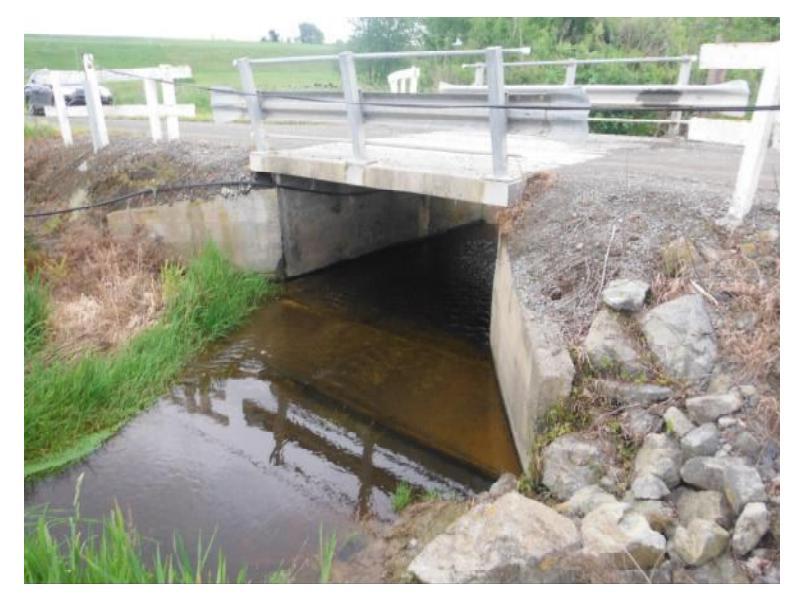
The condition of road safety barriers on bridge approaches and bridge decks across the network is considered to be poor. A combination of sight rail timber fencing and safety barriers exists on the network. Non-compliant safety barrier components include end terminals, fishtails, blockouts, installation heights, insufficient length of need and damage to existing barrier components.

Figure 4-12: Bridge S42 guardrailing of insufficient length

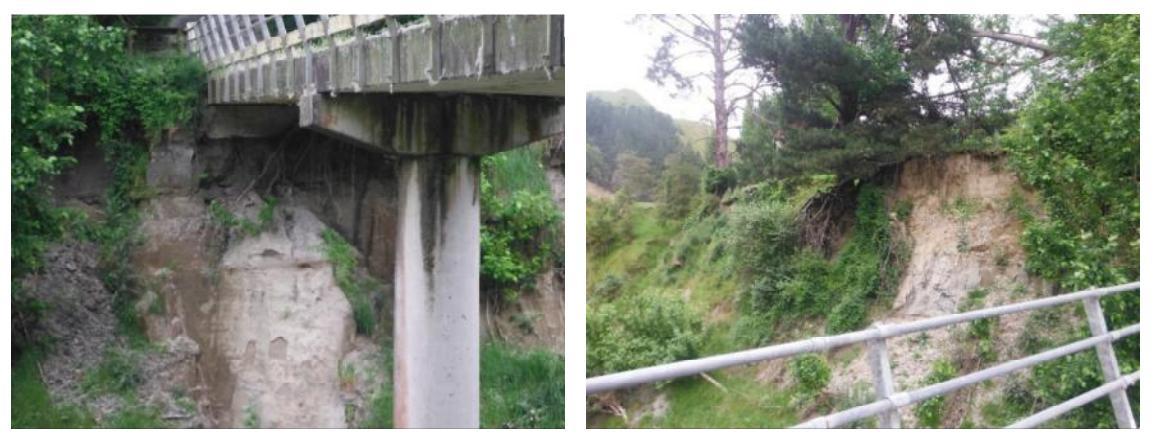
Historically, it has been noted that the watercourse at bridge 42 has overtopped the deck following severe weather events.

Figure 8-1: Erosion of true right embankment and exposed concrete abutment at bridge 42

- 1. Carry out routine and structural maintenance items listed in Appendices D & E.
- 2. The foundation detail of bridge 42 true right abutment be determined by referencing as-built drawings and a ground model of the underlying geology be prepared to predict future regression to enable a suitable embankment protection detail.

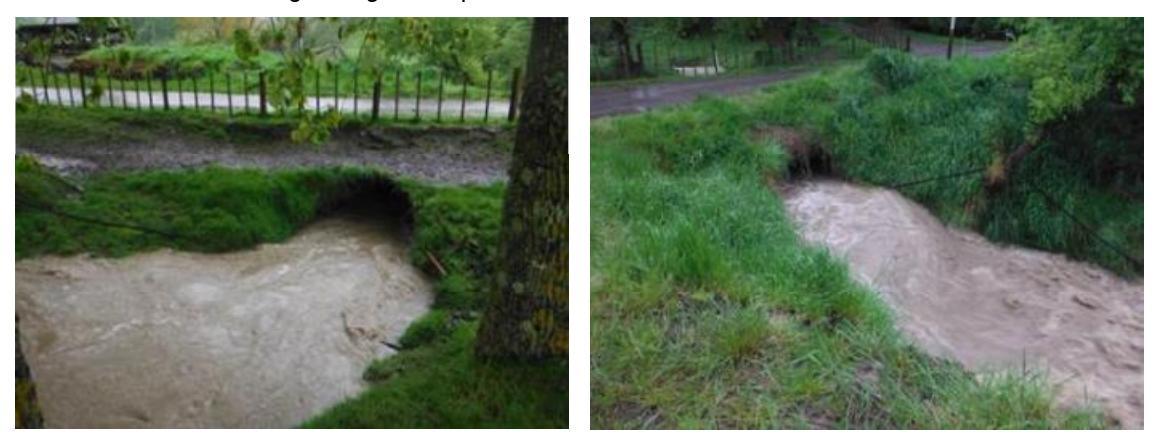
The hydraulic capacity of bridge 302, a galvanised steel armco culvert was nearing its limit following heavy rain during the 2016/17 inspection. The watercourse downstream was so torrent that the embankment was eroding during the inspection.

Figure 8-2: Bridge 302 watercourse in spate

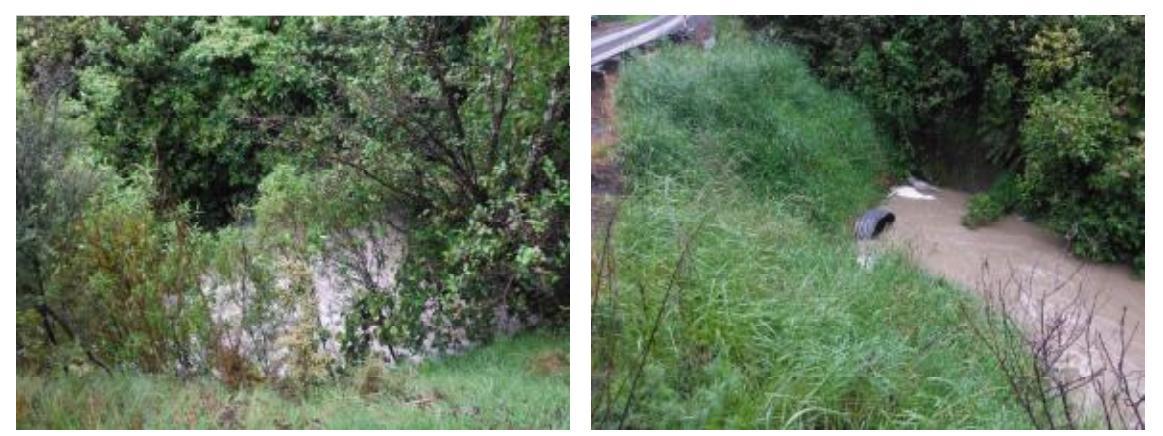
During the time of inspection, the pipe culvert was close to overtopping. The flow rate downstream was torrent and vegetation prevented from inspecting the outlet. There is a risk of scour downstream due to the ferocity of water discharging.

Figure 8-3: Upstream and downstream of bridge 150

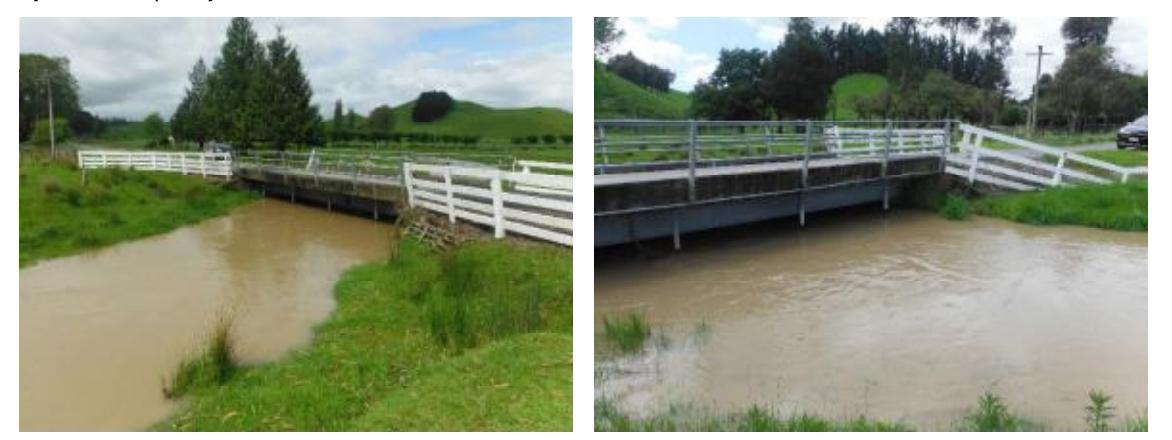
The freeboard level to the steel beam soffits at bridge 9 was approximately 200mm, therefore it was not possible to fully inspect the beams and deck soffit due to high water levels at the time of the inspection. This structure is at risk of overtopping and subject to damage flood debris damage due to insufficient hydraulic capacity.

Figure 8-4: Freeboard level at bridge 9

- 5. Bridge 9 be re-inspected following flooding for scour and flood damage.
- 6. Boulders be place on the true right, downstream side of bridge 170 to mitigate the risk of scour and collapse of gabion baskets.

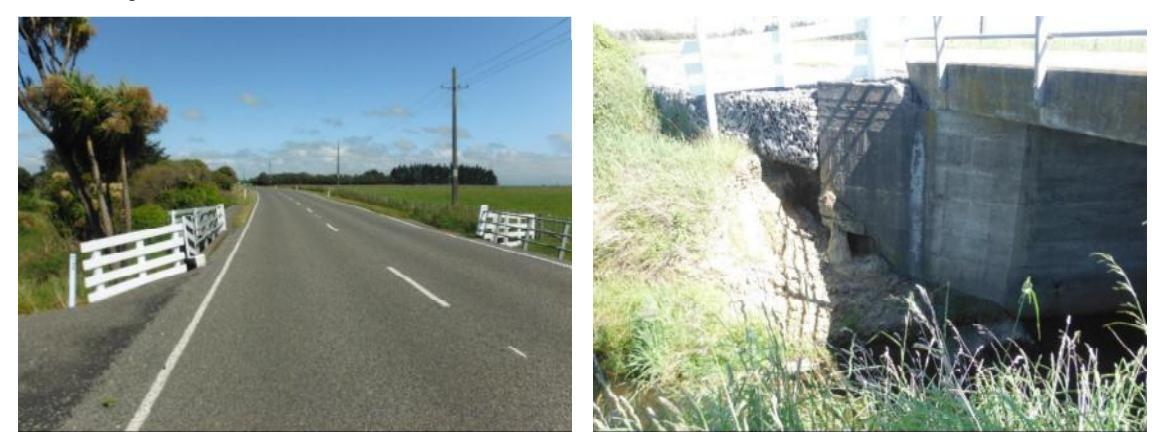
The true right, downstream side of bridge 170 has been undercut and is susceptible to scour damage. The gabion baskets placed behind the wingwall to retain the carriageway are at risk of collapsing due to fines being washed out from surface water run-off.

Figure 8-5: Scour risk at bridge 170

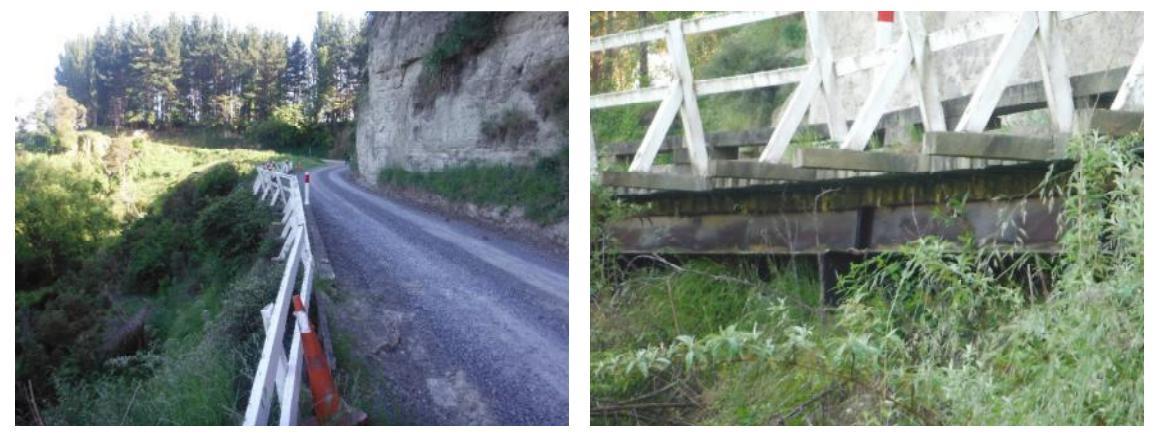
The original timber deck on bridge 155 has been overlain with a second timber deck and gravel road. This configuration significantly increases the dead load of the structure whilst retaining moisture, which in turn promotes decay. It was not possible to access the underside of this structure due to the steep drop off on the downslope of the half bridge. It was noted during the inspection that the outside beams are subject to rotational failure. It was not possible to confirm whether the beams are restrained with diaphragms nor was it possible to confirm the condition of the corrosion protective system applied to the substrate.

Figure 8-6: Bridge 155 deck and downslope

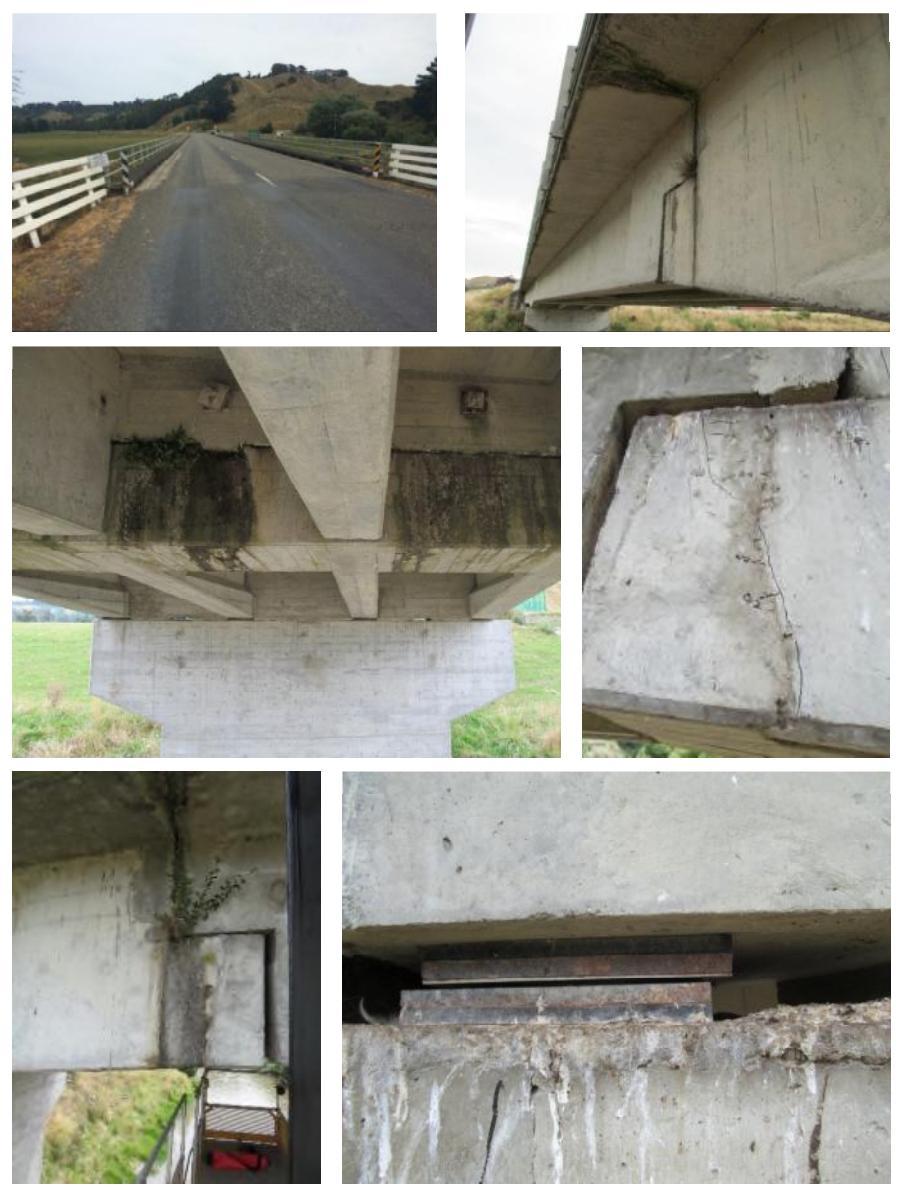
The central span of bridge 73 is supported on half joints in the form of corbel elements. Water and sediment become trapped within this joint promoting growth of vegetation, retention of moisture and ongoing deterioration of the concrete and steel bearing plates and fixings. The half joint at both ends of the bridge displayed leakage along most of the bridge width. There are diagonal cracks present on the external face of the bottom corbel element, up to 0.3mm wide, which could be the region of a cold joint or suggestive of a structural defect such as shear cracking due to inadequate detailing and strength. There is also relative movement between the bearing plates indicating movement of the bridge in the longitudinal direction. The bearing plates display surface corrosion. On the downstream face of the half joint there is a neoprene pad instead of plates.

Figure 8-7: Concrete half joint detail showing leakage, vegetation growth and diagonal cracking

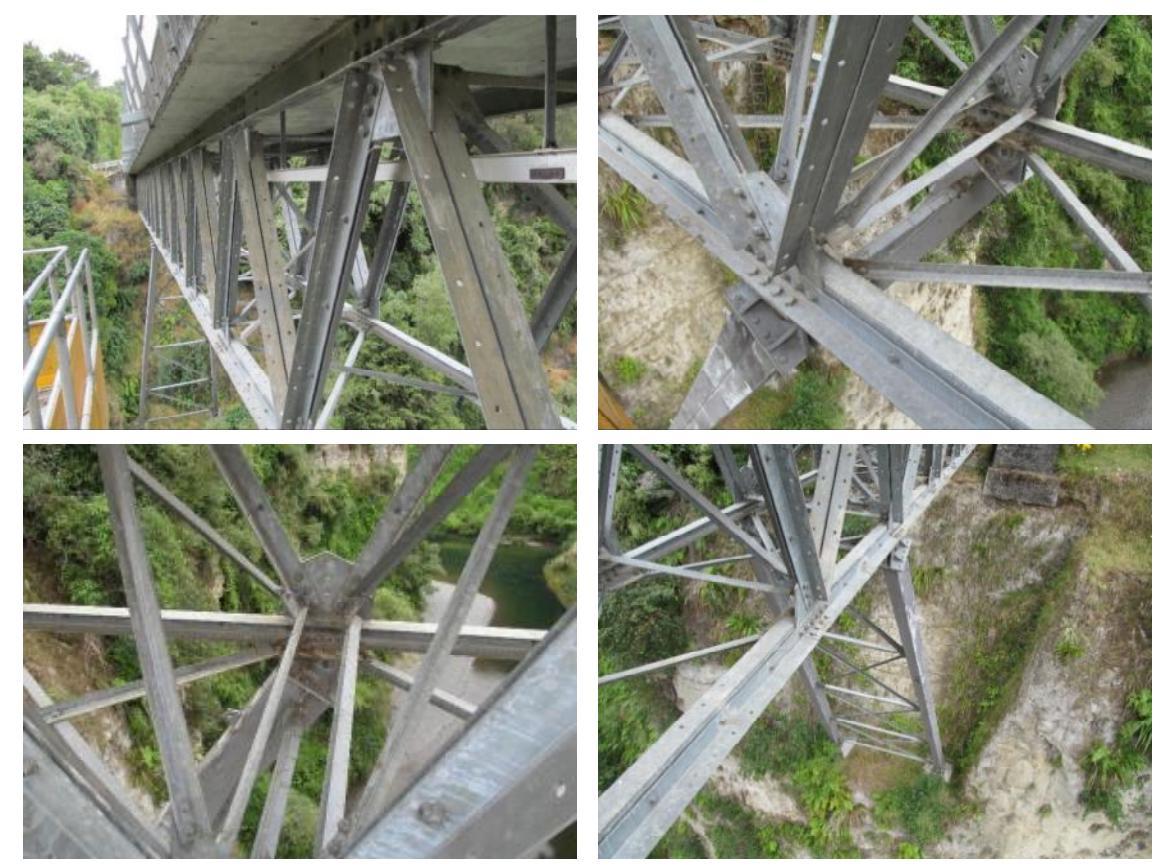
The galvanised coating on the superstructure truss and pier elements is deteriorating. There is a large amount of staining to the steel elements which makes it difficult to assess the extent of the re-coating required but it is likely that after a low pressure waterblast to remove loose material the total quantity of spot coating repair will be less than 10% of the total bridge steel surface. Where there are clear signs of corrosion progressing is on the bottom gusset plates which, being flat, retain moisture and salts for longer.

Figure 8-8: Deterioration of galvanised coating system to superstructure and pier steel elements – spot repairs recommended

- 8. A Special Inspection of bridge 22 be undertaken to waterblast loose material off the superstructure and pier substructure steel elements followed by a detailed inspection to quantify the required re-coating extent.

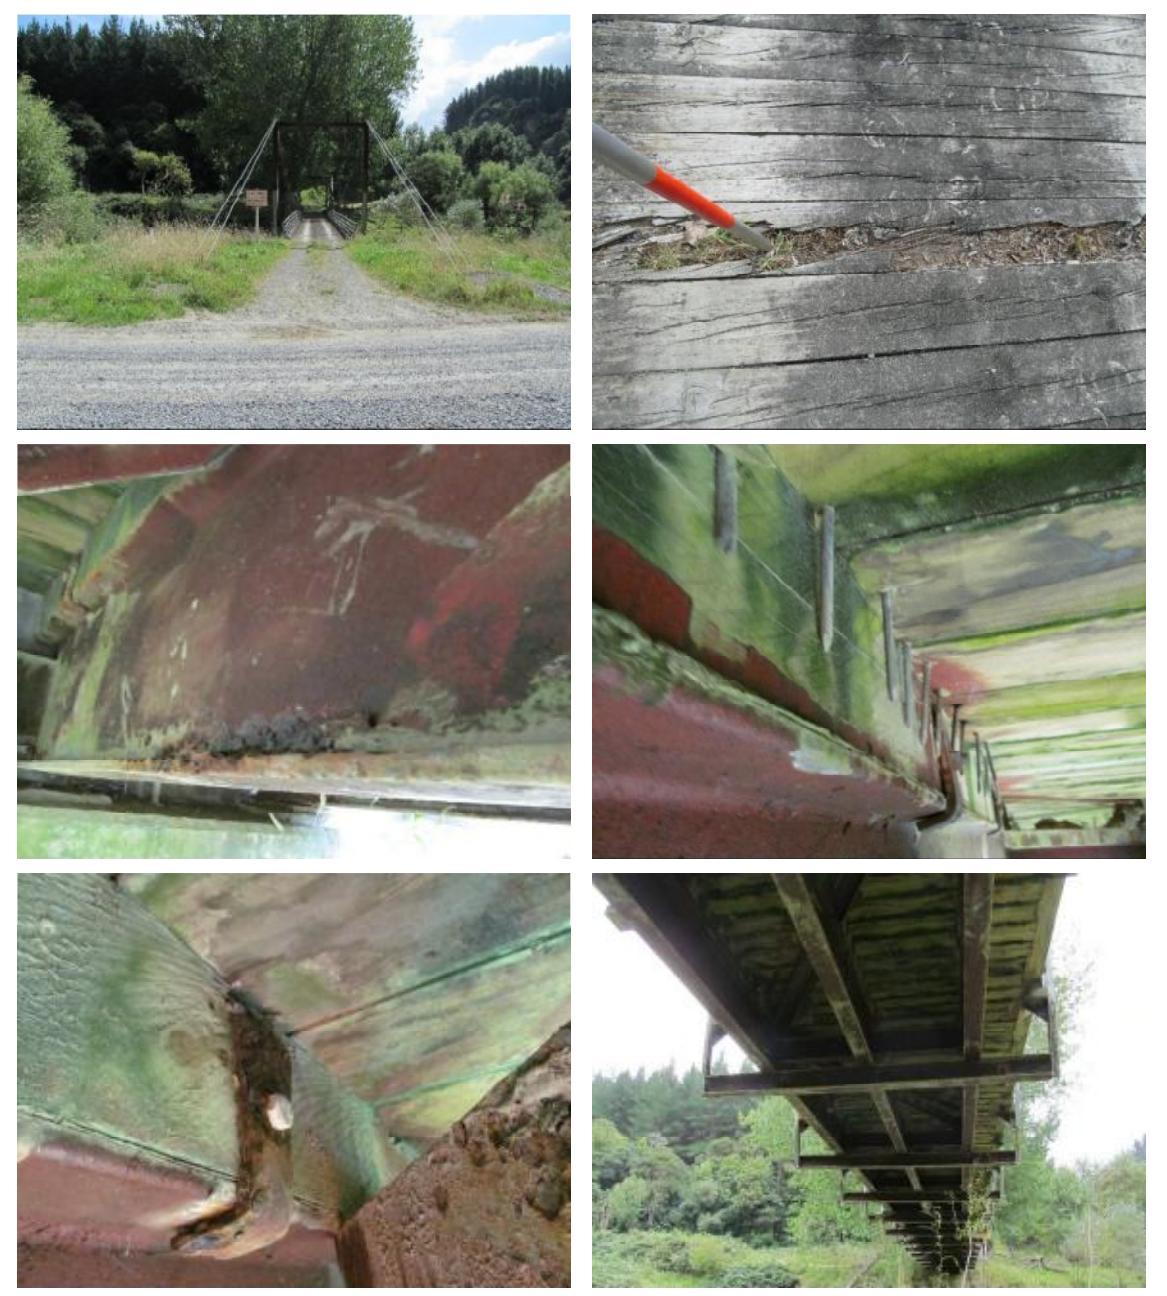
bridge length. It is unknown how long the posting has been in place but the lack of an axle restriction to reflect the deteriorated deck condition suggests the posting needs re-evaluation.

Figure 8-9: Failure of gold seal system, corrosion of main steel elements and deterioration of timber elements

- 9. A Special Inspection of bridge 41 be undertaken to assess the extent of corrosion to the steel elements. At the same time as the special inspection the logistics and cost of reapplying Gold seal could be evaluated to assess whether it is feasible to install the coating system at the same time as the special inspection. The frames and hangars should also be assessed for an appropriate paint coating system. The existing posting should be revaluated once the results of the special inspection are complete and an axle limitation introduced to reflect the deteriorated condition of the deck.

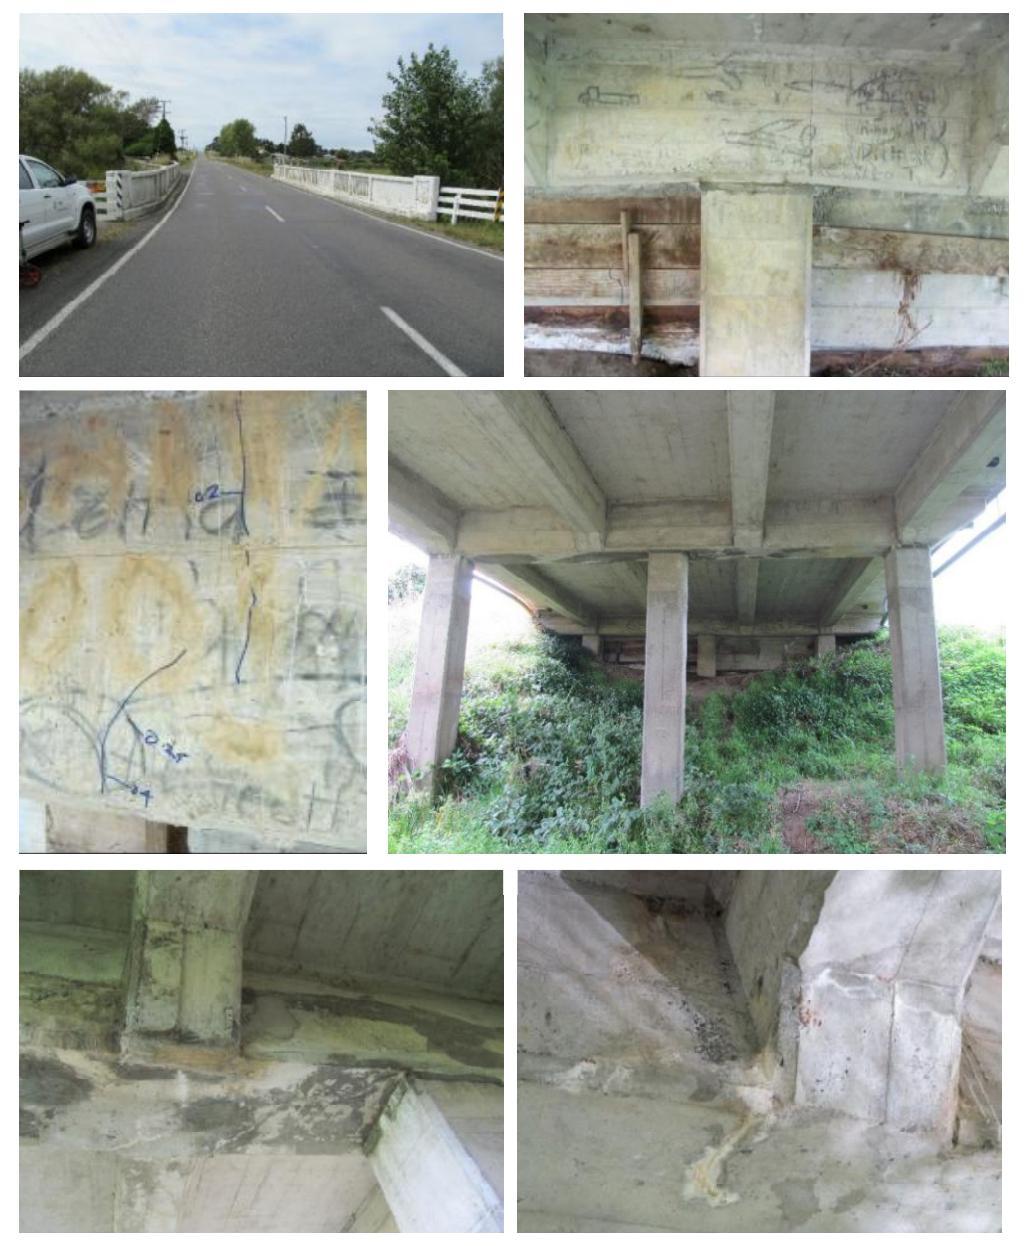
There are multiple cracks present on the pile cap of both the abutment and pier elements. The size of the cracks near the pile/pile capping beam interface are approximately 0.4mm in width. There also appears to be a noticeable hog in the pile cap over the abutment piles. The pier caps have had crack repairs undertaken previously but this illustrates the large extent of cracking. The bridge is not posted and during the inspection it was noted there was a large frequency of heavy commercial vehicles that used the bridge.

Figure 8-10: Multiple repaired and existing cracks on the pile cap elements for both the abutment and piers

- 10. The As-Built drawings for the bridge 2 be located and a posting or HPMV assessment undertaken to assess the bridge capacity. If the bridge capacity is found to be understrength there are options for strengthening including FRP and bonded steel plates.

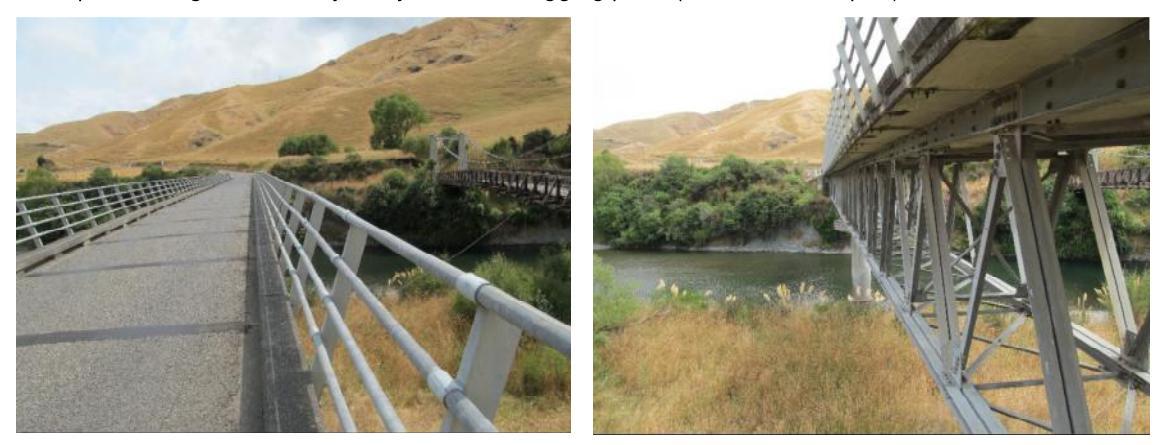
At the pier location there appears to have been settlement illustrated by a visible low point along the bridge span, particularly in the handrails. However this could also be a result of hogging at the pier, with the dip occurring immediately away from the hogging point (which is at the pier).

Figure 8-11: Visual low point along bridge at approximate pier location
