BRIDGE INSPECTION REPORT 2016/2017

Prepared for Manawatu and Rangitikei District Councils May 2017

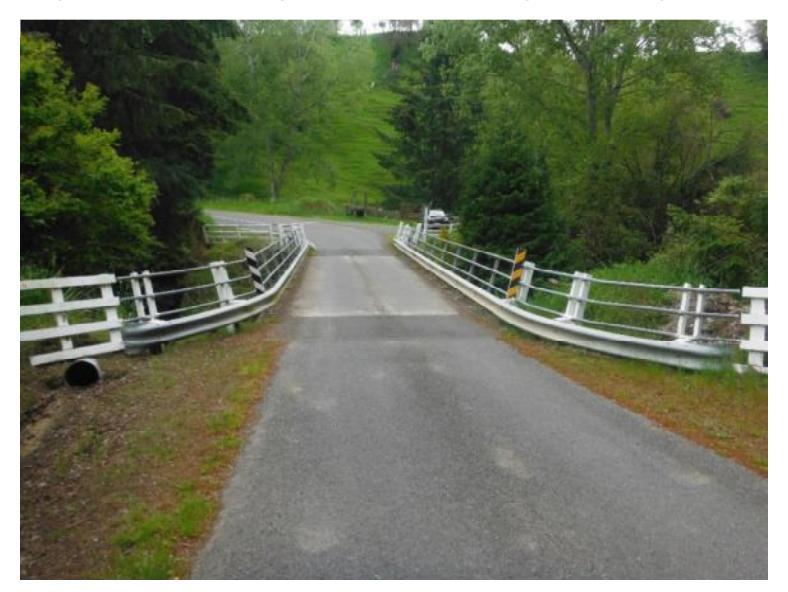
The condition of road safety barriers on bridge approaches and bridge decks across the network is considered to be poor. A combination of sight rail timber fencing and safety barriers exists on the network. Non-compliant safety barrier components include end terminals, fishtails, blockouts, installation heights, insufficient length of need and damage to existing barrier components.

Figure 8-13: Bridge 26 – Non-compliant height and end terminals

- 20. A bridge safety barrier assessment across the network is recommended to ensure adequate steps are being taken to protect road users.
- 21. RDC undertakes seismic screening of their bridge stock.
