Rangitikei District Council

**GEOTECHNICAL ASSESSMENT REPORT
FOR RESIDENTIAL LAND-USE CHANGES**

Bulls, Marton & Mangaweka High Level Planning

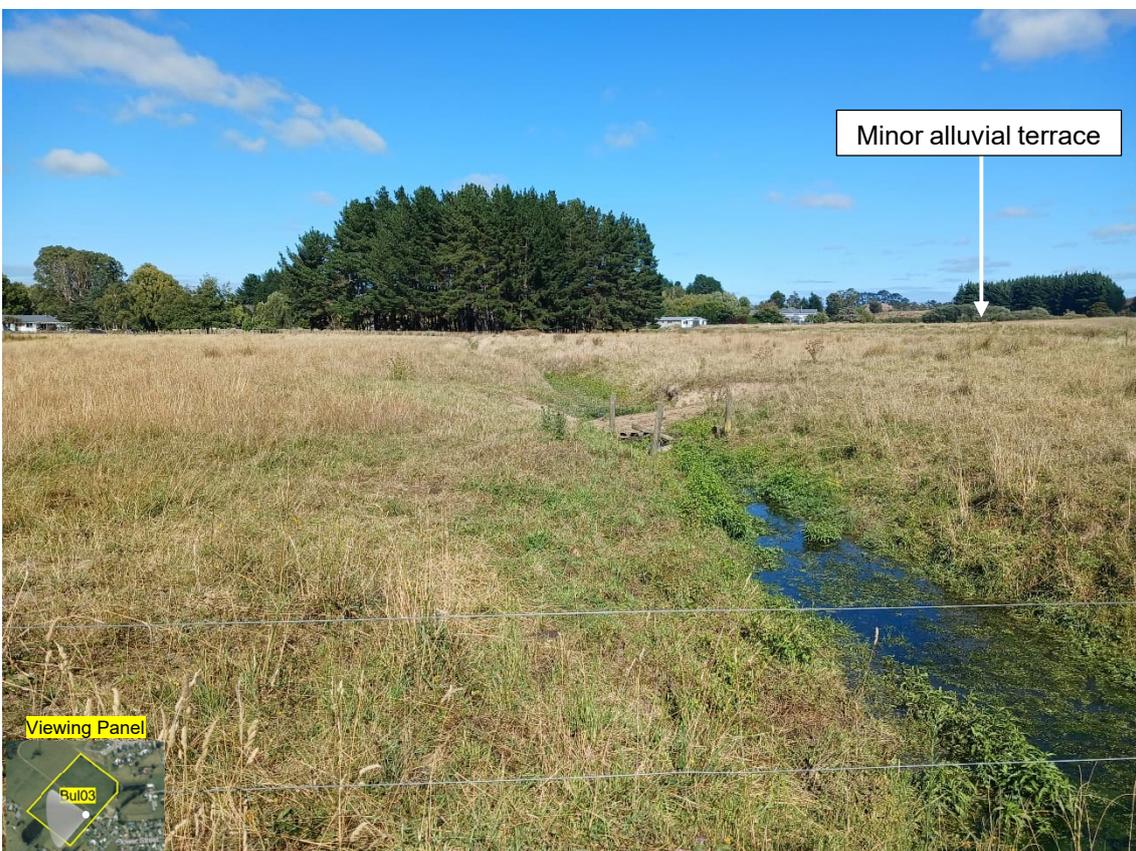
Photograph 2: Channel trending west through the lower area of Bul03, viewed towards the west.

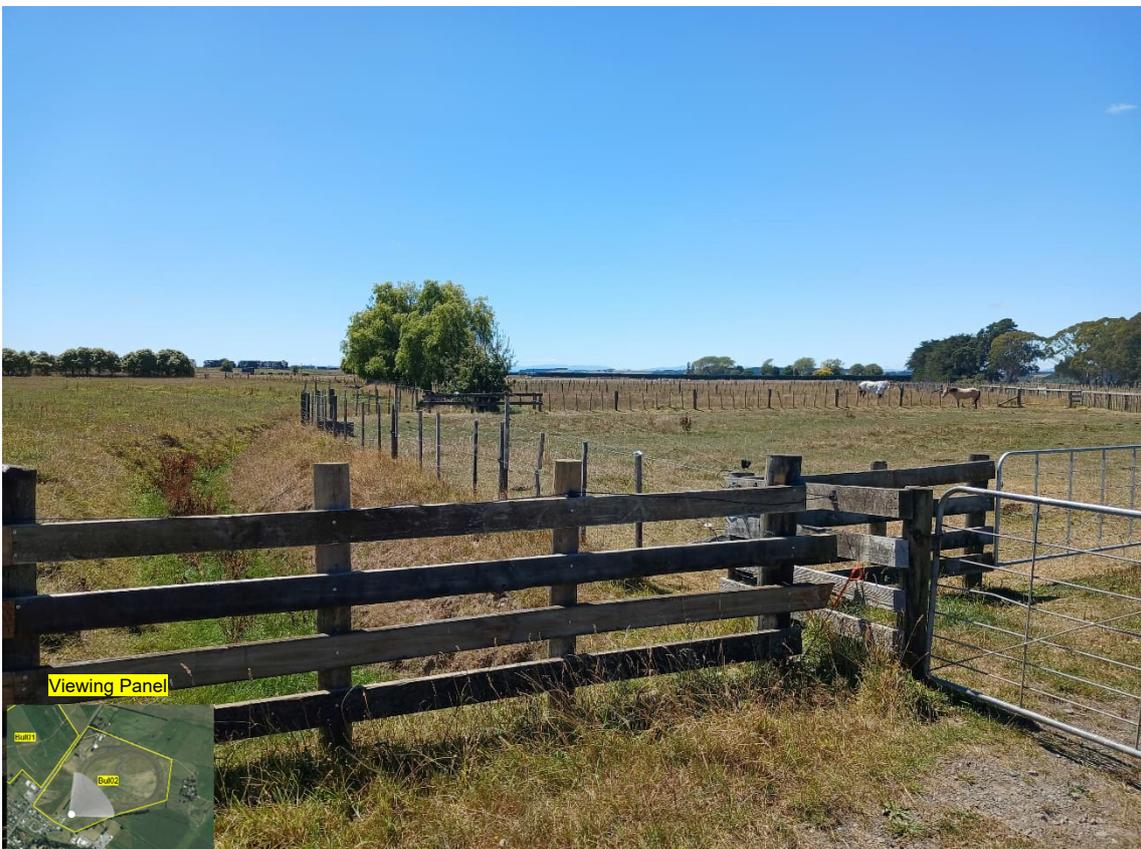
Photograph 6: View of the generally level ground of Bul02 and drainage channel through the site, viewed to the northeast from within the lower properties of Bul02.

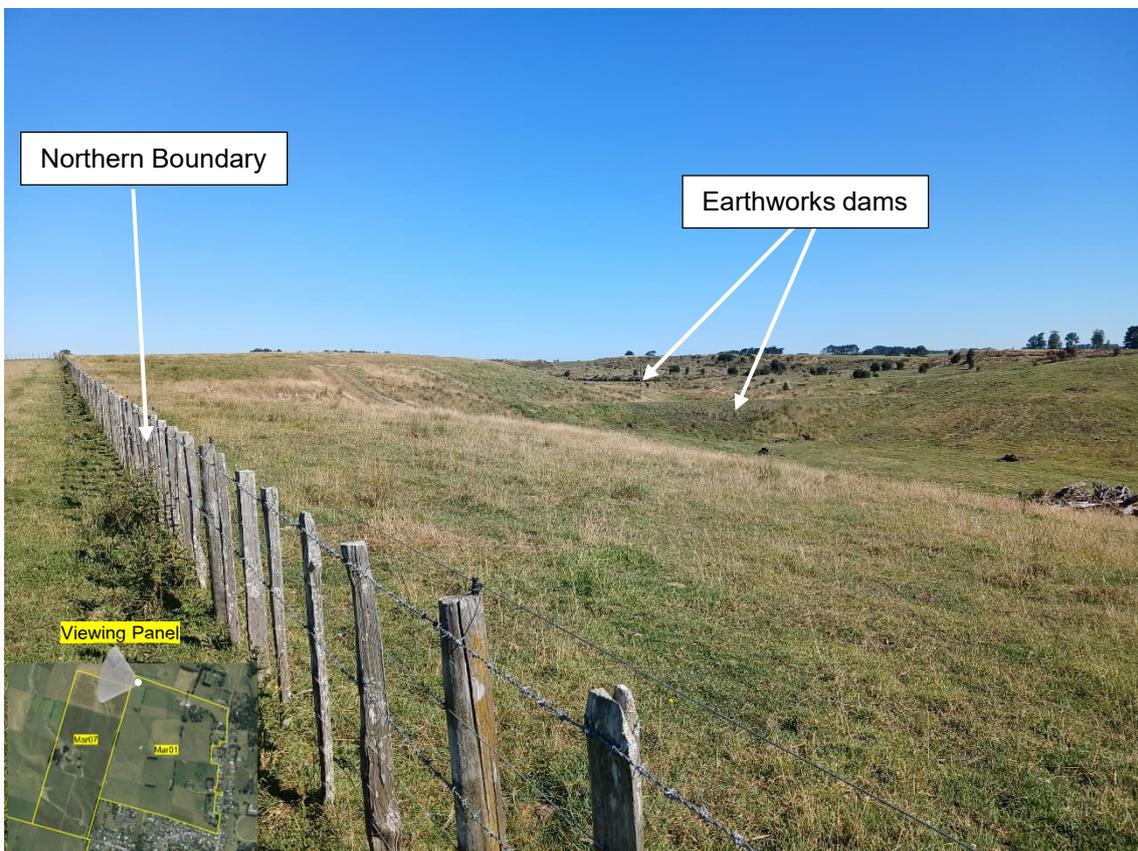
Photograph 14: View of the northern boundary of Mar01 and Mar07 with a moderate slope north of the site boundary. Also 2 earthworks dams are located within the deep alluvial channel to the north / northwest of Mar07, viewed towards the northwest.

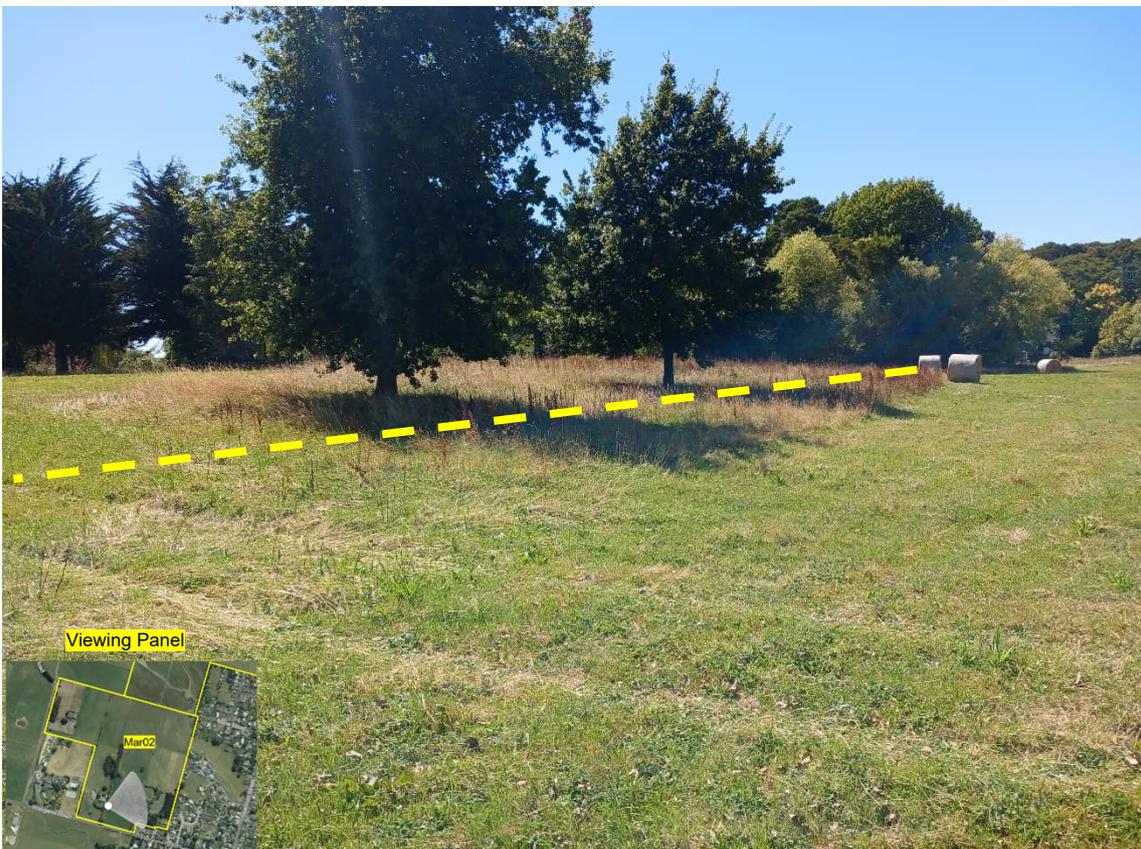
A surface terrace expression and Fault Avoidance Area are present for the mapped active fault trace within Mar02. The fault is noted as a normal fault, recurrence interval class IV (>5,000 to ≤10,000 years) and with a net slip rate of <0.04mm/yr and net single event displacement of <1m. Building within the avoidance zone is likely to be permitted for normal residential structures depending on the fault complexity and Building Importance level (BI1 and BI2)¹⁴, although high significance structures e.g. post-disaster emergency facilities (BI4), school halls (BI3) etc should be avoided. However at a regional scale, building is typically best suitable outside the avoidance zone in the first instance, with roading possible to cross the fault or the zones designated for parks, fields, etc.

Photograph 18: View of the mapped fault trace with the south of Mar02 as evident by minor terrace (trending west to east), viewed towards the east.

The Ministry for the Environment (MFE) report for planning for development of land on or close to active faults¹⁵ recommends a minimum buffer zone of 20m either side of known fault traces or likely surface fault rupture zones. The MFE report also states that the fault avoidance zone can be reduced if a detailed fault study shows that the zone of intense deformation and secondary rupture is less than 20m from the likely fault rupture zone.

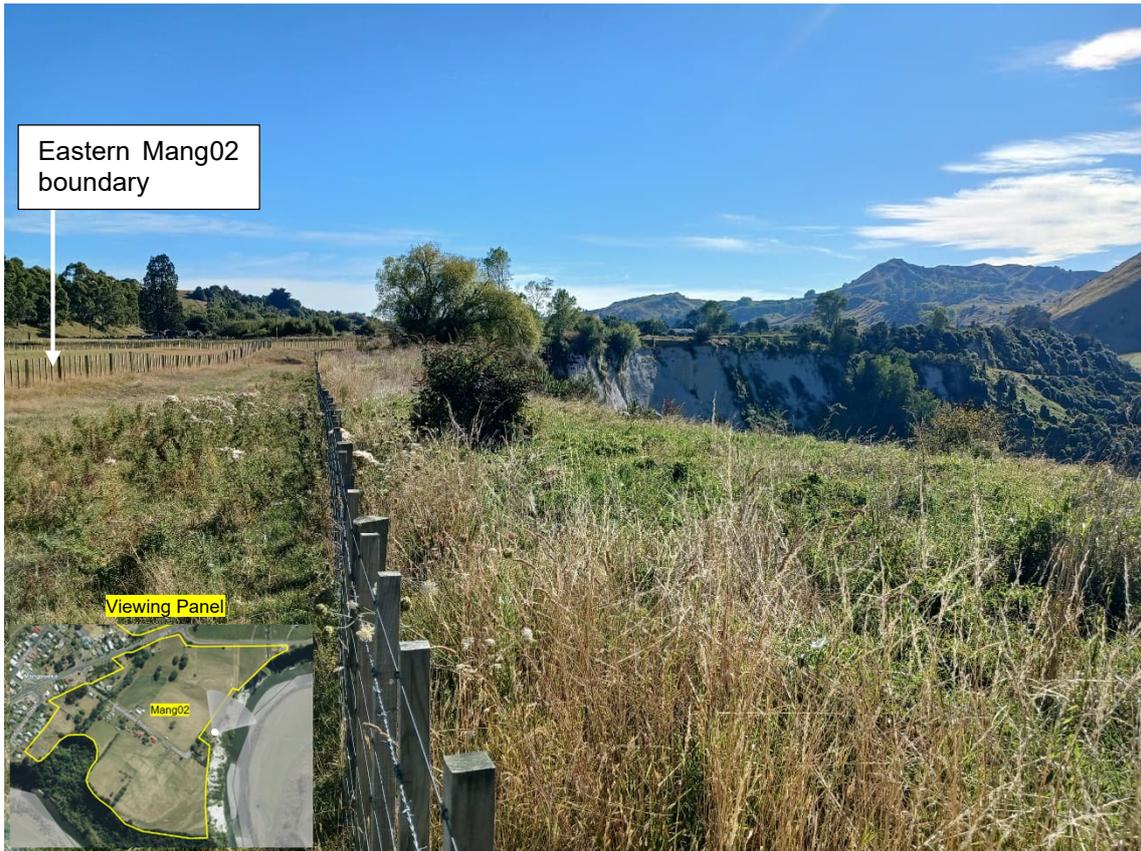
Photograph 23: View of the eastern boundary of Mang02 showing the alluvial cut bedrock cliffs which bound the eastern and southern boundaries of Mang02. Viewed towards the northeast from the eastern edge of Mang02.

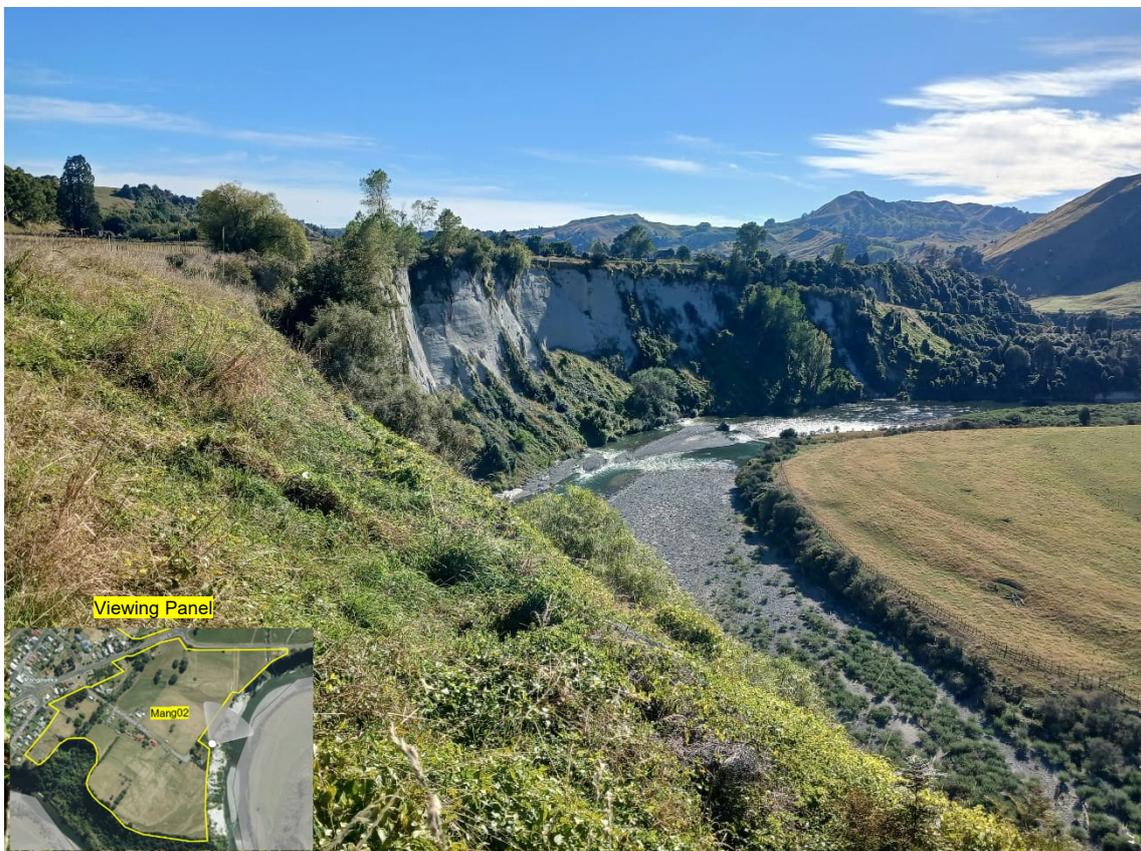
Photograph 24: Alluvial cut sedimentary bedrock cliffs below Mang02, viewed towards the northeast.

- Instability risk within Mang02 along deep channel and alluvial cliffs. Minimum setbacks distances behind a 45° line from the base is recommended unless supported by detailed stability assessments. A conservative set back distance as noted in the Slope Instability Section 5.3 can be adopted if determining the 45° line proves challenging.

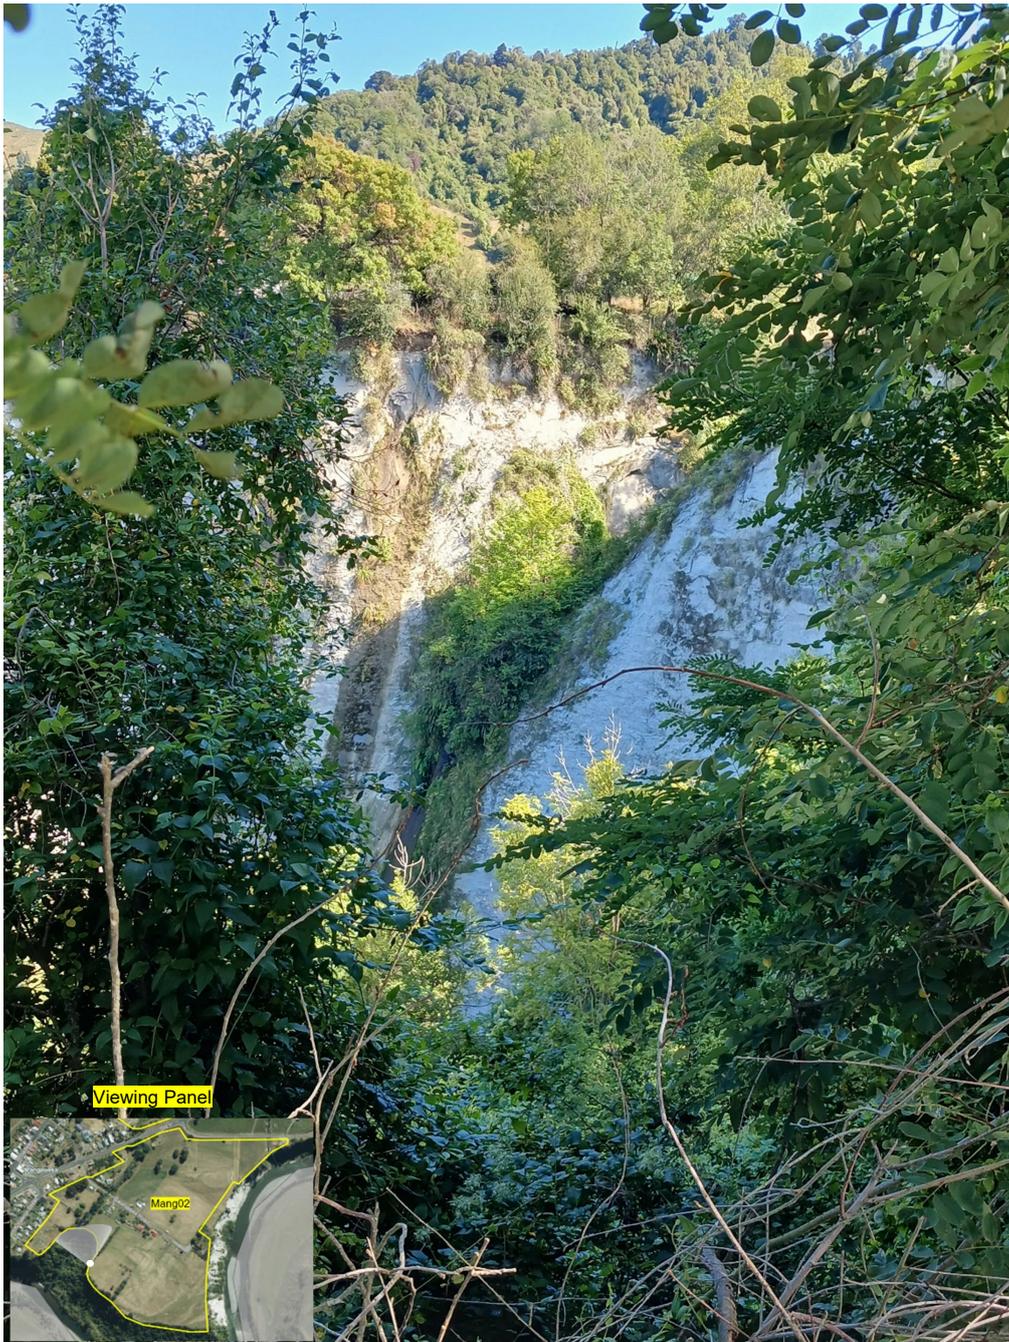
Photograph 25: Outflow of deep channel through the alluvial cliffs down to the Rangitikei River below, viewed the northwest from the southern edge of Mang02.

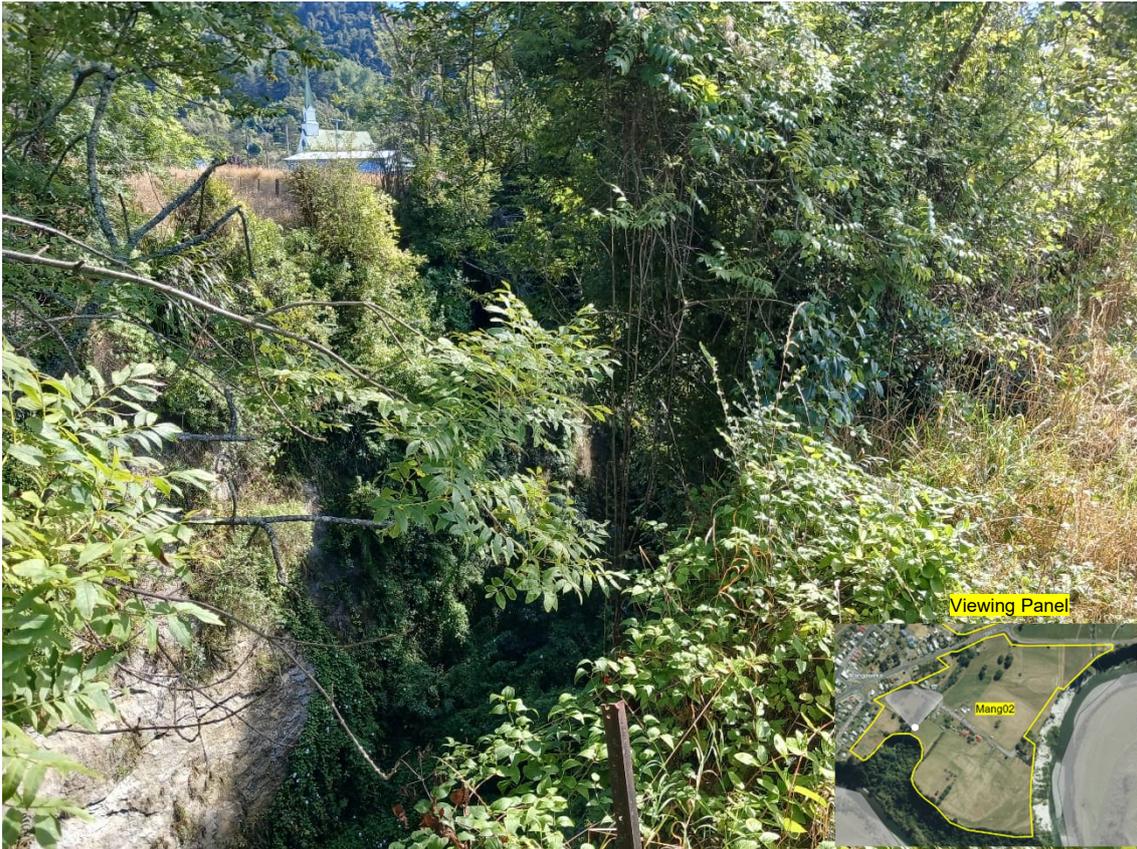
Photograph 26: View of the deep drainage channel (>10m deep) which flows towards the southwest to the outflow shown in Photograph 25 above. Viewed towards the north from the eastern side of the channel within Mang02.

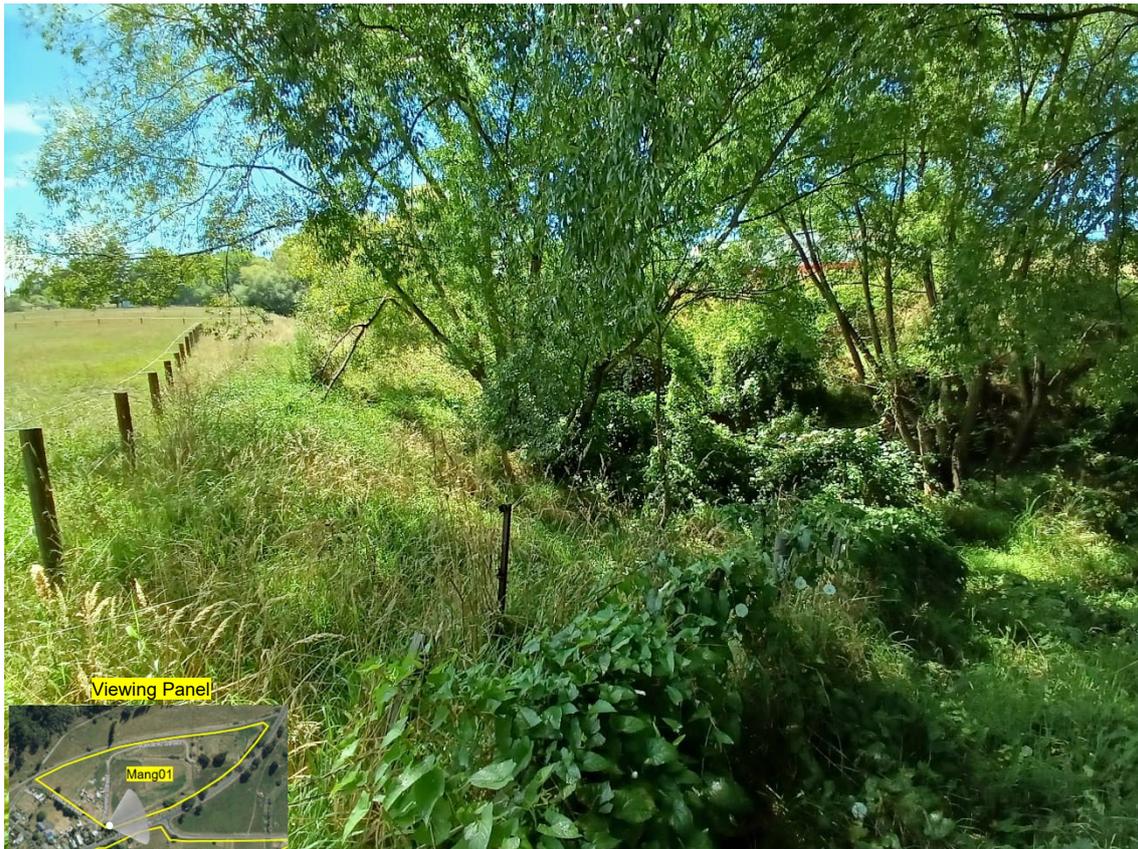
Photograph 30: View of one of the stormwater channels along the eastern boundary of Mang01 / SH1 which flows beneath the SH1 culvert and through the channel within Mang02 shown in Photographs 25 & 26 above. Viewed towards the northeast from the southern corner.
