Rangitikei District Council

Asset Management Plan

3 Waters – 2017-2018

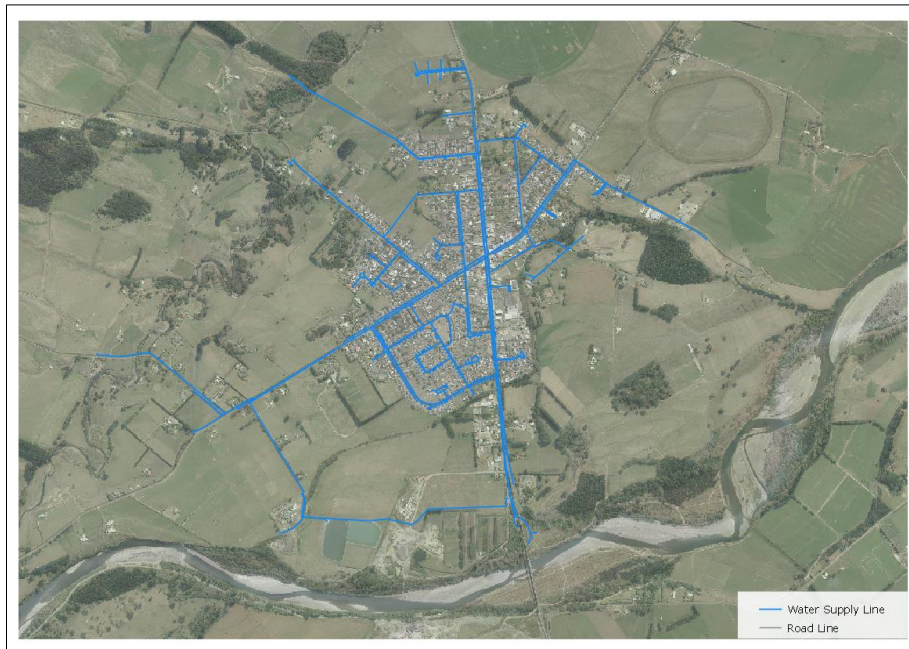
Figure 17: Bulls Water Supply

The Bulls water network comprises pressure mains ranging up to 200 mm diameter. Approximately two-thirds of all the pipes are Asbestos Cement pipes laid in the late 1960s and 1970s. This material was superseded in the late 1970s by MDPE and PVC, which now account for 30% of the network. There is a small portion of the network built from copper which is known to be in poor condition.

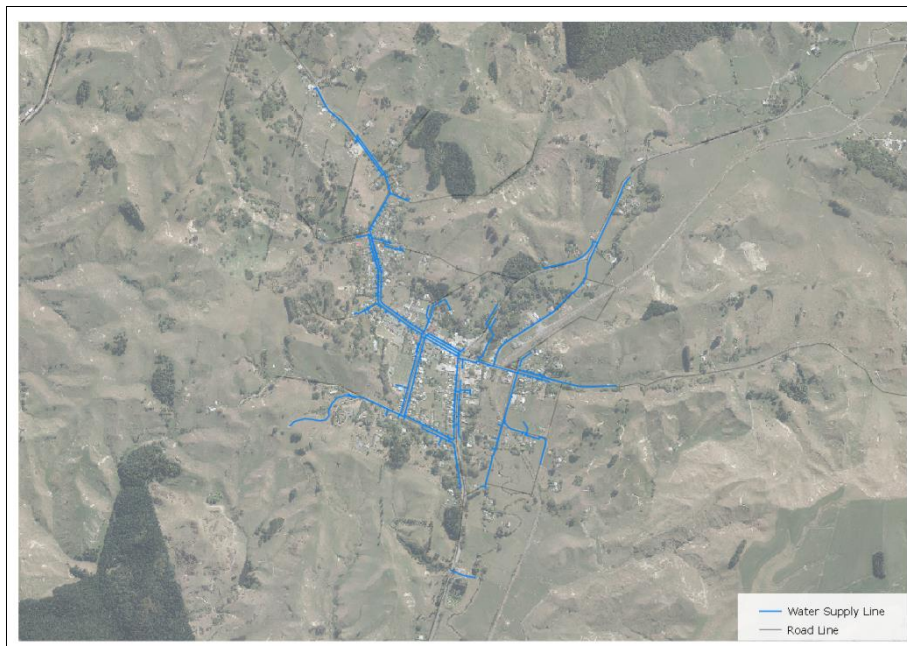
Figure 19: Hunterville Urban Water Supply

The Hunterville Water Network comprises pressure mains ranging up to 150 mm diameter. The network is relatively new, with no pipes listed as being older than 30 years, and 30% being less than 10 years old.

Figure 19 shows the extent of the Hunterville Urban water supply.

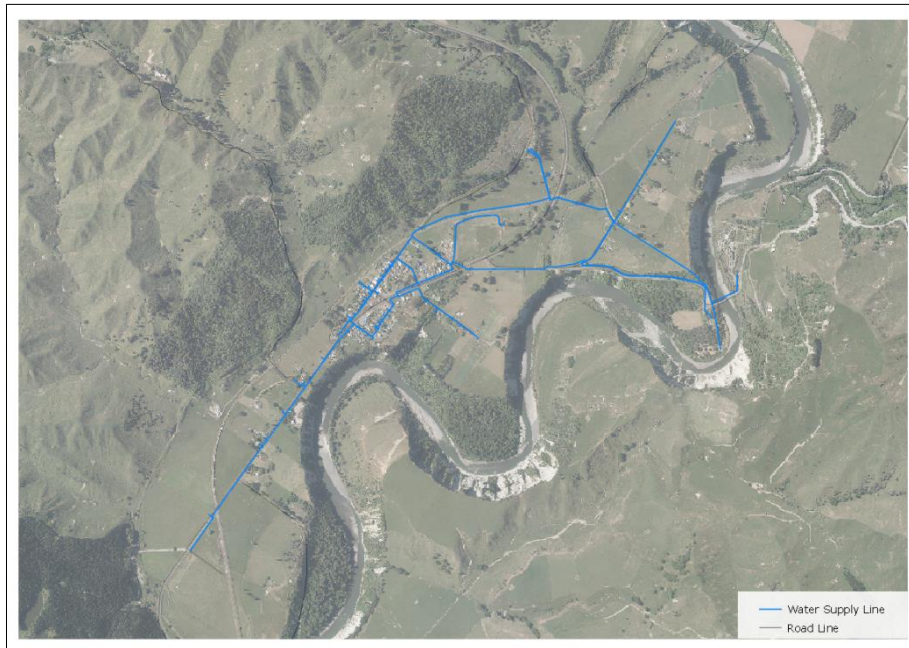
Figure 21: Mangaweka Water Supply

The Mangaweka water network comprises pressure mains ranging up to 200 mm diameter. Approximately half of the network was replaced during the 1990s and many service connections renewed as part of the consumption meters installed in the 2000s. Asbestos pipes from the 1960s and original steel pipes from the 1910s make up the remainder of the network.

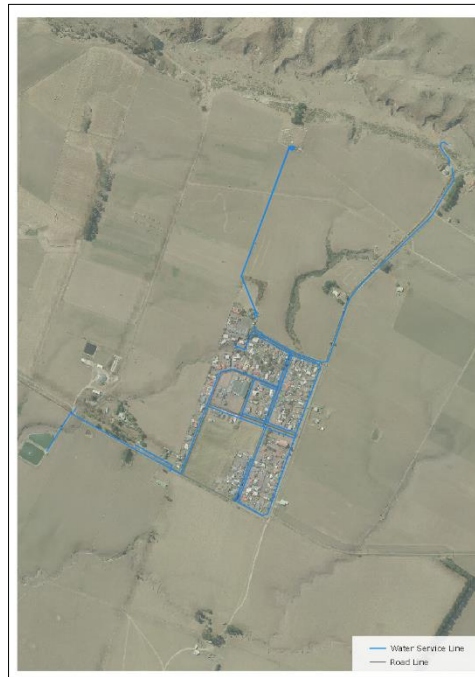
Figure 25: Rātana Water Supply

The Rātana water network comprises pressure mains ranging up to 150 mm diameter. More than half of all the pipes are Asbestos Cement pipes laid in the late 1970s. The network was progressively extended in the 1980s-1990s with MDPE and PVC, accounting for 43% of the network.

The Rātana water supply is shown in Figure 25.

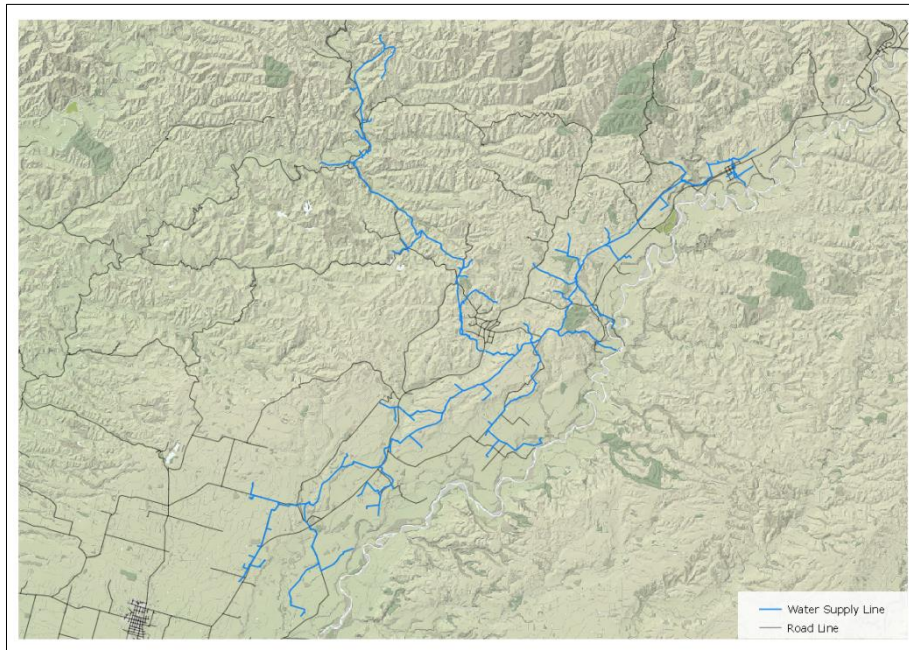
Figure 31: Hunterville Rural Water Supply

The water network comprises pressure mains ranging up to 150 mm diameter. Nearly the entire scheme was constructed in 1985 from PVC pressure pipe. Some growth of the system occurred in early 2000. Replacement of pipelines has been initiated by mains breaks or land slippage. Extent of replacement has been minimized to only that required to resolve the issue.

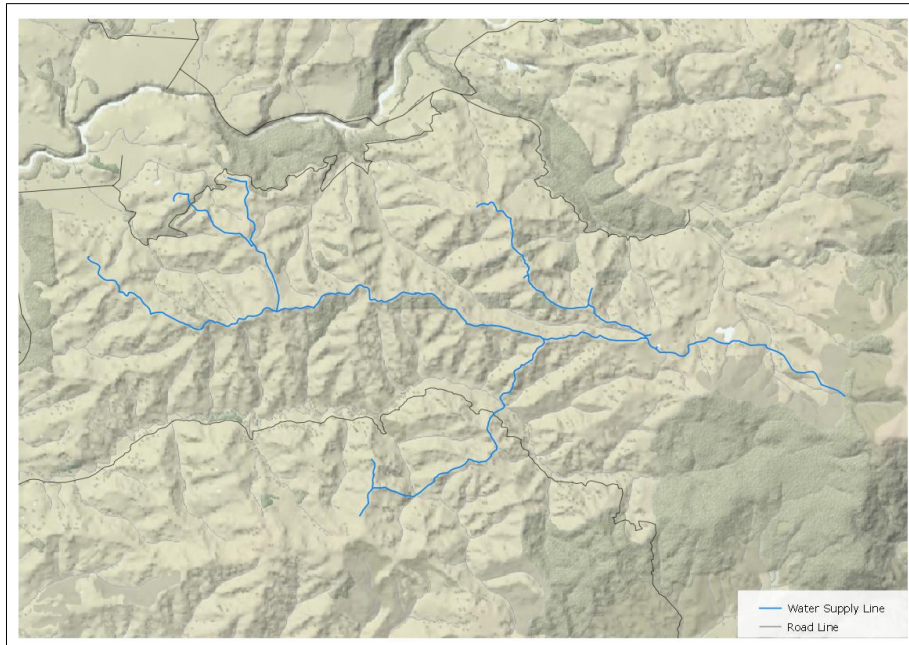
Figure 33: Omatane Rural Water

The Omatane water network is managed by the farm owners it supplies. Council staff provide a management role only; this includes performing monitoring compliance for resource consents, and advising the farmers as required.

The extent of the Omatane scheme is shown in Figure 33.

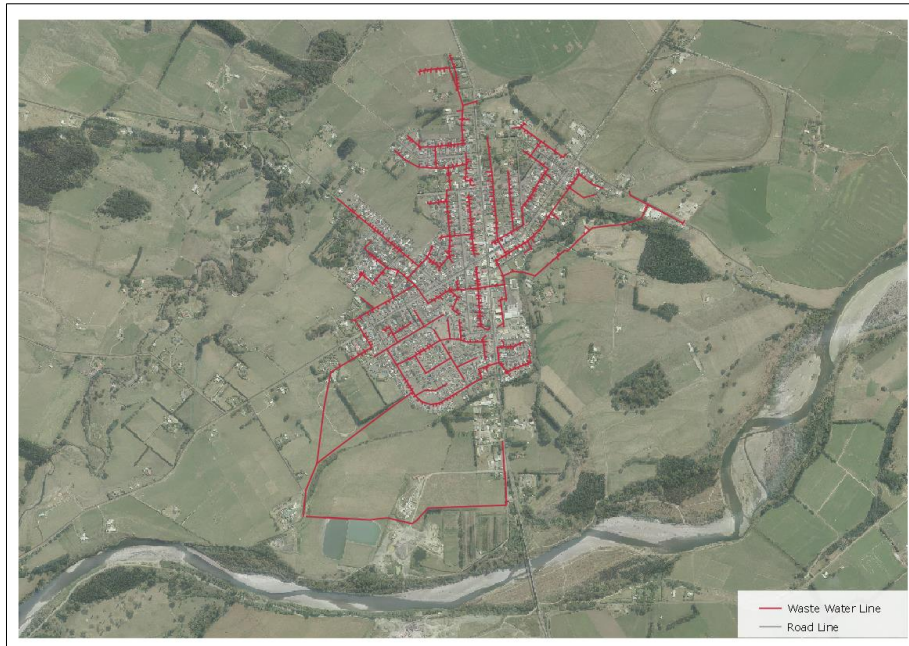
Figure 39: Bulls Wastewater

The Bulls wastewater network comprises pipelines ranging from 100 to 375 mm in diameter. The network is relatively young with an age of less than 40 years. The majority pipe material is Asbestos Cement, which has exhibited accelerated deterioration in other communities. However, there is very little industrial waste in the township and the expected remaining life for this material is expected to be longer than elsewhere.

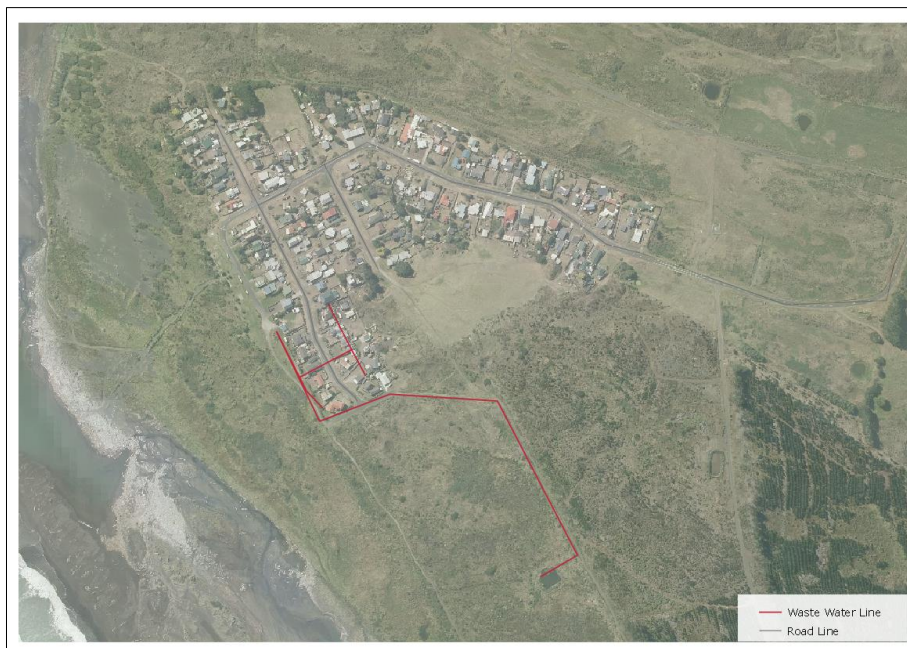
Figure 45: Koitiata Wastewater

A key issue is the compliance issues of the majority of the septic tanks in Koitiata. Regardless of the material of construction, a septic tank must be watertight and structurally sound to protect the environment and function properly. A survey of septic tank systems, and sampling of groundwater, has been carried out by Council. This has revealed that there is no contamination of groundwater by septic tank effluent. The results have been communicated to Horizons Regional Council, which is the governing authority for septic tank discharges.

Figure 45 shows the extent of the Koitiata wastewater network.

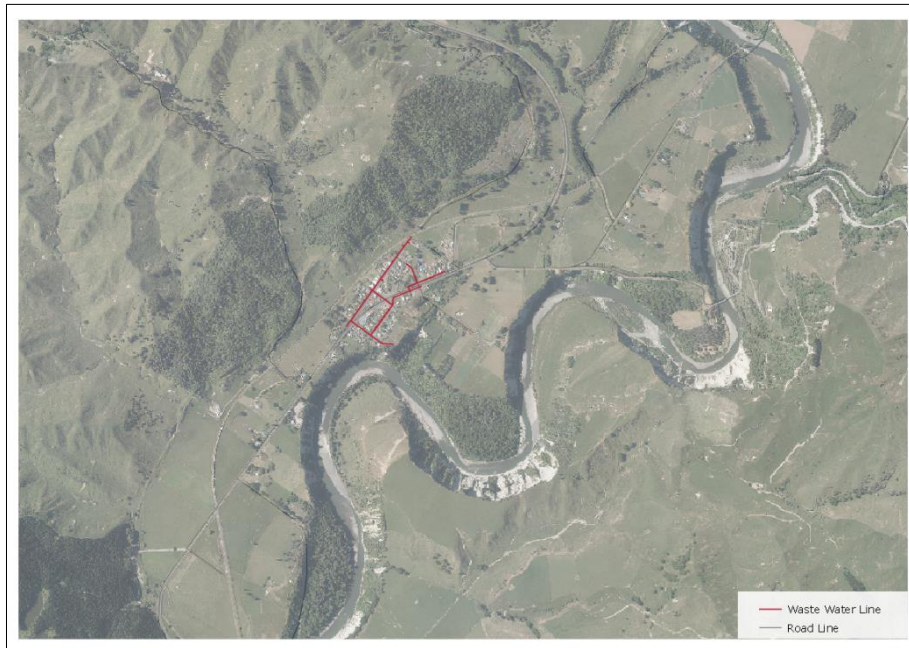
Figure 48: Mangaweka Wastewater

There are mostly two materials found in wastewater pipe assets in Mangaweka: glazed earthenware and Asbestos Cement (Figure 49).

The extent of the Mangaweka wastewater system is shown in Figure 48.

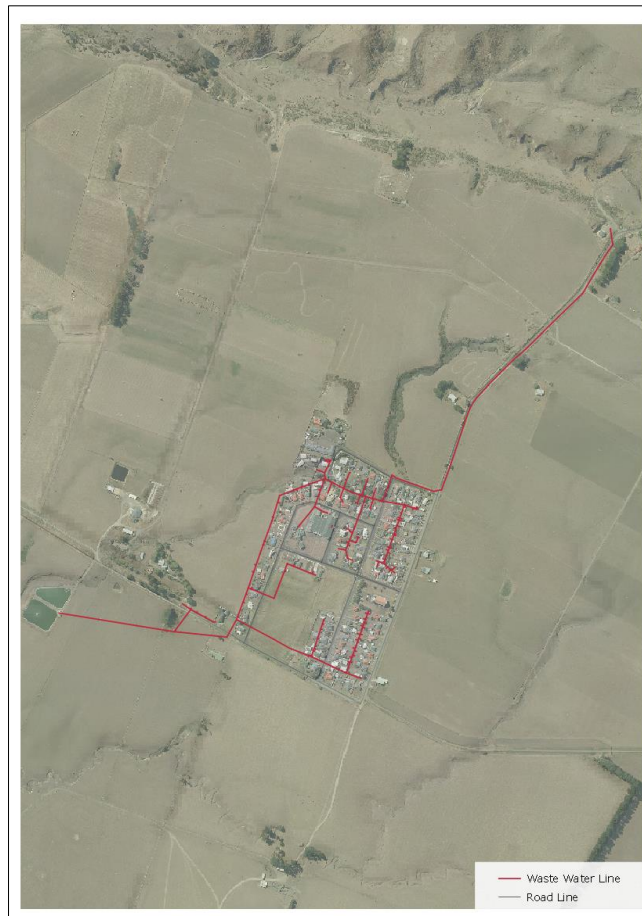
Figure 54: Rātana Wastewater

Wastewater pipes in Rātana, due to their fairly recent installation, are entirely PVC plastic. This is shown in Figure 55.

The extent of the Rātana network is shown in Figure 54.

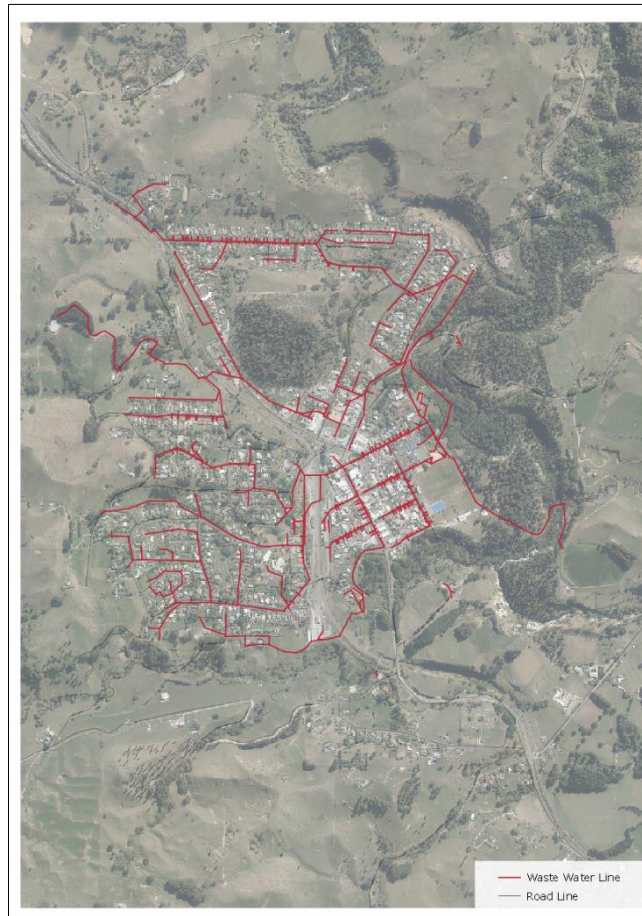
Figure 57: Taihape Wastewater

The Taihape wastewater network comprises pipelines ranging from 100 to 375 mm in diameter. Approximately 70% of the network is thought to be glazed earthenware pipes over 90 years old.

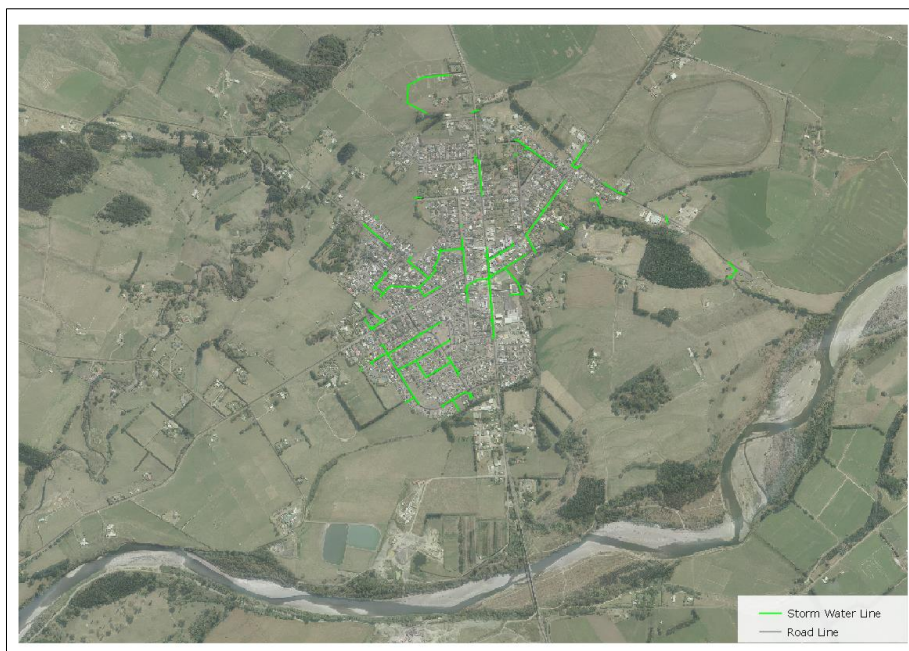
Figure 63: Bulls Stormwater

A breakdown of pipe materials used for Bulls stormwater is given in Figure 64. Predominantly, the pipes are made of concrete. But at least 17% of the pipe network is plastic. Material is unknown for approximately 3% of stormwater pipes in Bulls.

The extent of the stormwater system for Bulls is shown in Figure 63.

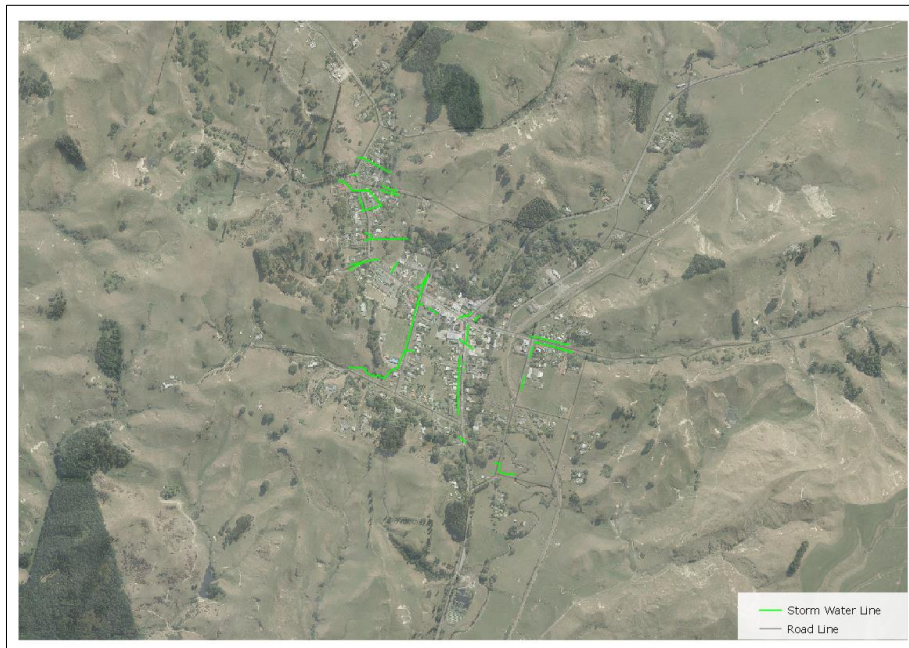
Figure 66: Hunterville Stormwater

Most stormwater pipes in Hunterville are concrete, as indicated in Figure 67. There is a reasonable amount of Asbestos Cement pipe on the network as well.

The area served by the Hunterville stormwater network is displayed in Figure 66.

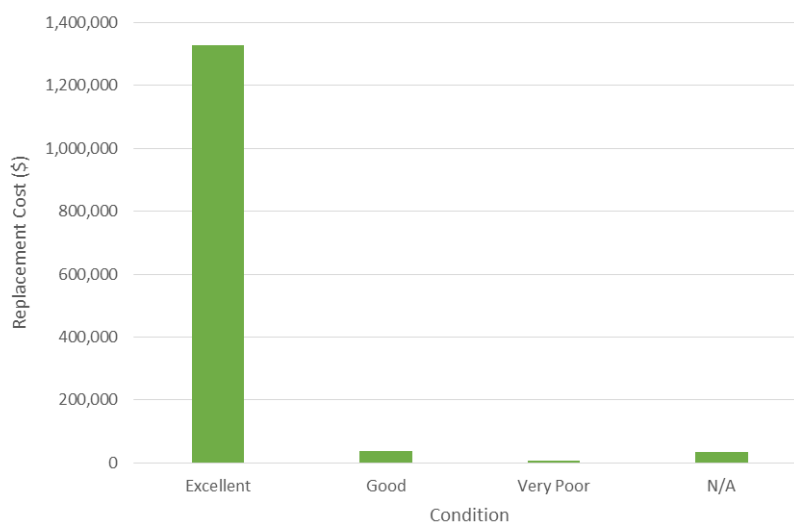
Figure 68: Asset Condition - Hunterville Stormwater

The condition of stormwater assets in Hunterville has generally been assessed as “Excellent”, as seen in Figure 68. There are some gaps in information for this network, however. Condition grading following CCTV inspections and more accurate dates of installation will allow the Council to improve our asset information.

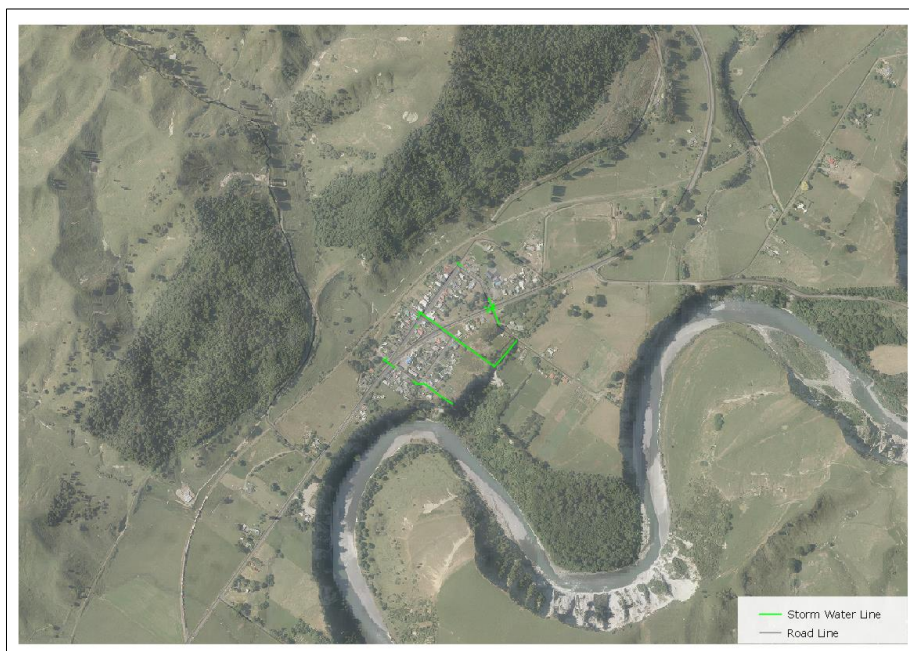
Figure 69: Mangaweka Stormwater

Figure 70 shows the breakdown of pipe materials used in Mangaweka stormwater. The pipes themselves are mostly concrete, but a significant amount of the assets are open drains.

The extent of the stormwater network for Mangaweka is shown by Figure 69.

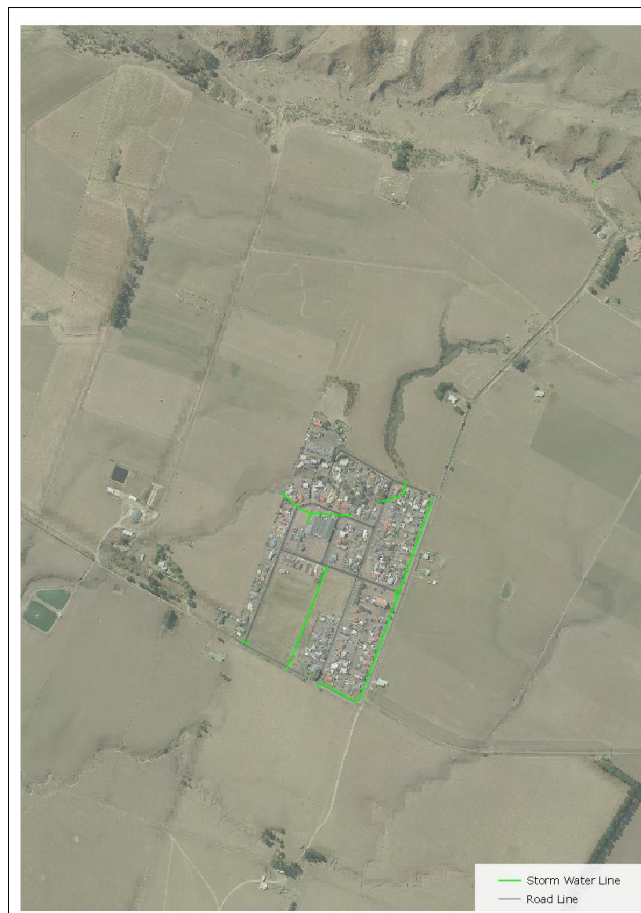
Figure 75: Rātana Stormwater

Stormwater pipes in Rātana are either concrete or uPVC. See below.

The Rātana stormwater system is shown in Figure 75.

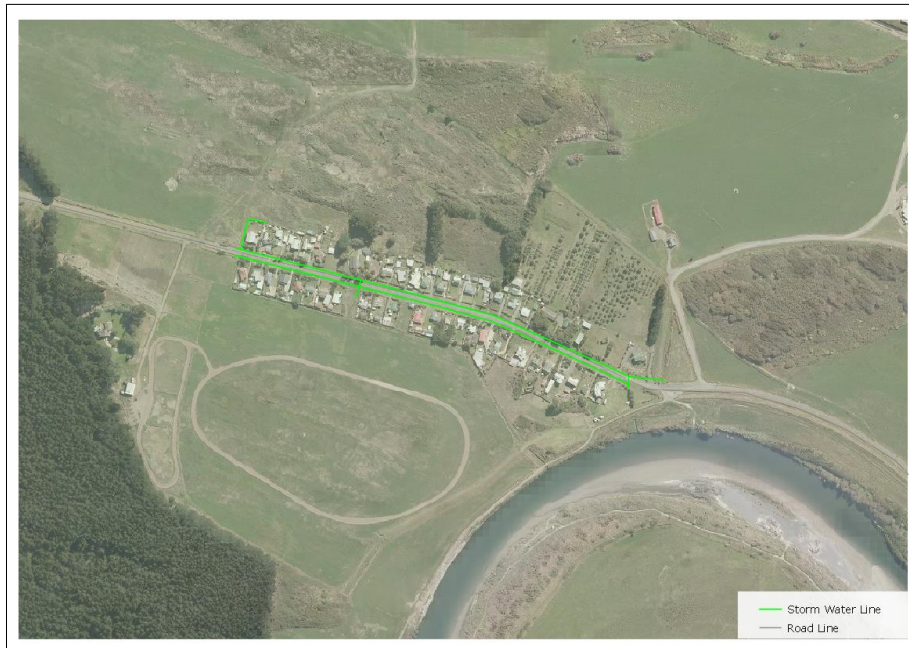
Figure 82: Scotts Ferry Stormwater

An investigation is required into stormwater levels of service for Scotts Ferry. Due to its location it is prone to flooding from the Rangitikei River, and ponding of stormwater can contribute to issues for the community. The scope and cost of potential improvements will be investigated. If necessary, Council may decide to apply rating for stormwater to Scotts Ferry so that funds are available to improve infrastructure at this locality.
