RANGITĪKEI
DISTRICT COUNCIL

Asset Management Plan

3 Waters – 2021-2031

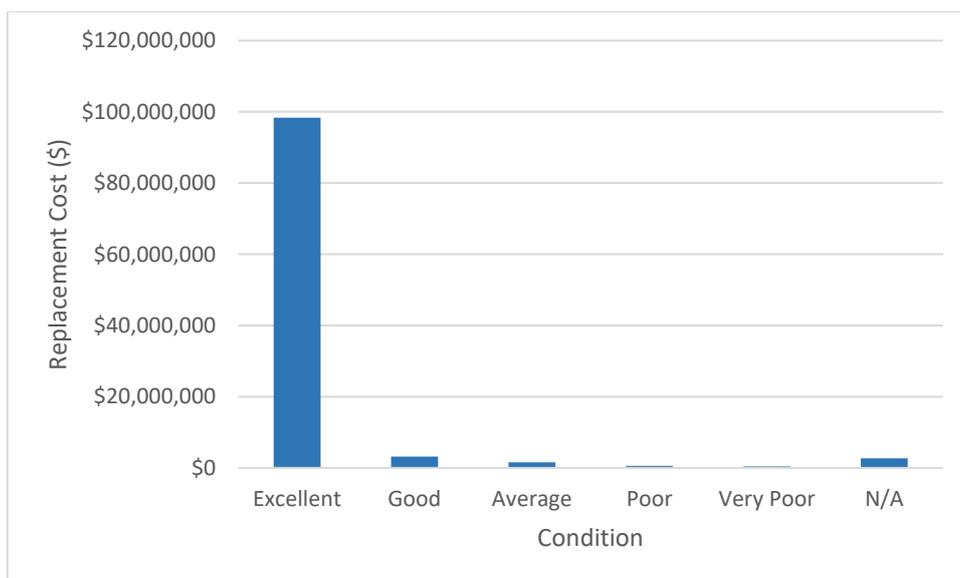
Figure 13: Asset Condition – Water Supply

Condition information on Water Supply assets needs improvement. The default Condition rating is “Excellent”, and there is a high proportion of assets given this score. See below.

The condition rating of “N/A” is used for assets where no condition information is available. All the assets are recorded on the asset management system, but some recorded assets do not contain any data on condition. Water supply assets shows 7% of recorder assets as having no condition rating data and marked as “N/A”. Improvement of condition information will be completed over the next 3 to 4 years as part of the new asset management strategy.

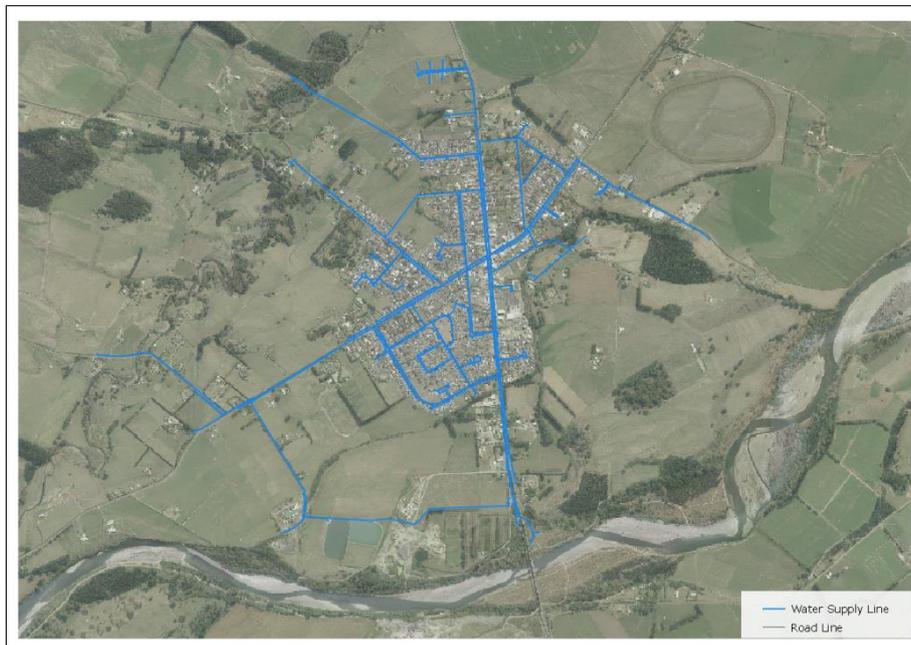
Figure 14: Bulls Water Supply

Bulls is located beside the Rangitikei River on two old river flats. Water is abstracted from several shallow bores. From there it is treated before being pumped to two water reservoirs at Tricker’s Hill on the north-western side of Bulls in the farmland adjacent to Tricker’s Hill Road. These two reservoirs have a total capacity of 540 m³. A trunk main from these reservoirs supplies the entire town of Bulls. A 227 m³ water tower located in Taumaihi Street previously supplied the RNZAF zone. This zone has now been combined with the town. The two reservoirs on Tricker’s Hill will be replaced by a new 1300 m³ reservoir being constructed in the Bulls Township. Water will be supplied to the network from a pump station on the same site.

The Bulls water network comprises pressure mains ranging up to 200 mm diameter. Approximately two-thirds of all the pipes are Asbestos Cement pipes laid in the late 1960s and 1970s. This material was superseded in the late 1970s by MDPE and PVC, which now account for 30% of the network. There is a small portion of the network built from copper which is known to be in poor condition.

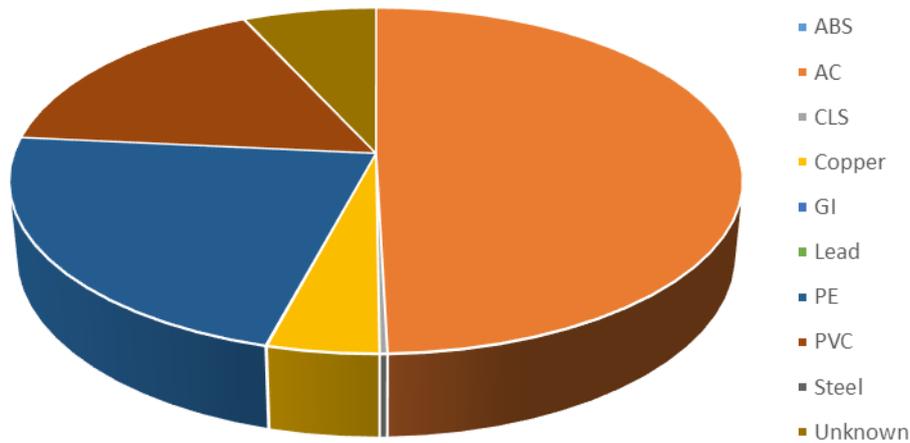
Figure 15: Pipe Material – Bulls Water

The various pipe materials used for water supply in Bulls are described in Figure 15. Predominantly, the pipes are made from Asbestos Cement. There is a significant amount of plastic pipe within the network as well.

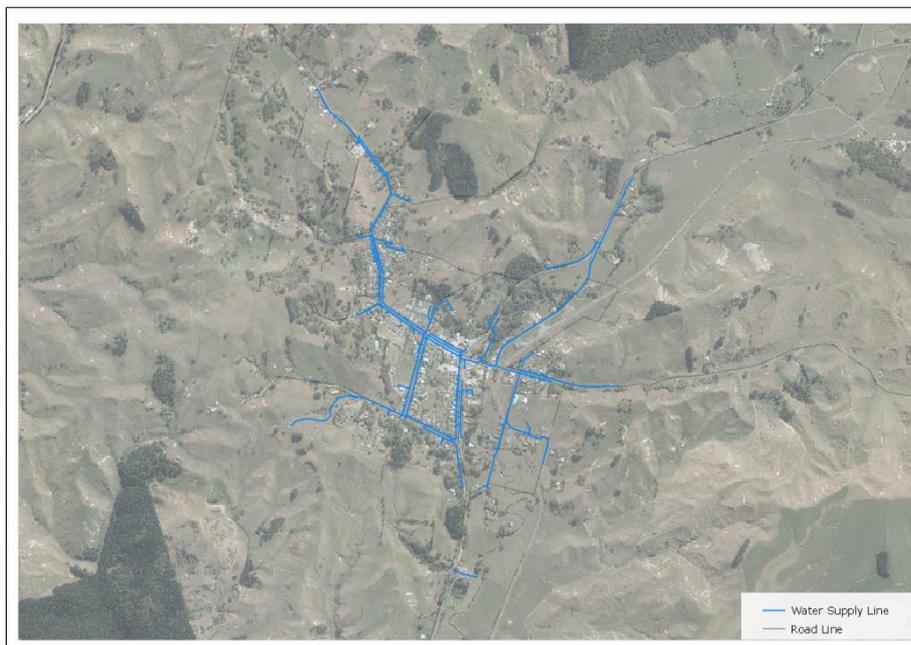
Figure 16: Hunterville Urban Water Supply

The Hunterville Water Network comprises pressure mains ranging up to 150 mm diameter. The network is relatively new, with no pipes listed as being older than 30 years, and 30% being less than 10 years old.

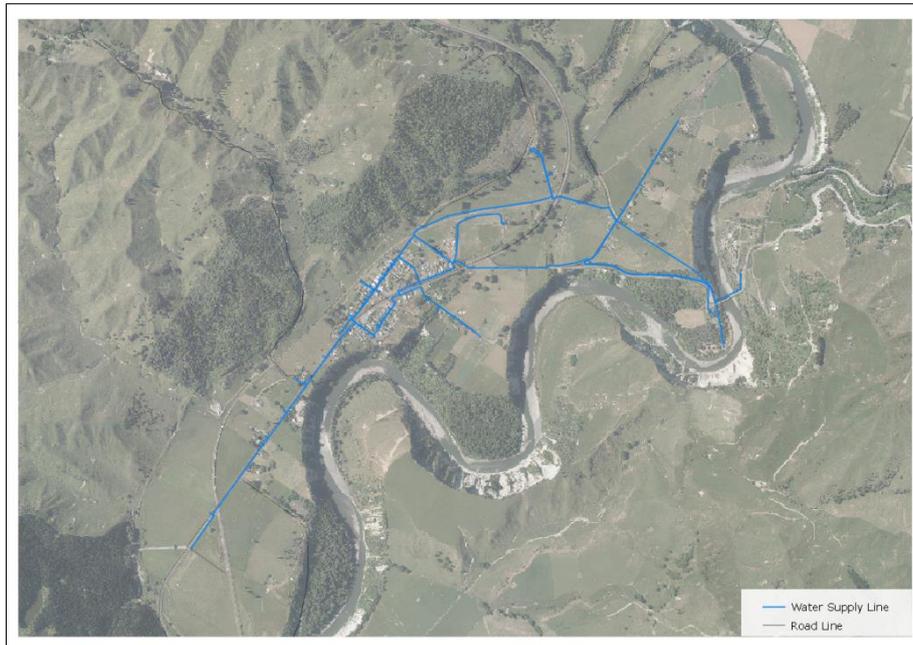
Figure 18: Mangaweka Water Supply

The Mangaweka water network comprises pressure mains ranging up to 200 mm diameter. Approximately half of the network was replaced during the 1990s and many service connections renewed as part of the consumption meters installed in the 2000s. Asbestos pipes from the 1960s and original steel pipes from the 1910s make up the remainder of the network.

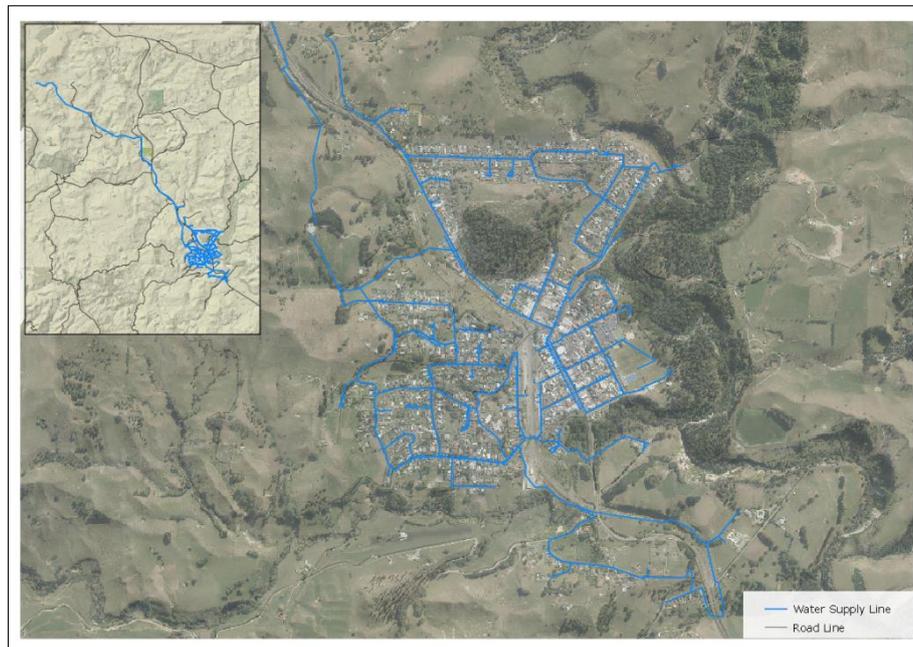
Figure 24: Taihape Water Supply

The Taihape water network comprises 21.9 km of pressure mains ranging up to 375 mm diameter. Approximately half of all pipes are the original steel mains laid from 1910 to 1960.

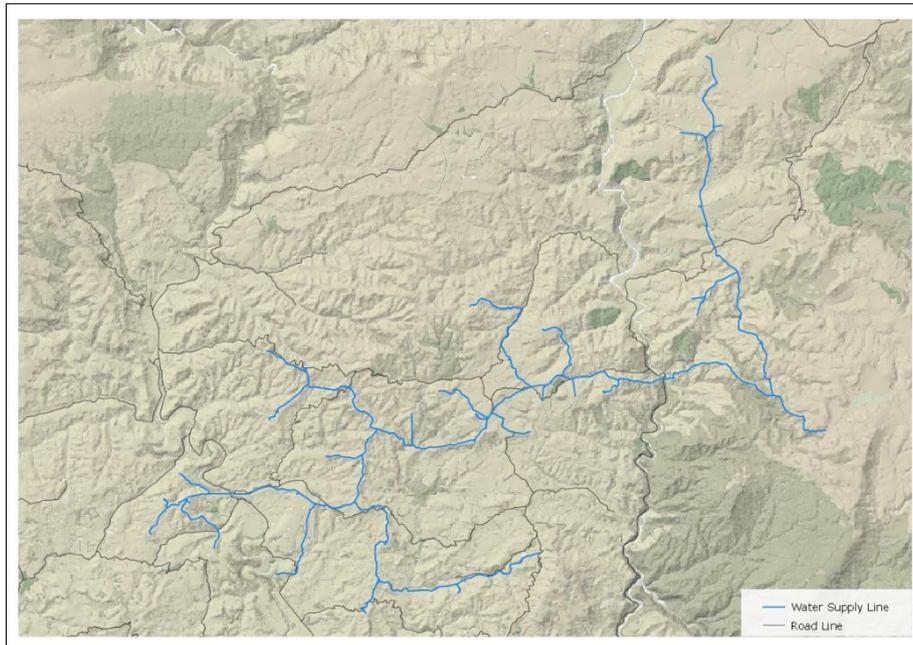
Figure 26: Erewhon Rural Water Supply

The Erewhon rural water network comprises constant flow pressure mains ranging up to 200 mm diameter. It was originally constructed with Asbestos Cement and steel pipes, with PVC used in the smaller diameters in the 1980s. The original steel pipe has shown over the years that it is susceptible to corrosion. An investment to replace this material with suitable pressure rated plastic alternatives means there is only 16% steel remaining.

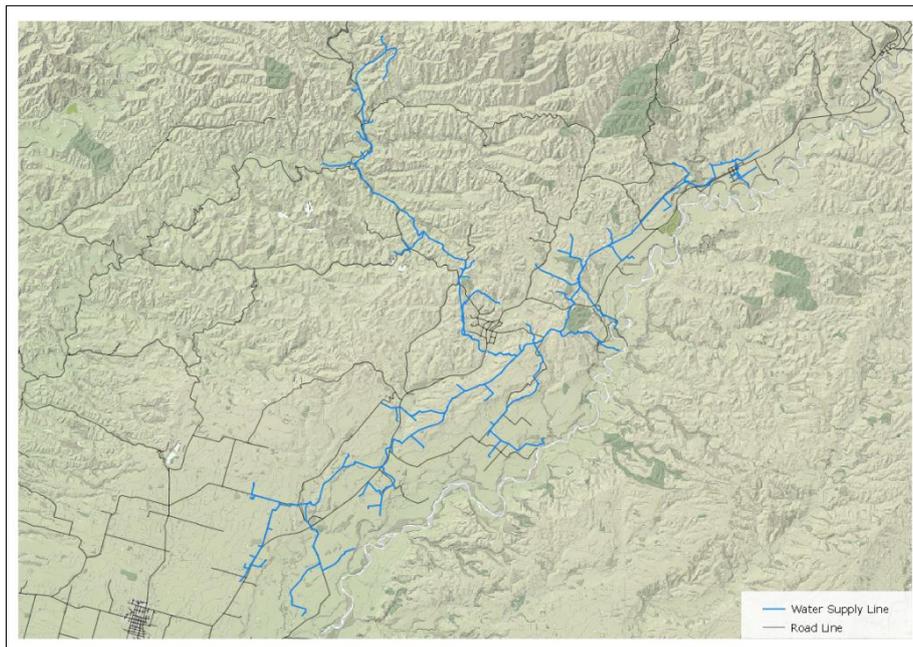
Figure 28: Hunterville Rural Water Supply

The water network comprises pressure mains ranging up to 150 mm diameter. Nearly the entire scheme was constructed in 1985 from PVC pressure pipe. Some growth of the system occurred in early 2000. Replacement of pipelines has been initiated by mains breaks or land slippage. Extent of replacement has been minimized to only that required to resolve the issue.

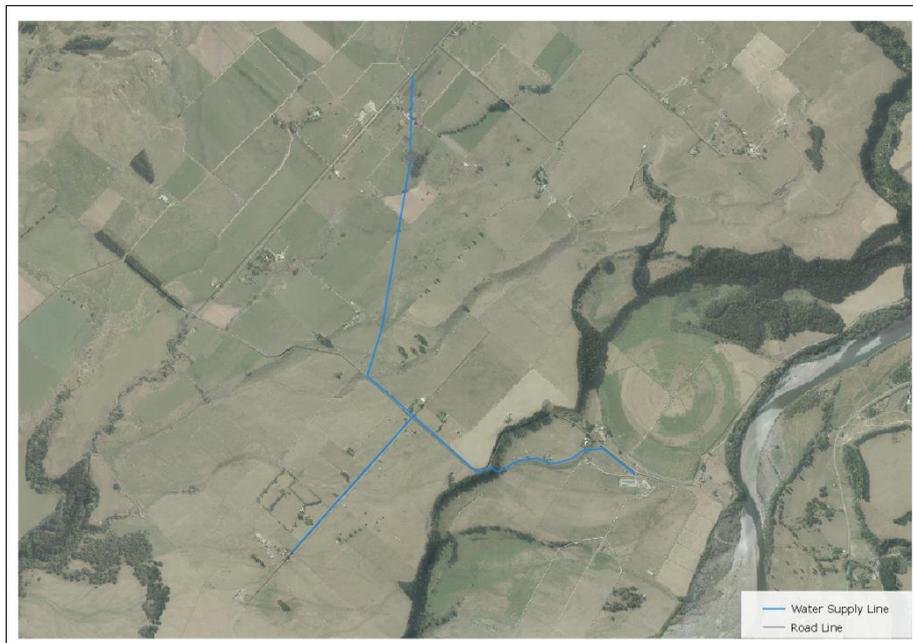
Figure 32: Putorino Rural Water

Pipe material in Putorino is mostly galvanized iron, since the mains are of small diameter (see Table 25). This is distinct from all other water supplies mentioned, in which the mains are larger and constructed from different materials.

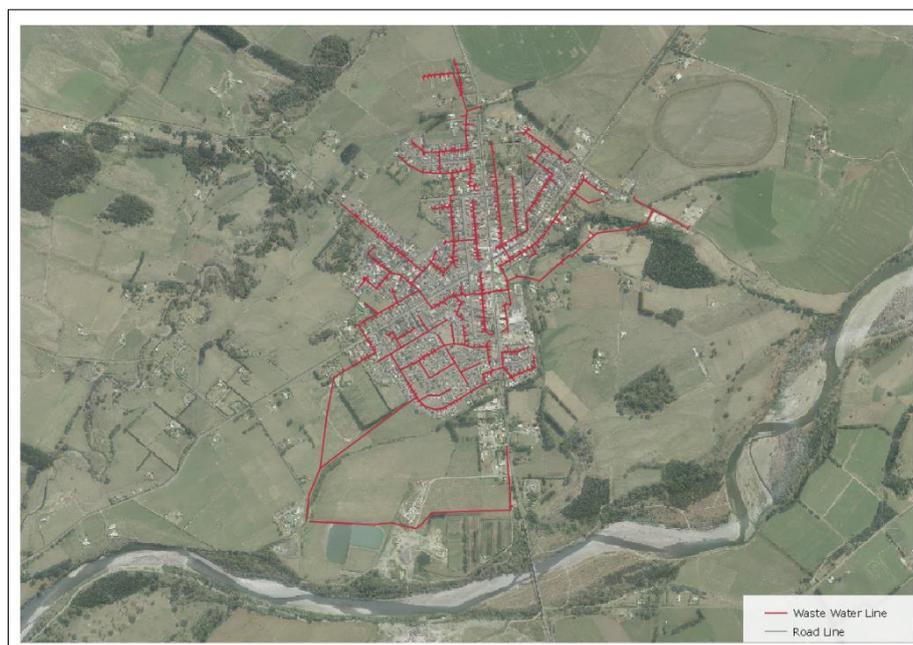
Figure 36: Bulls Wastewater

The Bulls wastewater network comprises pipelines ranging from 100 to 375 mm in diameter. The network is relatively young with an age of less than 40 years. The majority pipe material is Asbestos Cement, which has exhibited accelerated deterioration in other communities. However, there is very little industrial waste in the township and the expected remaining life for this material is expected to be longer than elsewhere.

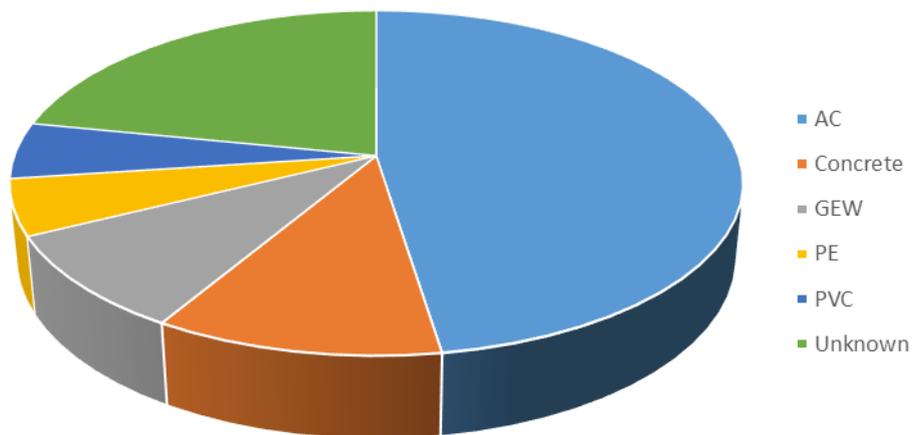
Figure 37: Pipe Material – Bulls Wastewater

The large amount of “unknown” pipe material can be shown to be the lateral connections from private property to the main. It is assumed these would be GEW pipes if they are part of the original construction.

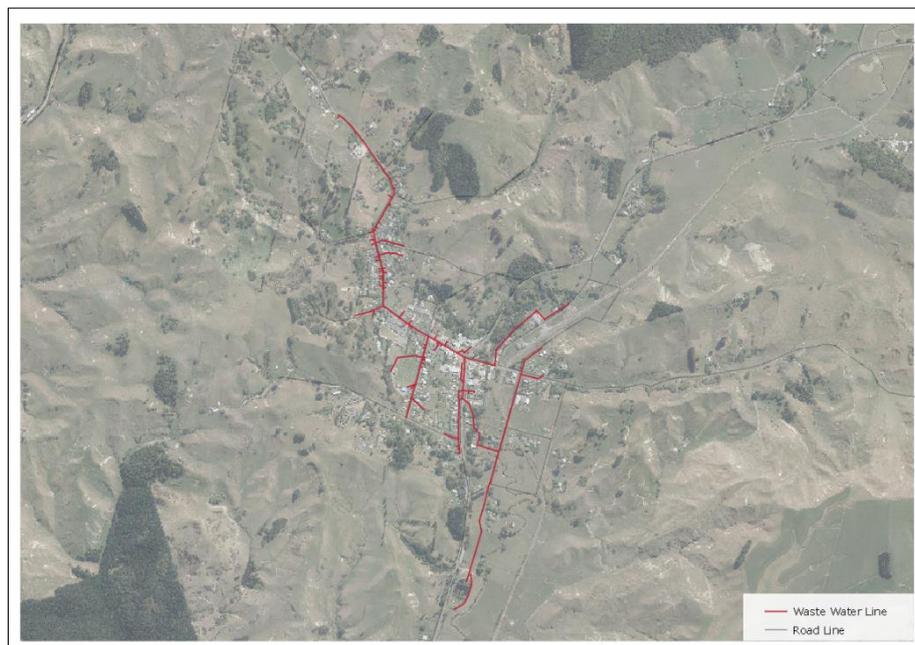
Figure 39: Hunterville Wastewater

Graphs of pipe age and material for the wastewater system in Hunterville follow. 50% of the reticulation was installed in the 1910s, and is now around 100 years old.

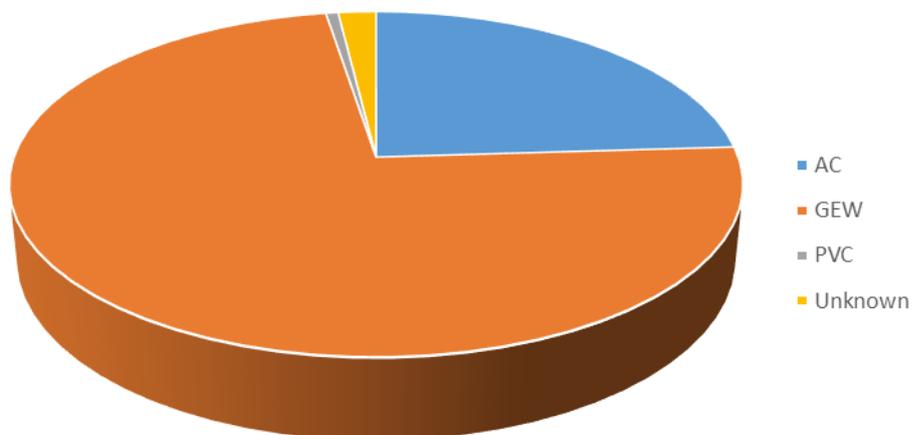
Figure 46: Pipe Material – Mangaweka Wastewater

There are mostly two materials found in wastewater pipe assets in Mangaweka: glazed earthenware and Asbestos Cement (Figure 46).

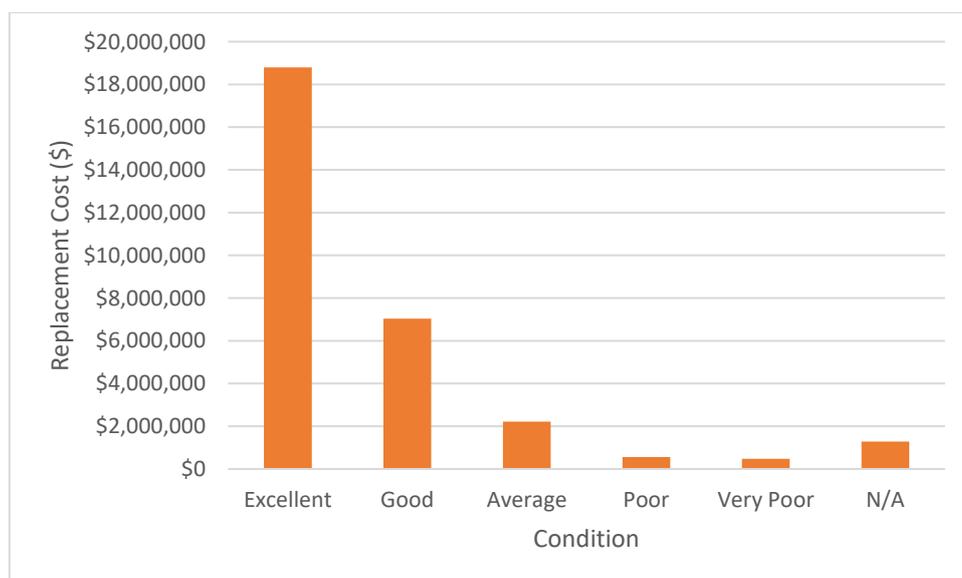
Figure 50: Asset Condition – Marton Wastewater

Approximately 12% of the network is in poor or very poor (condition 4 & 5). The age of these pipes are between 60 and 100 years old. The Asbestos Cement pipes laid in the 1970s are on average in worse condition than other pipe materials of similar age. Asbestos Cement pipe has suffered in some areas of town due to the aggressive acidic attack by industrial wastes suggesting poor material choices in the past. Overall most pipes in the network are in good condition.

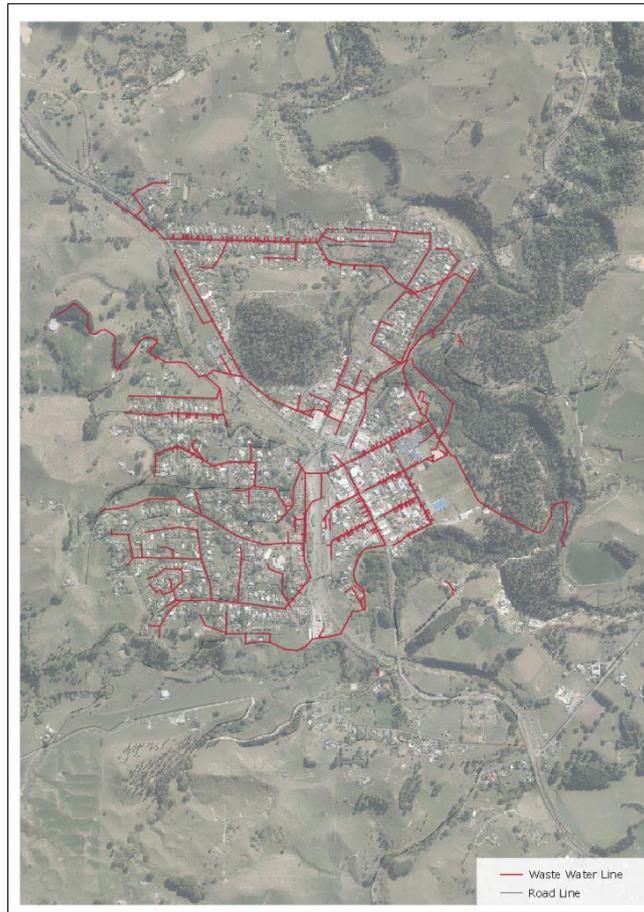
Figure 54: Taihape Wastewater

The Taihape wastewater network comprises pipelines ranging from 100 to 375 mm in diameter. Approximately 70% of the network is thought to be glazed earthenware pipes over 90 years old.

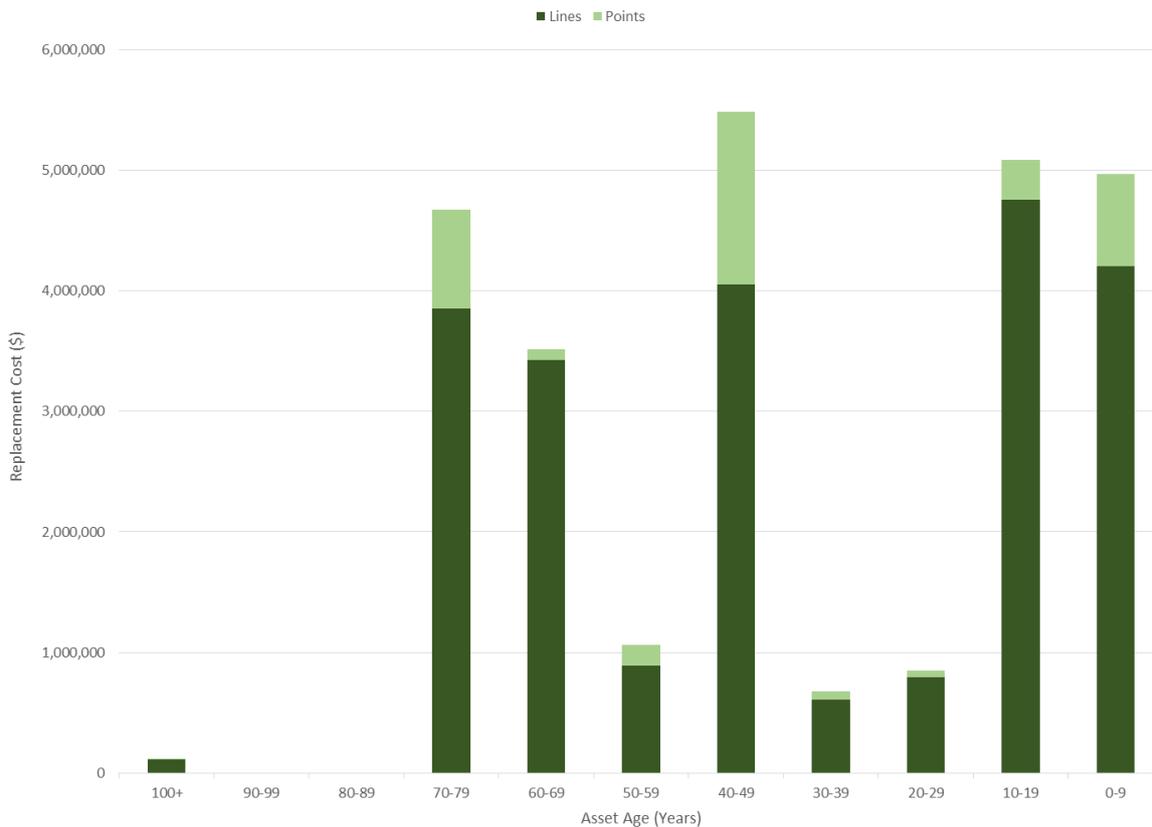
Figure 58: Asset Age - Stormwater

The age distribution of stormwater varies across the District. Age profile by total replacement cost of assets is given in Figure 58.

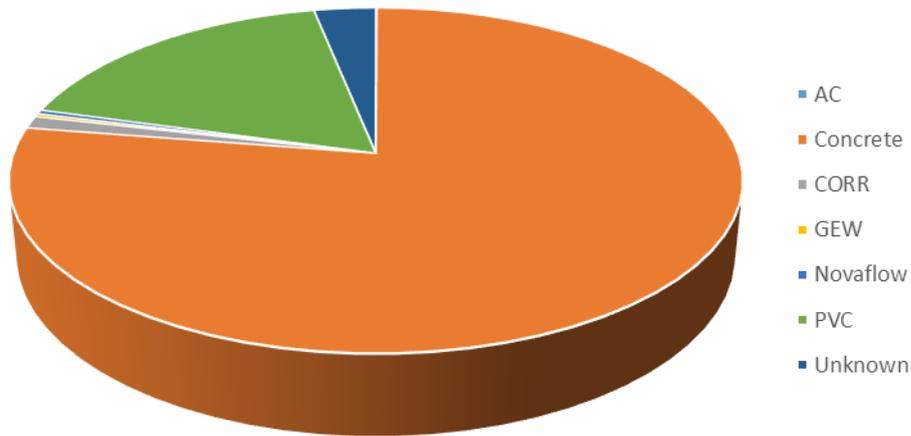
Figure 61: Pipe Material - Bulls Stormwater

A breakdown of pipe materials used for Bulls stormwater is given in Figure 61. Predominantly, the pipes are made of concrete. But at least 17% of the pipe network is plastic. Material is unknown for approximately 3% of stormwater pipes in Bulls.

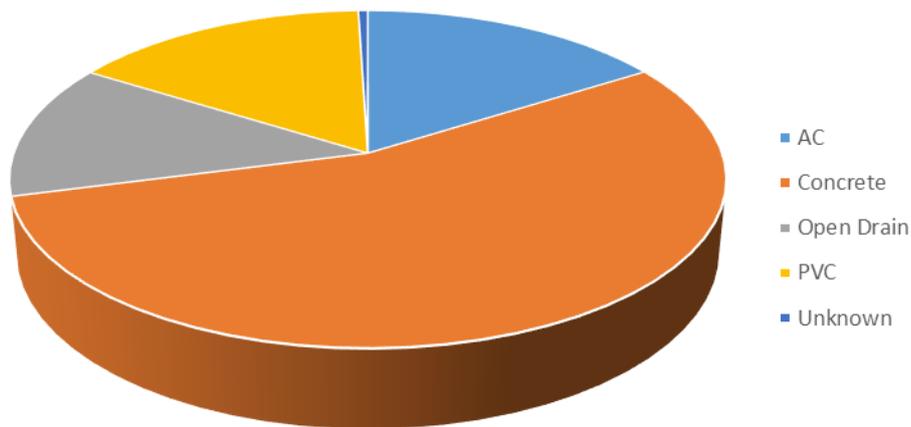
Figure 64: Pipe Material - Hunterville Stormwater

Most stormwater pipes in Hunterville are concrete, as indicated in Figure 64. There is a reasonable amount of Asbestos Cement pipe on the network as well.

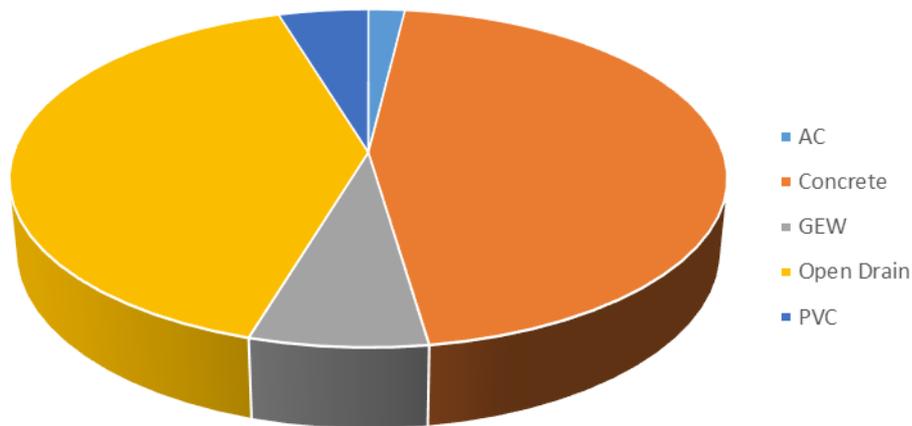
Figure 67: Pipe Material – Mangaweka Stormwater

Figure 67 shows the breakdown of pipe materials used in Mangaweka stormwater. The pipes themselves are mostly concrete, but a significant amount of the assets are open drains.

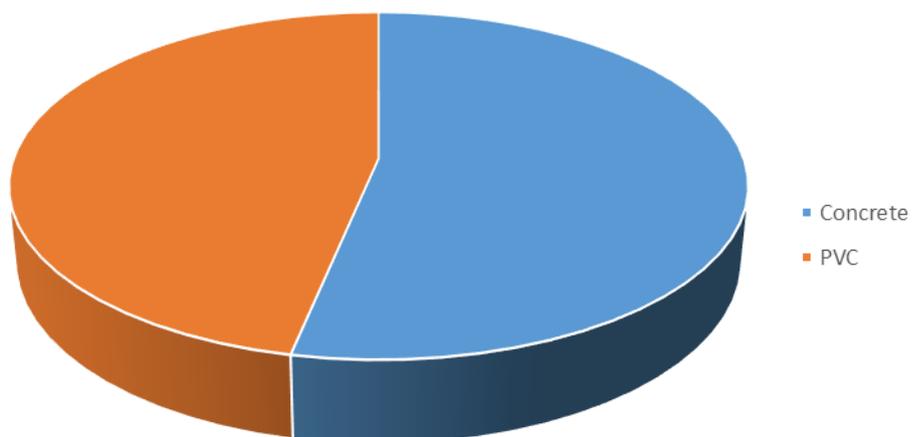
Figure 73: Pipe Material - Rātana Stormwater

Stormwater pipes in Rātana are either concrete or uPVC. See below.

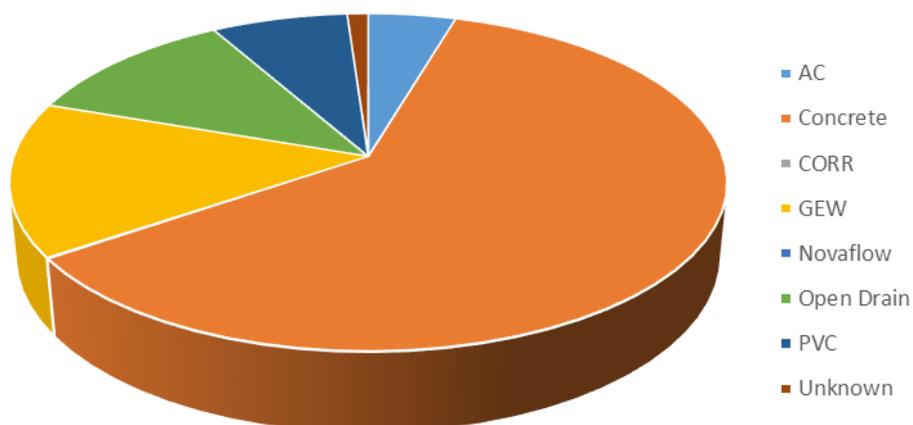
Figure 76: Pipe Material – Taihape Stormwater

The most commonly found stormwater pipe material in Taihape is concrete (see Figure 76). There are also significant amounts of glazed earthenware and uPVC.
