Bulls Community Committee

BULLS COMMUNITY COMMITTEE MEETING

SUBJECT: **Scotts Ferry Stormwater**
TO: Bulls Community Committee
FROM: David Rei Miller, Asset Engineer
DATE: 8 August 2017
FILE: 6-SW-1-9

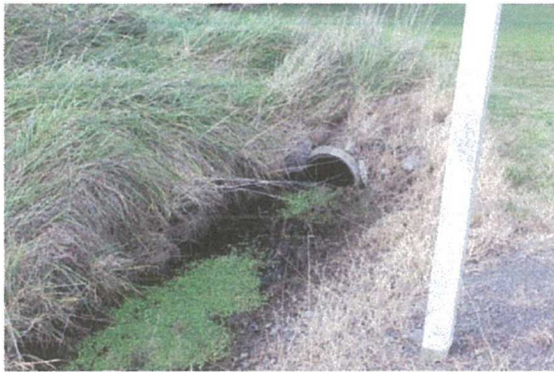
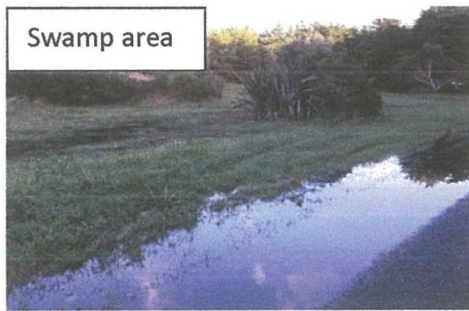
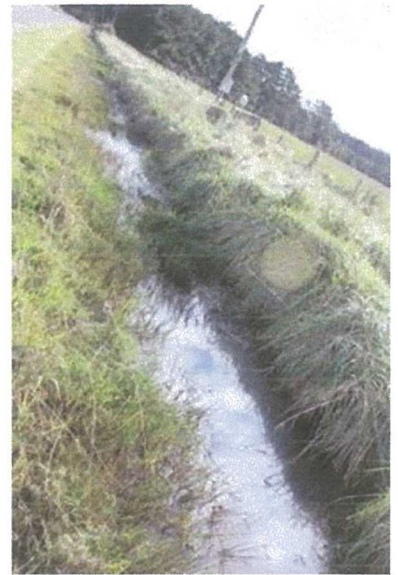
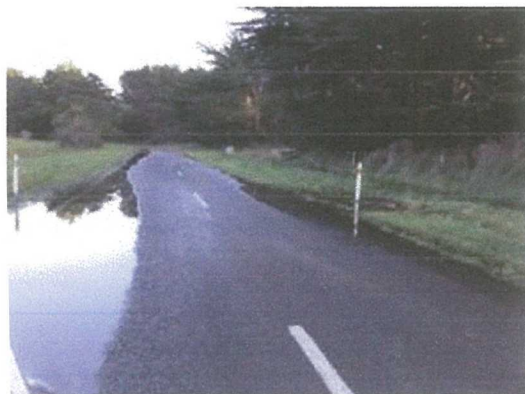
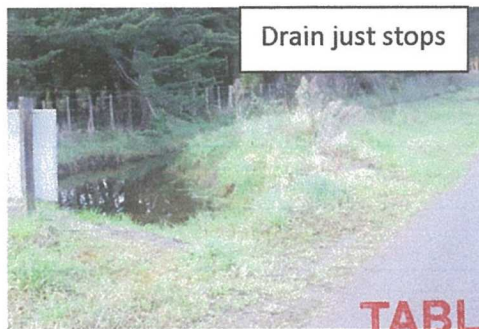
The drains at Scotts Ferry were installed by the council, they have not been renewed or regularly maintained since they were installed 20 years ago. They no longer perform as they were meant to, due to lack of maintenance and due to an increase in water volume. The road drain to the western end of the village has been installed to run nowhere? When we have rain, it fills the already water logged drains and spills over the road cutting off our only emergency exit, should a large flooding event occur. This continual flooding over the road is causing roading issues and also creating a swamp land where we did not have one before. The open drains are clogged with weed and grass and they are stagnant and do not drain.. The underground perforated storm water drains... we suspect... have also become blocked due to lack of maintenance over the years..... causing drainage issues for houses and waterlogging land around the village

We would like all drains to be cleaned and maintained so that they function to a satisfactory standard for the amount of water they now have to cope with.

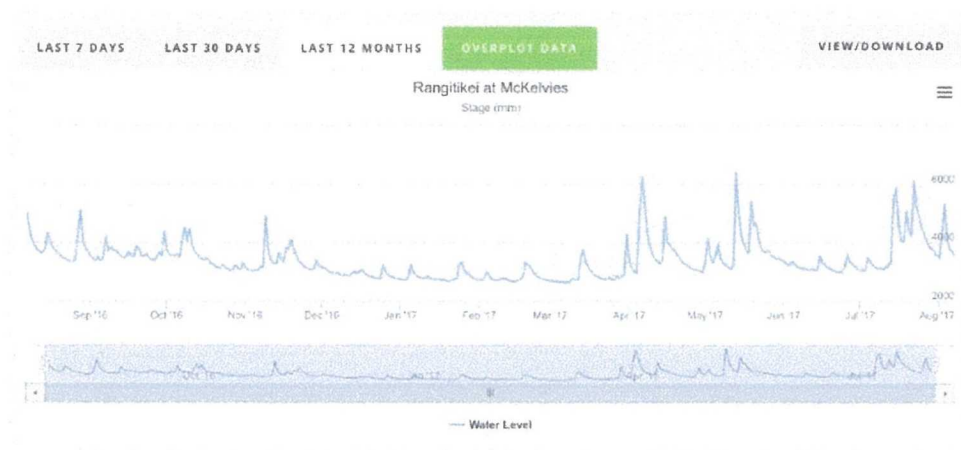
Three flood gates have been installed. There is a large flood gate at Amons Creek and two smaller ones at the eastern end of the settlement. These gates allow storm and surface water flow from the village in to the river. When the river reaches a height of 4.5mts the pressure of the flowing river shuts the gates and stops the river flowing back in to the settlement... Herein lies a problem.... Amon's creek is spring feed. Once the gate is shut the water from the creek and also from the runoff over the flattened dairy farm land, continues to build up behind the gate. This then floods the paddocks and floods over Parewanui road cutting off our legal road access in and out of the village. When the other two smaller gates are closed a similar situation occurssurface water and storm water builds up behind the stop bank and around the houses and camp ground at the eastern end of the village. Then all the drains back up with water right thru the village as it has nowhere to go.

These flood gates were closed 8 times last month between 14th and 25th July 2017Scotts ferry is waterlogged

We would like pumps installed at the two eastern end drains to remove the surface and storm water that builds up around the village when the flood gates are closed.

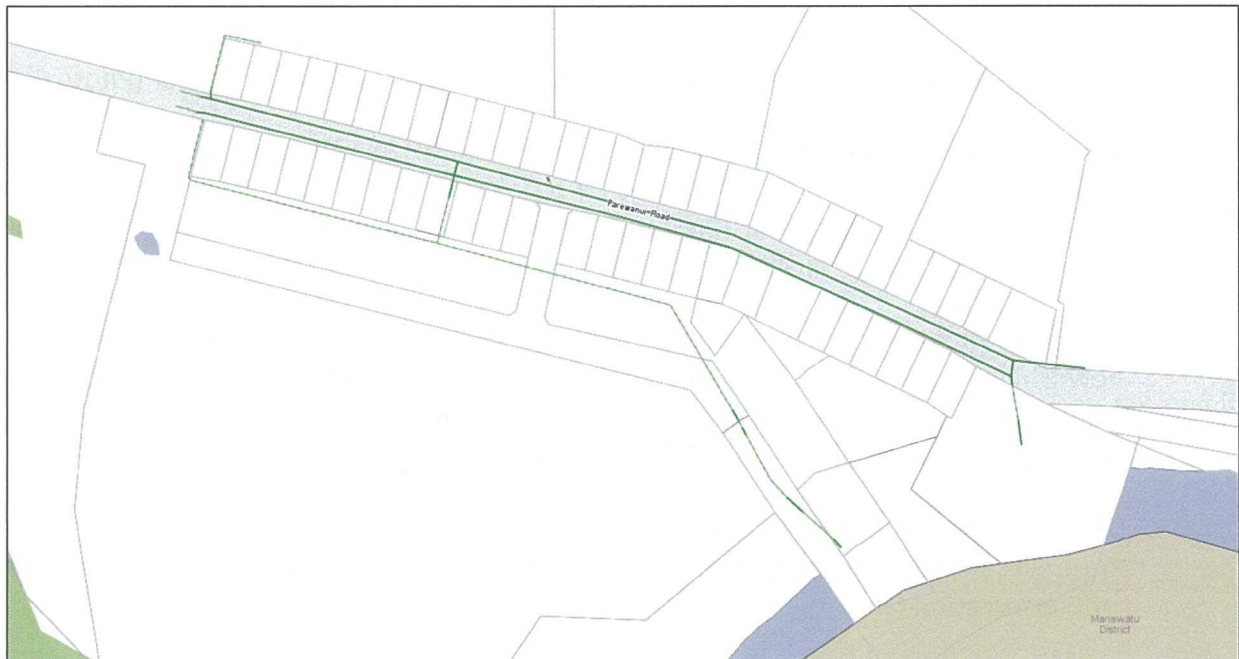
Figure 1: Location Map

Stormwater assets in Scotts Ferry are indicated in Figure 1, with solid green lines for pipes and dotted green lines for open drains.

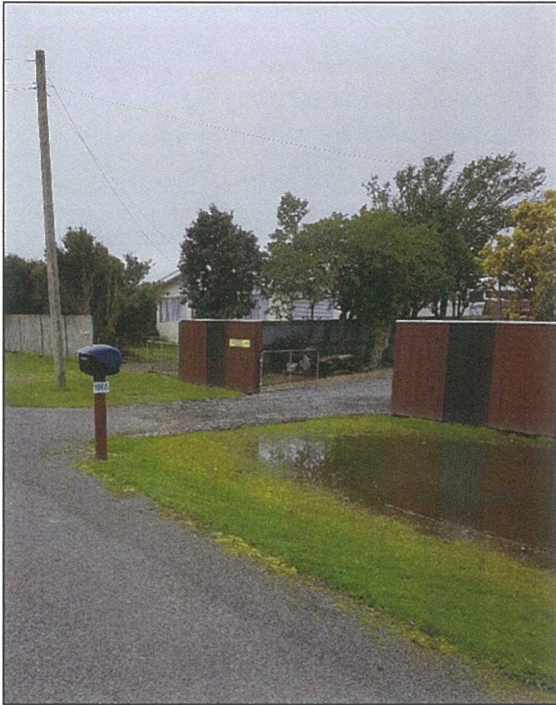
Photo 1: Example of Ponding on Berm

1. Novaflow stormwater pipes, installed in the berms on both sides of the road through the township, may not be performing at 100%. There are sections where flow is impeded, and ponding occurs (Photo 1). The installation year of these pipes is recorded as 1998. Although they seem to be in good structural condition, their performance is in places inadequate.

Issue	Solution	Responsibility
1. Novaflow performance	A. Inspect Novaflow. B. Clear or clean out Novaflow as required. C. Replace sections of Novaflow as necessary.	RDC Utilities
2. Sumps	A. Uncover sumps where necessary. B. Clean out sumps as required.	RDC Roading
3. Culverts	A. Clean out blocked culverts as required.	RDC Utilities RDC Roading
4. Roadside drains clogged	A. Clear drains as required.	RDC Roading

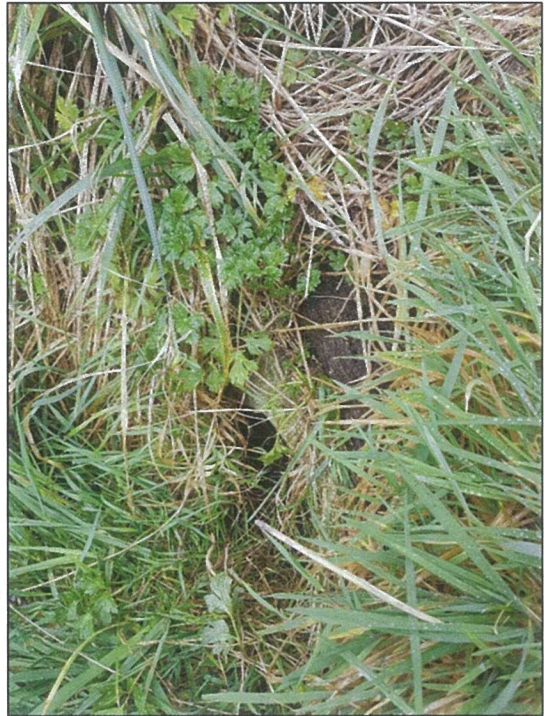
Photo 3: Overgrown Culvert

3. There are culverts, most notably road crossings, which are partly blocked (Photo 3). Culverts under the road are the responsibility of RDC Roding, culverts under driveways Utilities.

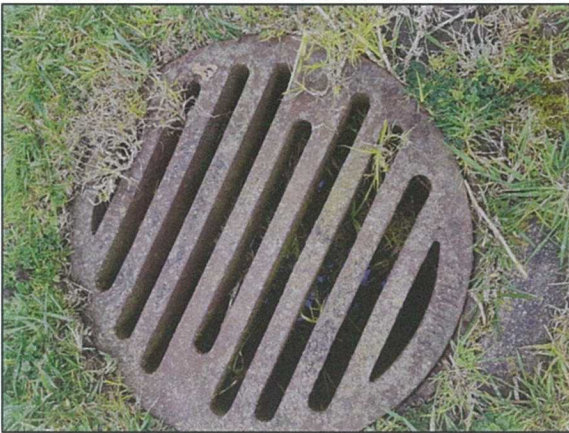
Photo 2: Sump with Detritus

2. Some of the sumps installed along these pipes have silted up, and their capacity is reduced (Photo 2). Phil Gifford from RDC Roding indicates that some of the sumps identified in our GIS have been covered over. Regarding responsibility, this is the same across the District in that Roding is responsible for roadside sumps and legs (including those in the berm at Scotts Ferry), with Utilities responsible for the remainder of stormwater assets.

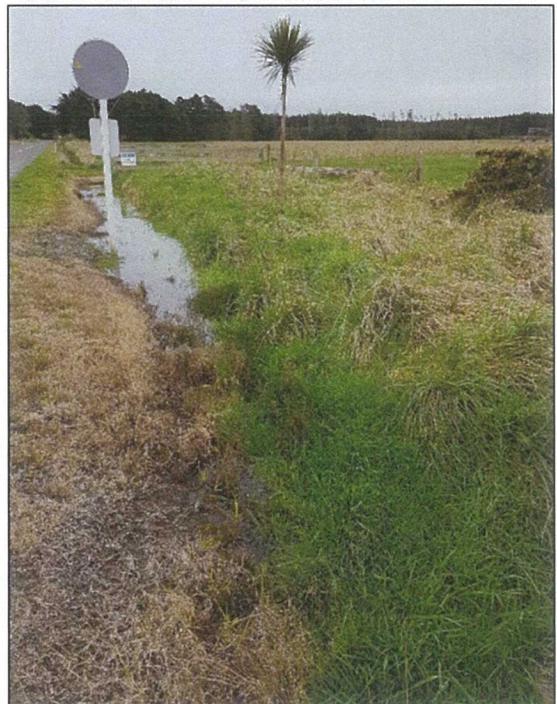
Photo 4: Overgrown Roadside Drain

4. Roadside drains to the west of the township are clogged with plant matter (Photo 4).
5. Roadside drains to the west of the township come to an end prior to the end of the road. Stormwater is not draining, roads are flooding more frequently, and pavement damage is starting to appear (Photo 5). Levels have been taken by a surveyor, and it may be impractical to facilitate drainage all the way to the beach.

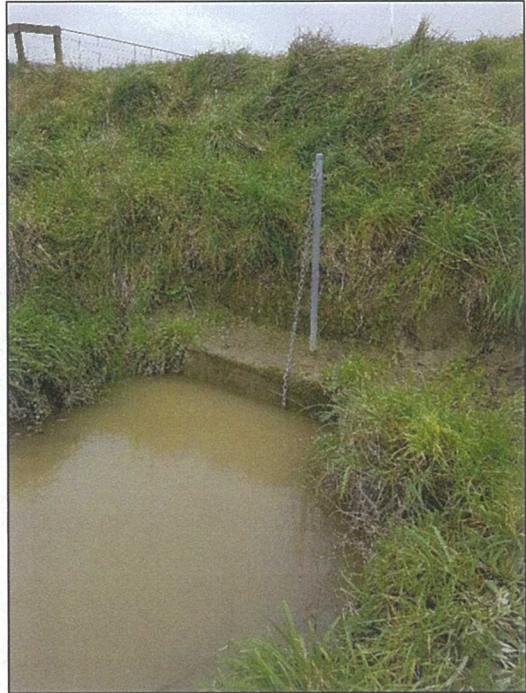
Photo 7: Closed Flap Valve (River Side)

8. When the river height is such that the flap valves close, there is no permanent means by which to pump stormwater over the stopbank and into the river (Photo 7 and Photo 8). At times in the past, various temporary solutions have been used: a nearby farmer has assisted with a tractor-driven pump; a fire water pump from the township's fire station has been used; or a pump has been provided by Horizons Regional Council.

Issue	Solution	Responsibility
5. Roadside drains end	A. Investigate suitable receiving environment.	RDC Roding
6. Open drain blocked	A. Have drain cleared. B. Have bridges removed. C. If bridges required, replace with smaller number having adequate culvert dimensions.	See below
7. Open drain private	A. Take on ownership of drain by negotiation with current owners.	RDC Utilities
8. Flap valves closing	A. Either install permanent pumps on township side of each flap valve, OR make a dedicated pump permanently available at the Scotts Ferry Fire Station.	Horizons Fire and Emergency NZ
10. River bed accreting	A. Discuss solution with Horizons Harbourmaster.	RDC Utilities Horizons
11. Levels	A. If necessary, re-grade drains. B. Discuss with Horizons whether flap valve levels can be altered.	RDC Roding RDC Utilities Horizons

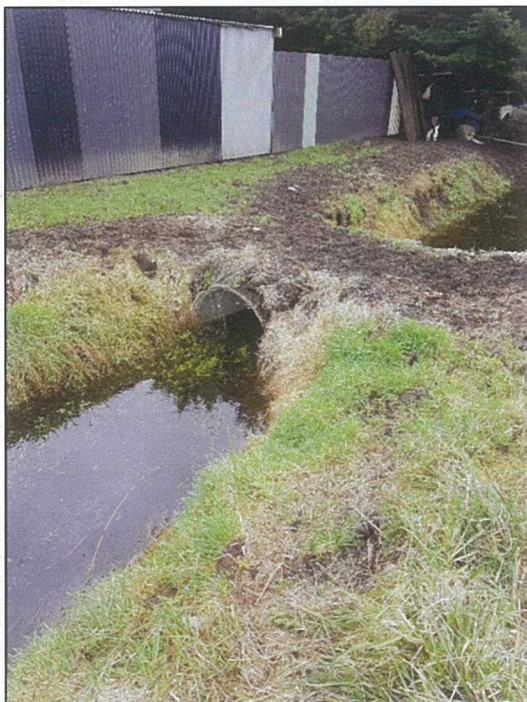
Photo 6: Open Drain

6. The open drain on the southern side of the township takes a large proportion of the township's stormwater. This drain is partly clogged by plant matter, and in places its banks are worn by the passage of cattle. In addition, it has several restrictions in the form of bridges placed over it, with small diameter culverts (Photo 6).

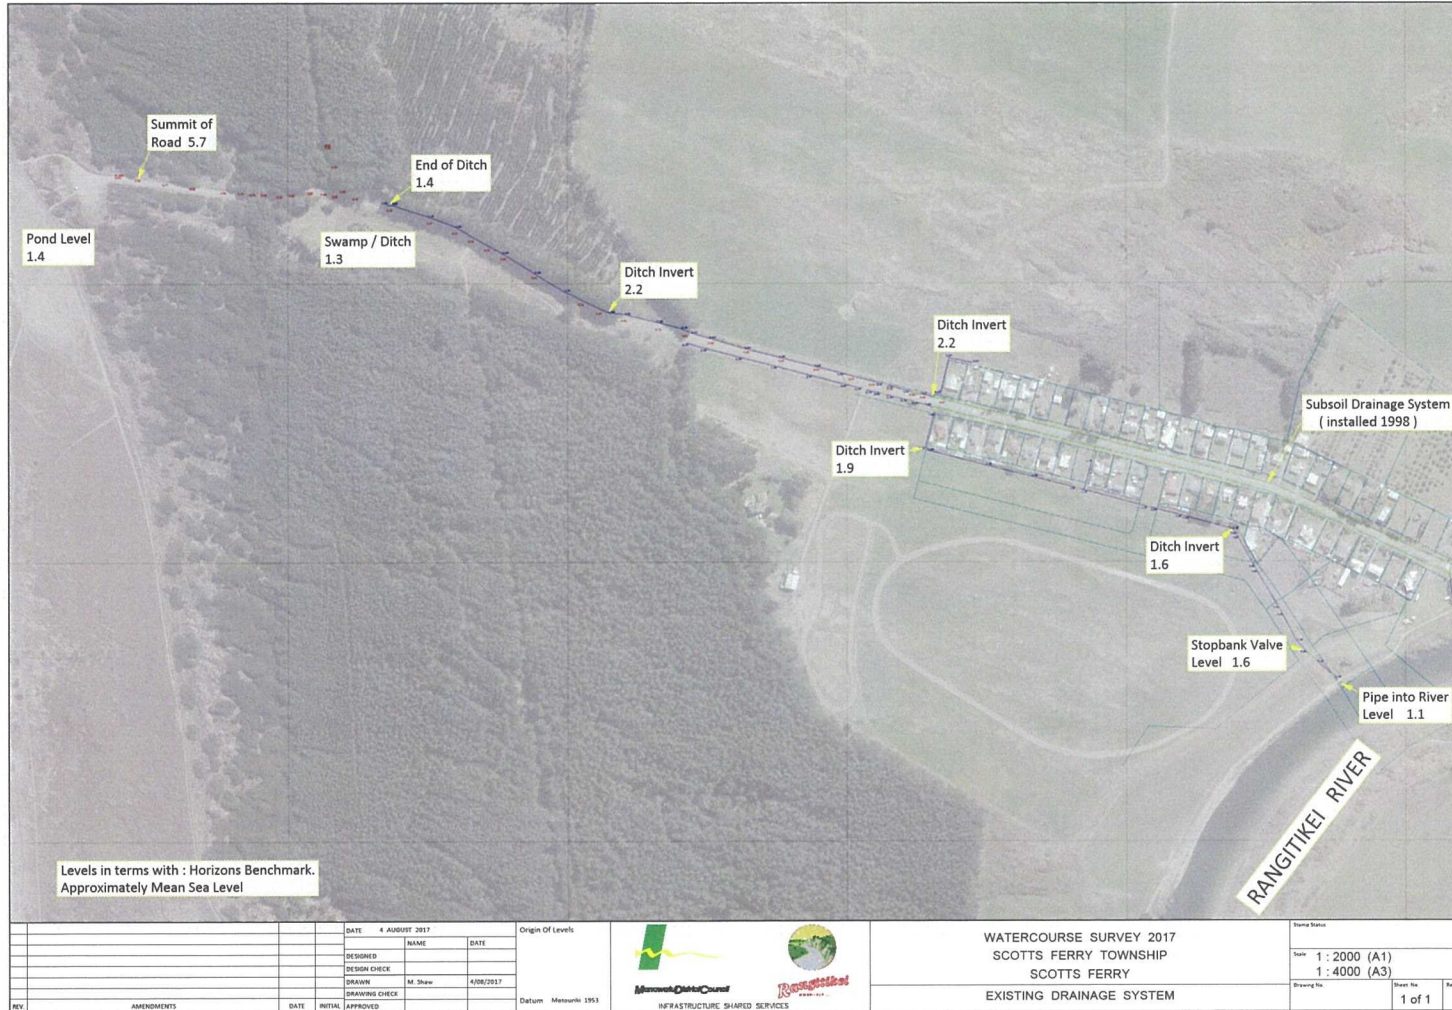
Appendix 2 – Levels

9. Paddocks to the north of the township have been flattened over recent years. They are now being irrigated for dairying, contributing to soil moisture.
10. The Gibbsses indicate that the bed of the river in the extent of the township has accreted (raised) by some 1200 mm due to silt build-up.
11. Levels have been taken by a surveyor. These indicate that even with adequate maintenance, there may not be sufficient fall to drain all stormwater away from the township.
