BULLS NEW BUS LANES SHELTERS FAIL OF DESIGN

28 March 2022

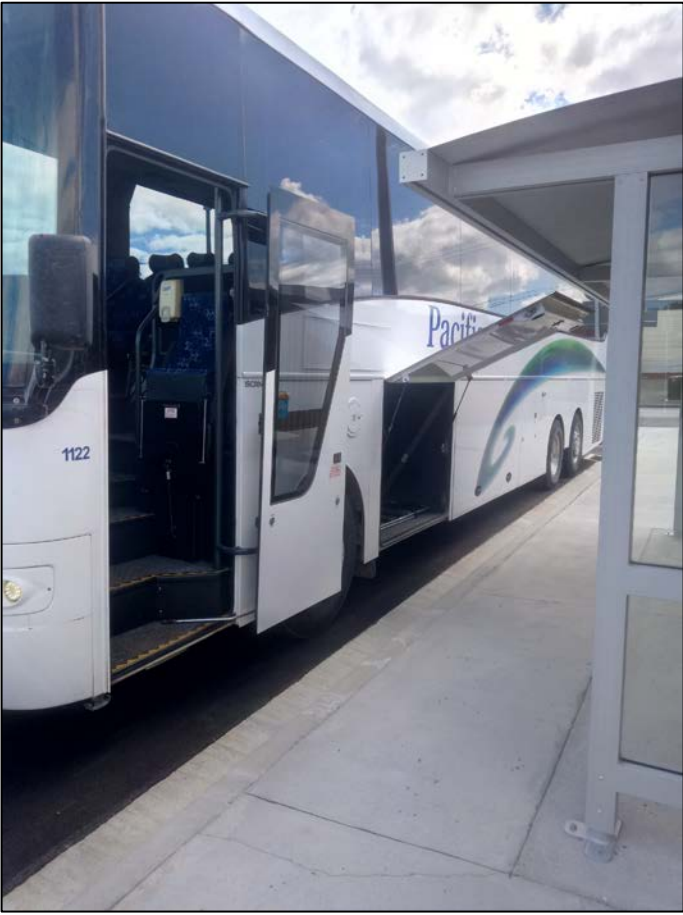
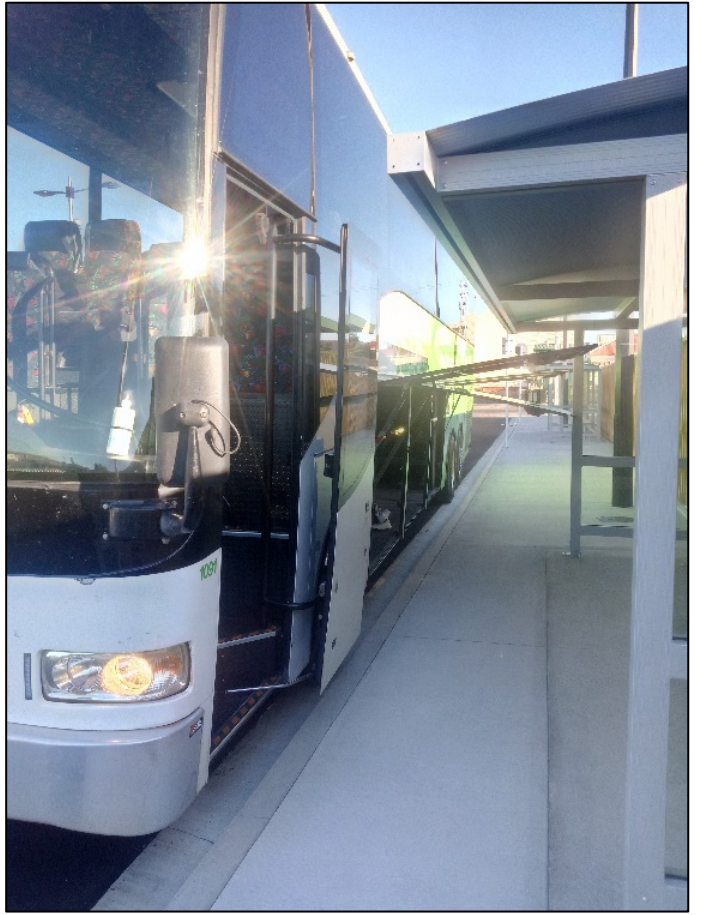
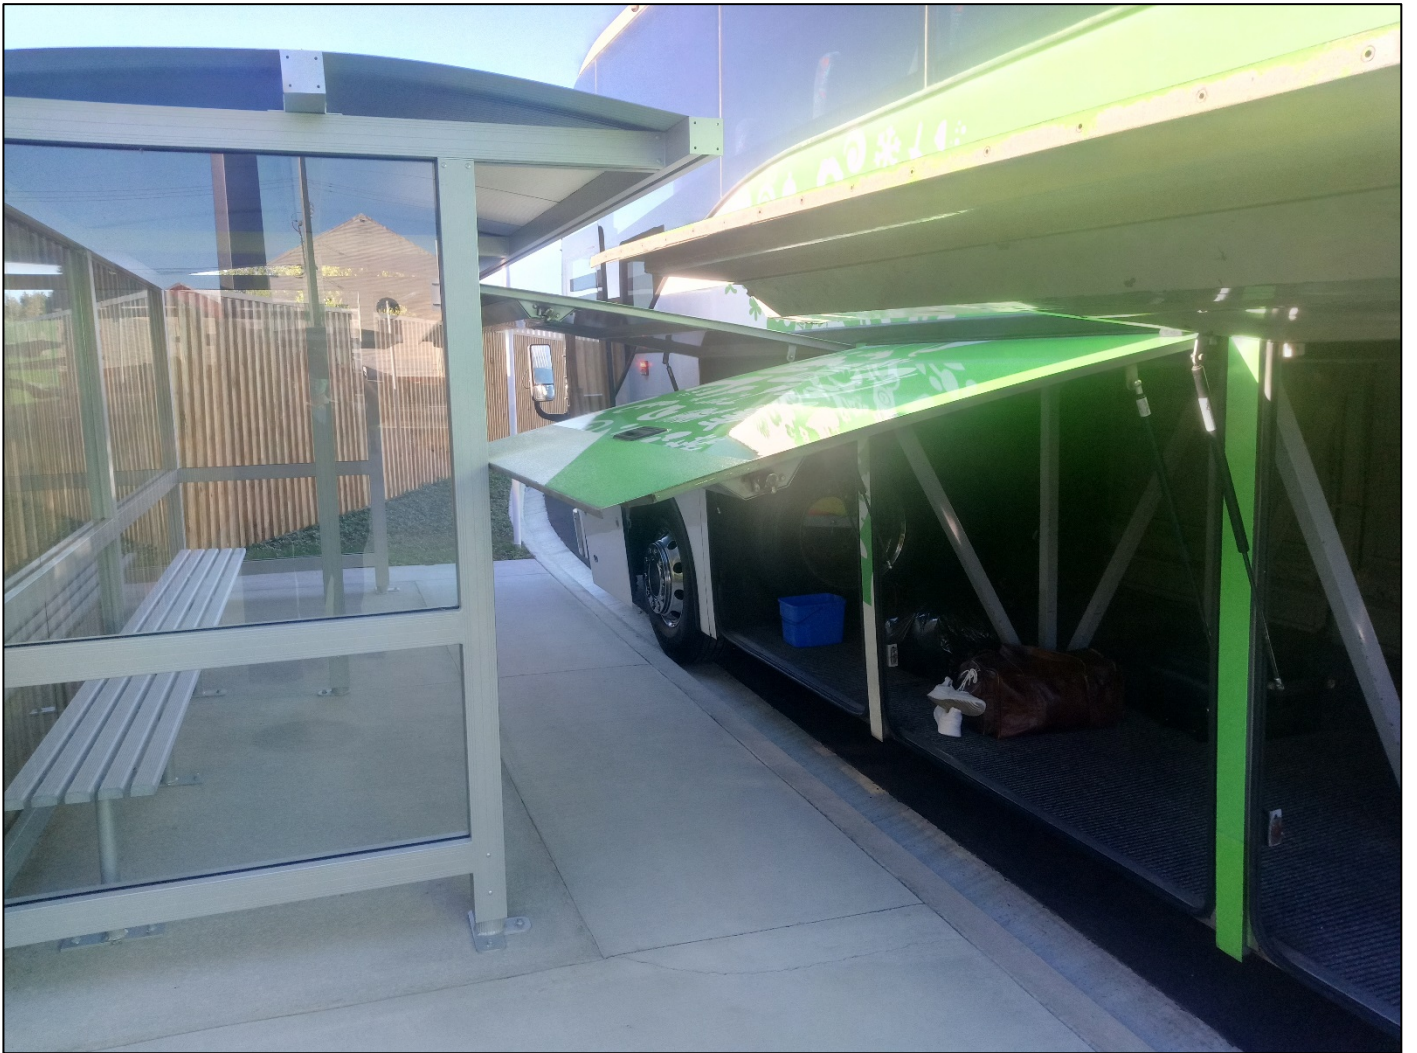
- a.** Not enough distance between shelter supports and curbing of road to allow opening of doors or lockers in a safe manor and protection of bus/coach passengers and loading and unloading of baggage. Distance between shelter upright and open luggage doors of coaches should be at best 3 meters.

- b.** Bus sign poles too close to curb edges, that will cause damage to coach mirrors, or the mirrors will be ripped off by the poles, or the signs will scratch the windows or paint work of the coach all the way down the side of the coach. Design fail to have signs fitted about 30cm's out into the roadway beyond the curb edge where coaches drive past.

11. This is a Health and Safety Issue, and the danger is to the driver as he tries to open the luggage doors, and to the passengers being injured from the doors and the driver as he tries to open the luggage doors into the shelters. The design is unsafe, to drivers, passengers and likely damage to the vehicles.

12. Solution: The only solution to this design failure, is to dig out from the current curb up to 1.5 meters into the sealed driveway, build a new curb, concrete up to the new curb for an addition of a footpath, and add new seal to the edge of the new curb. That places distance from the shelters to coaches, to remove dangers and damage.
