# DETAILED SEISMIC ASSESSMENT

## ASSESTS BUILDING

### 46 HIGH STREET, MARTON

18 FEBRUARY 2022

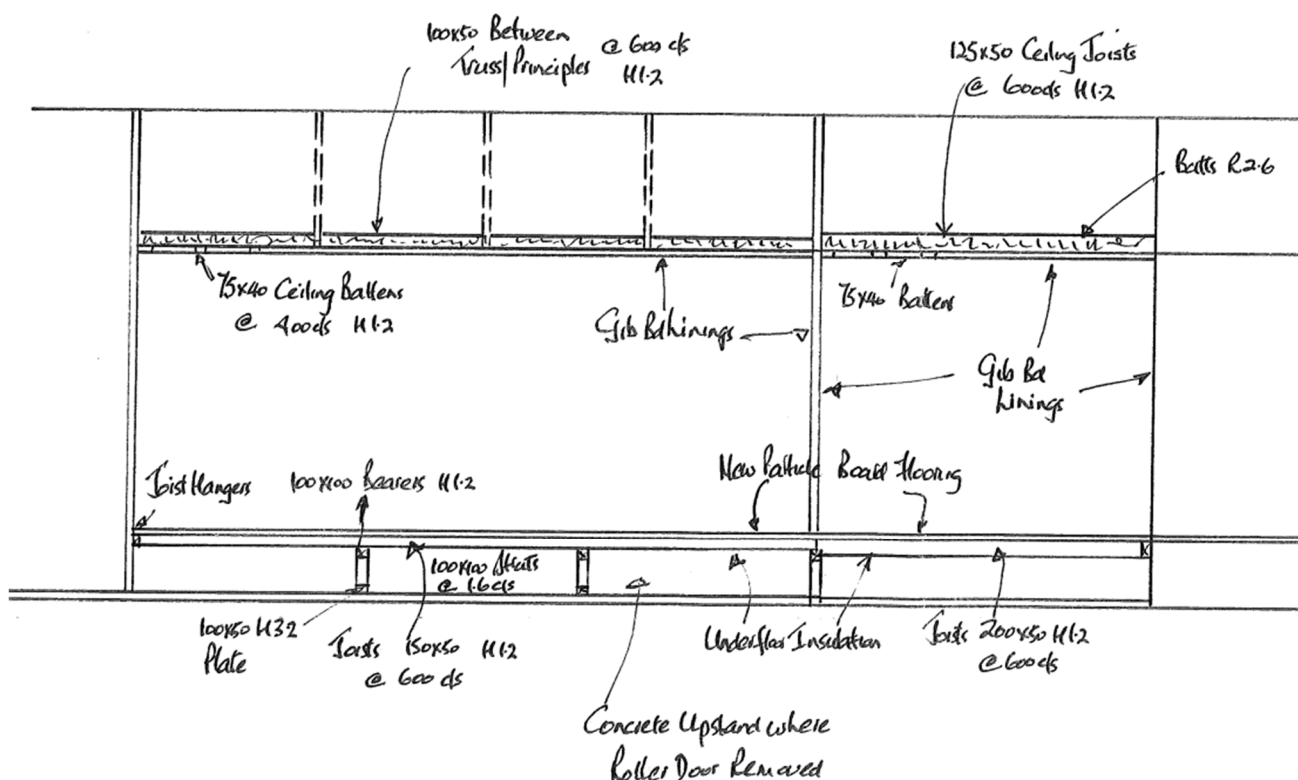
Figure 8: Typical section (along)

While the external stud walls (with masonry veneer) are supported on a concrete perimeter footing, the internal stud walls are supported on a suspended timber floor which is supported by timber piles (refer to Figure 8). Observations from earthquake damage in Christchurch have showed that buildings with perimeter foundations and internal piled floors have shown good performance. This is partly due to the internal floor acting as a diaphragm (BRANZ report no. 141). It is also noted that lightweight timber structures have shown good performance during earthquakes due to low mass and the ability to deform via the connections (serviceability might not be achieved, but no significant life safety hazard).

The external wall construction is susceptible to out-of-plane failures and especially vulnerable as the steel ties connecting the exterior veneer to the timber frame can be weakened by corrosion. ~~The condition of the ties were not investigated and assumed to be in a good condition.~~ Cavity ties have been investigated (WSP site investigation memorandum dated 02 February 2022) and found to be in good condition i.e., no signs of corrosion.
