Detailed Seismic Assessment

Marton Civic Centre

Corner of Broadway and High Street, Marton

Date: 11-07-2019
Reference: 5-WT489.01
Status: Issue 1

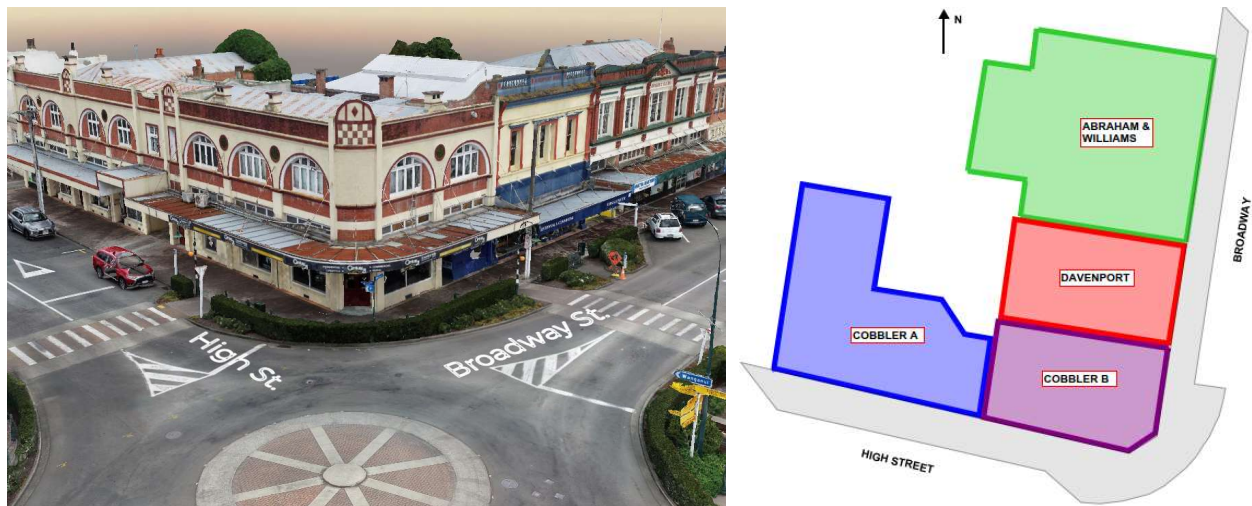
The site consists of four unreinforced brick masonry buildings forming the corner of Broadway and High Street in Marton as shown in Figure A below. The structures are two storey buildings that were constructed between 1900 and 1920. The buildings are heritage listed as Category 2 and are considered important to the streetscape of the Marton Township.

Figure A. Marton Civic Centre - Layout and photo of buildings looking northward

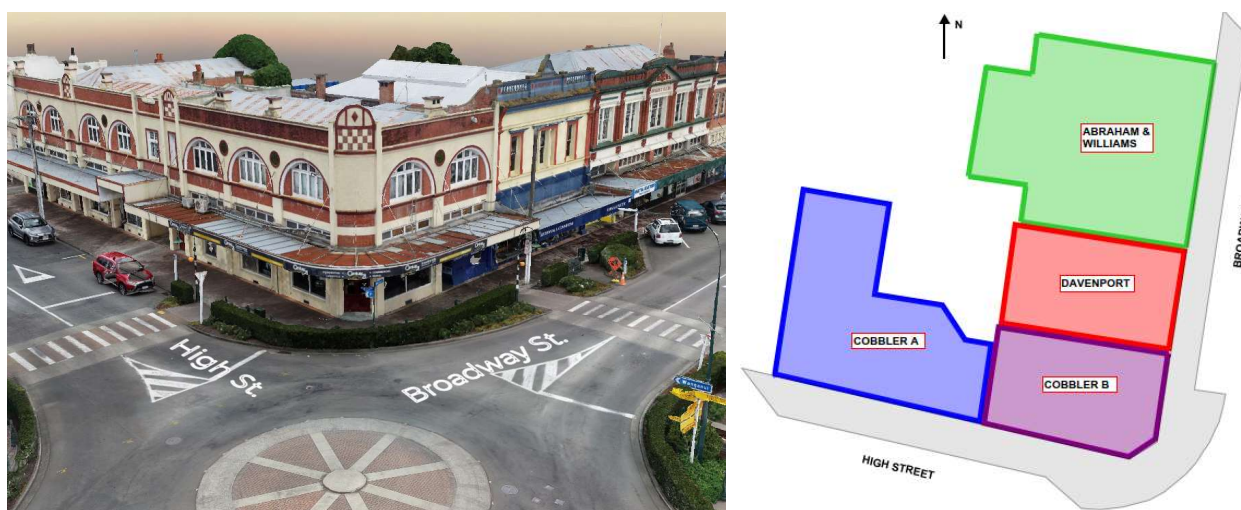
The Marton Civic Centre comprises of four unreinforced brick masonry buildings forming the corner of Broadway and High Street in Marton. The buildings are two storey structures constructed between 1900 and 1920. The buildings are listed as heritage Category 2 and are named as follows;

Figure 1. Marton Civic Centre - Layout and photo of buildings looking northward

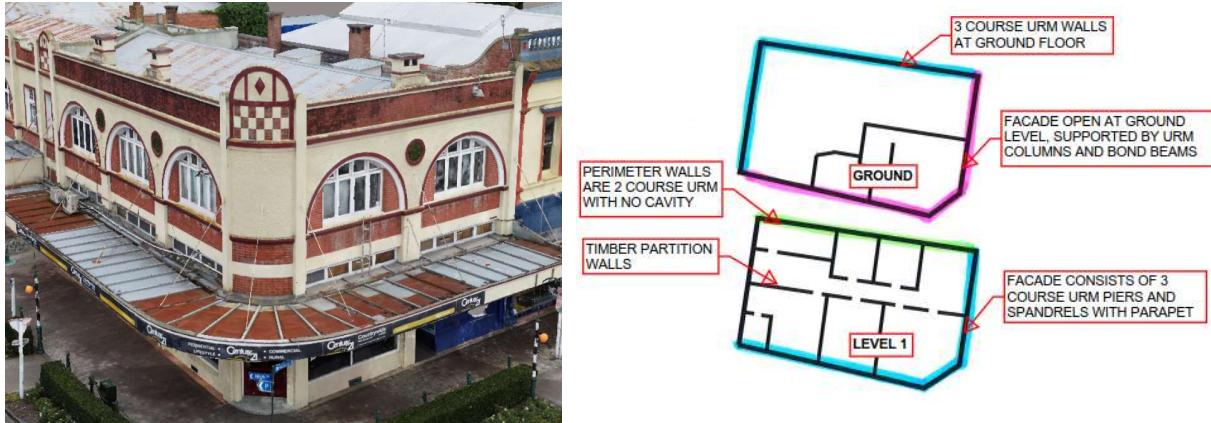
The Cobbler B building was built in 1913 on the corner of Broadway and High street. The two storey structure consists of 3 course URM walls with large openings at ground level of the street-facing façade.

Figure 2. Cobbler B façade and plan views

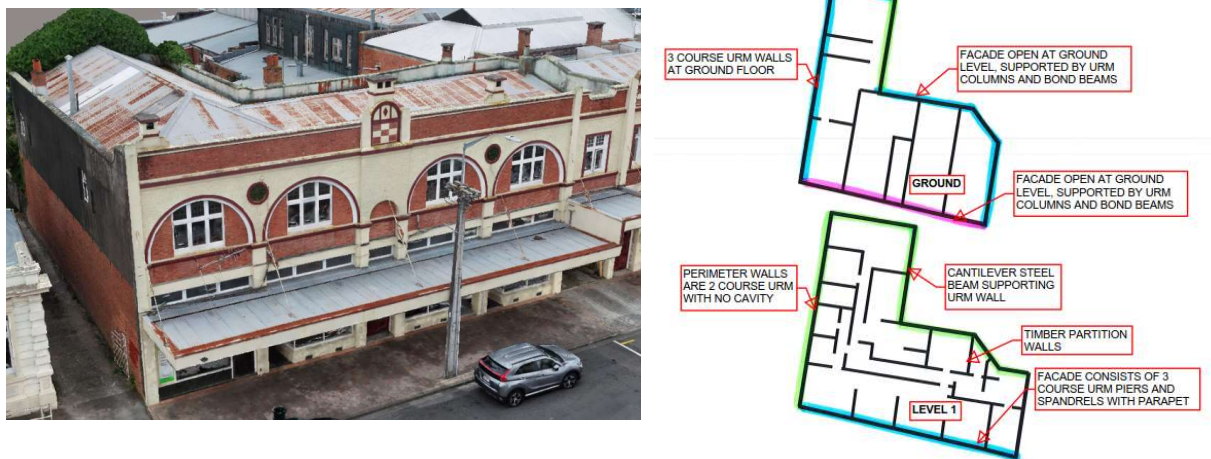
The Cobbler A building was built in 1914 as an addition to the Cobbler B building. The buildings are connected through at only the upper level. Construction consists of columns at ground level of the façade and URM walls without bond beams around the perimeter. The rear section of the building contains a cantilevered steel beam supporting the brickwork.

Figure 3. Cobbler A façade and plan views

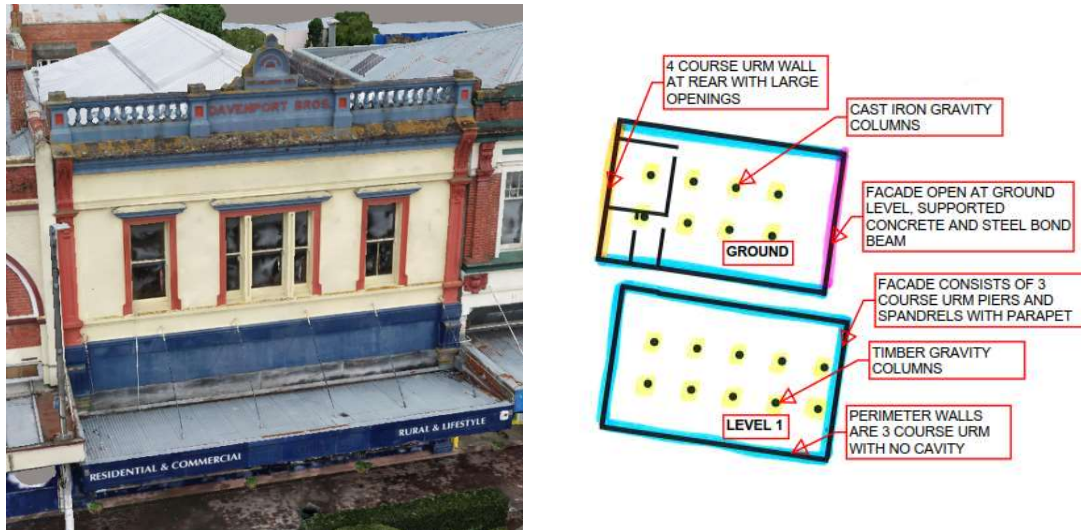
The Davenport Brothers building is the oldest structure of the four in the precinct. It was constructed in approximately 1905 with a floor area of 200 m² and consists of URM perimeter wall with cast iron gravity columns providing support to the upper level.

Figure 4. Davenport façade and plan views

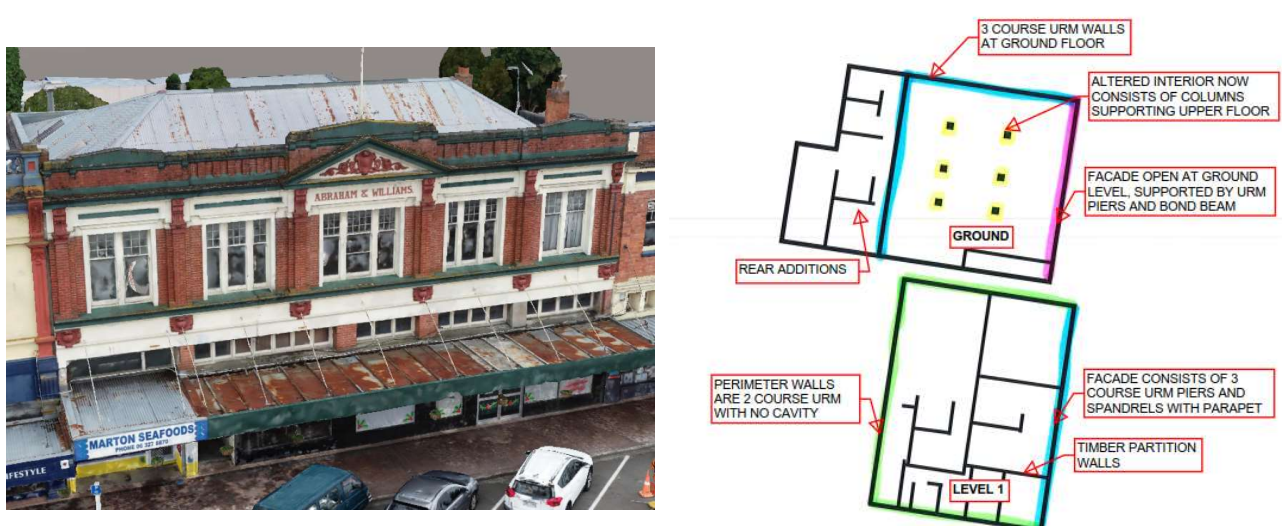
The Abraham and Williams Building was constructed in approximately 1915 with a floor area of 295 m². The original building contained URM perimeter walls with internal URM and timber-framed walls. The lower level has been altered to be open plan and now contains columns providing the gravity support.

Figure 5. Abraham and Williams' façade and plan views

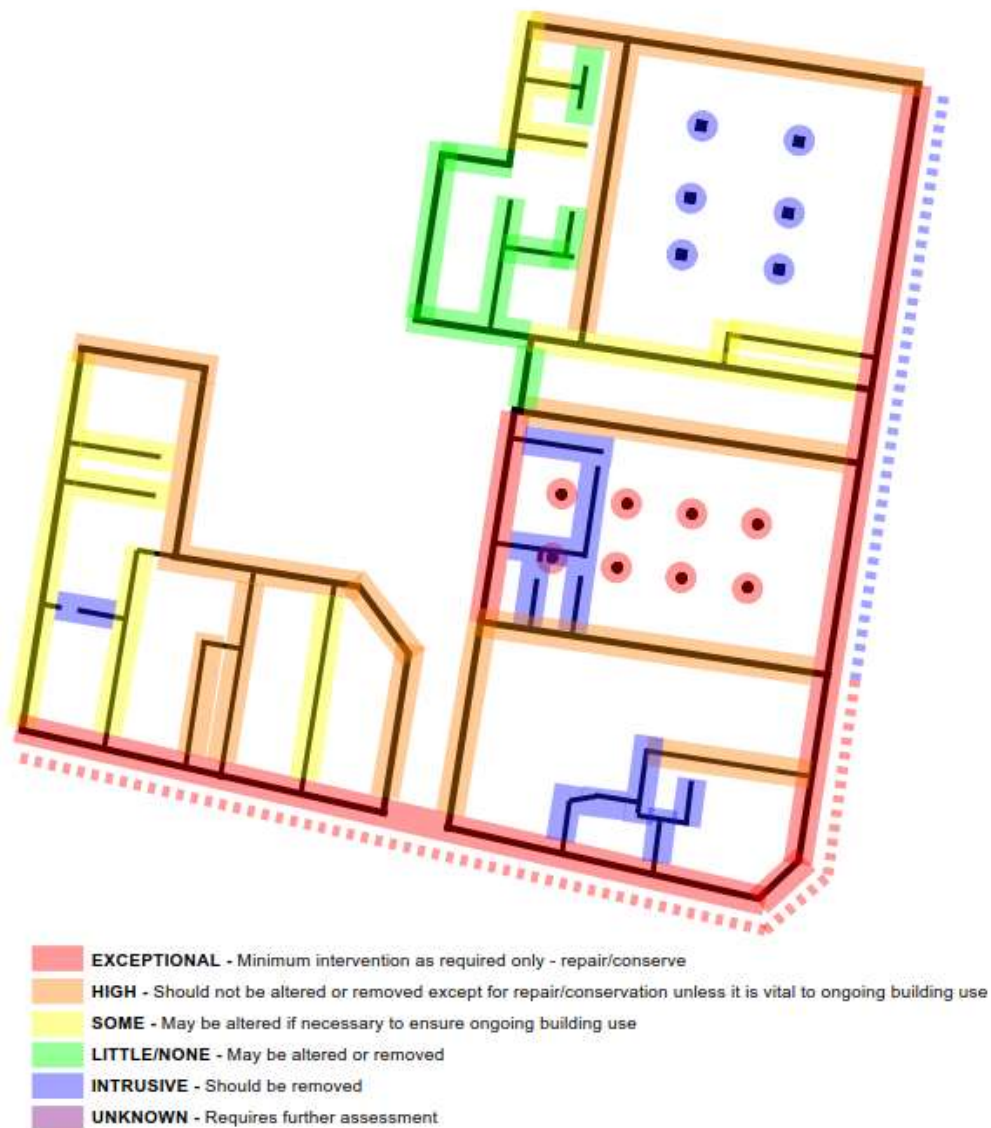
The heritage significance of each of the elements is presented in Figure 13 below as per the heritage architect's recommendations. The %NBS score for building structural elements is provided in Table 3 below.

Figure 13. Heritage significance

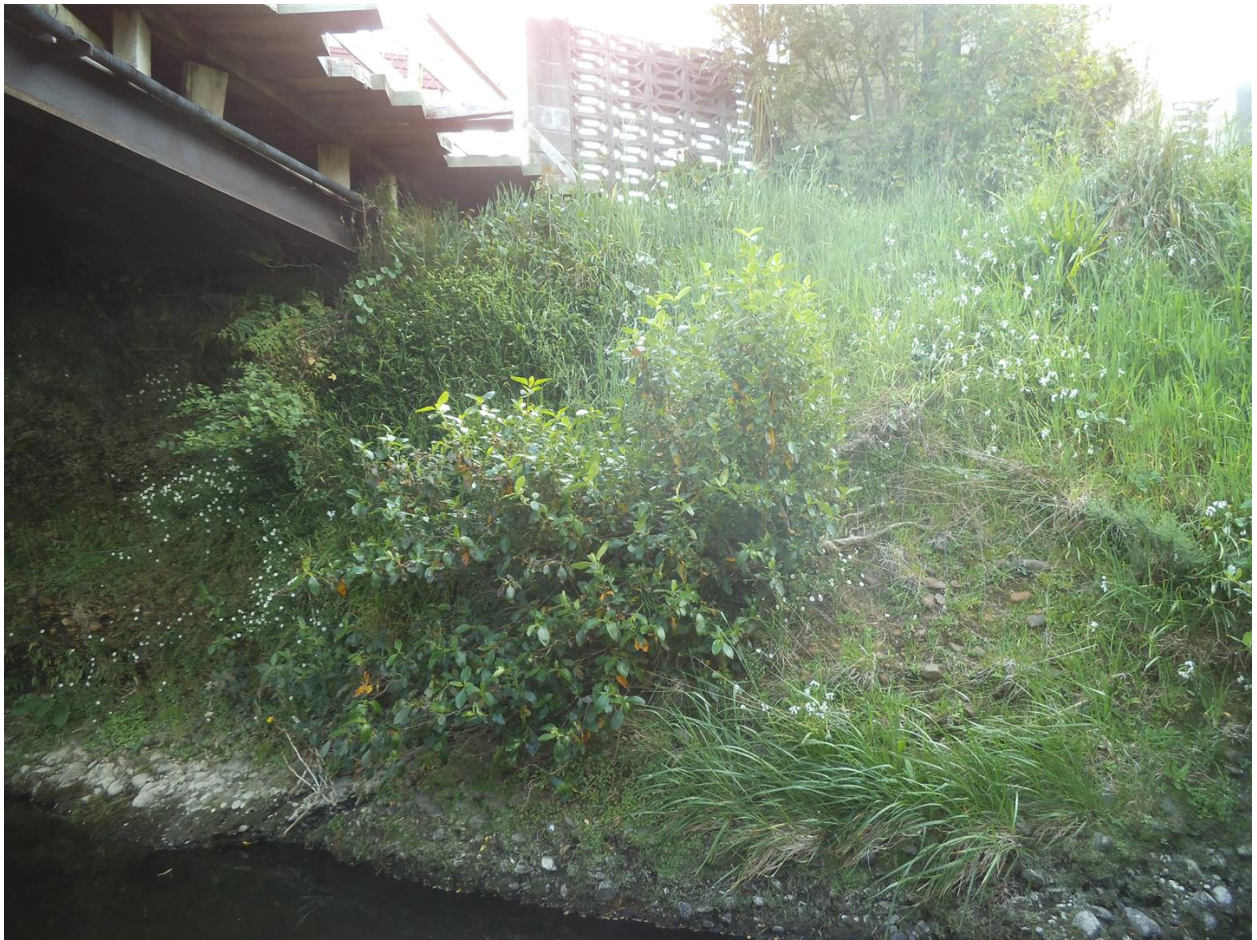
Similar ground conditions are exposed in the steep sides of the Tutaenui Stream as it passes through Marton. This stream is incised into the alluvial gravels by about 3.0 m, and exposures of a weathered gravel can be readily observed.

Photograph 1 : Tutaenui Stream at Russell Street, Marton
