BRIDGE INSPECTION REPORT 2016/2017

Prepared for Manawatu and Rangitikei District Councils May 2017

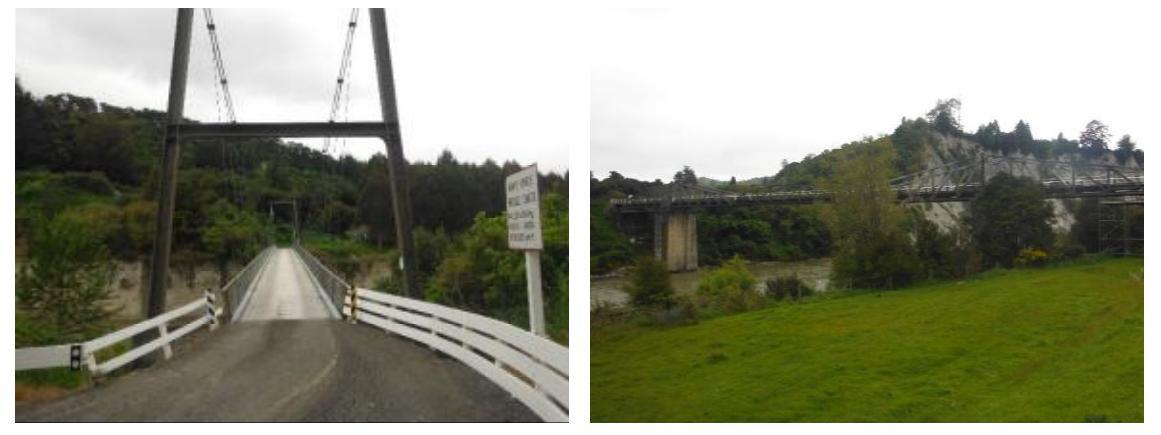
Figure 4-11: Bridges S142A and S250B

Of the bridges inspected during 2016/17, the following structures have posted weight and speed restrictions advertised on approaches: S142A and S250B.

Any further deterioration of bridge elements may have an impact on the overall capacity of the structure, conversely any remedial works may increase the capacity and thus negate the requirement of a posted weight and speed restriction.

- 7. Transverse cracking on bridge S142A be sealed with a flexible bitumastic based product to prevent water ingress and mitigate damage to the deck reinforcement. A posting and rating reassessment of this structure should be carried out annually with specific focus on the deck capacity factor due to the slender slab design and transverse cracking.

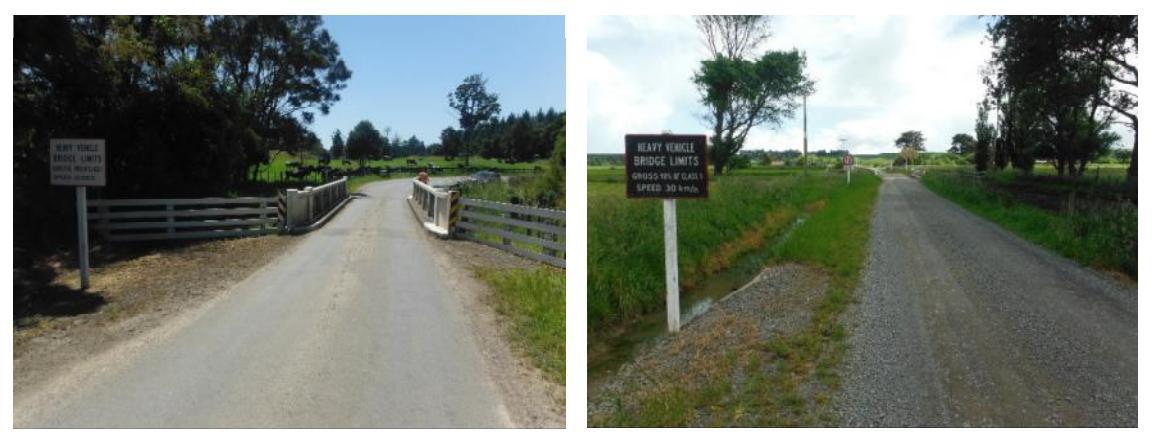
Figure 8-12: Bridges 11 and 131

Of the bridges inspected during 2016/17, the following structures have posted weight and speed restrictions advertised on approaches: 11 and 131.

Any further deterioration of bridge elements may have an impact on the overall capacity of the structure, conversely any remedial works may increase the capacity and thus negate the requirement of a posted weight and speed restriction.

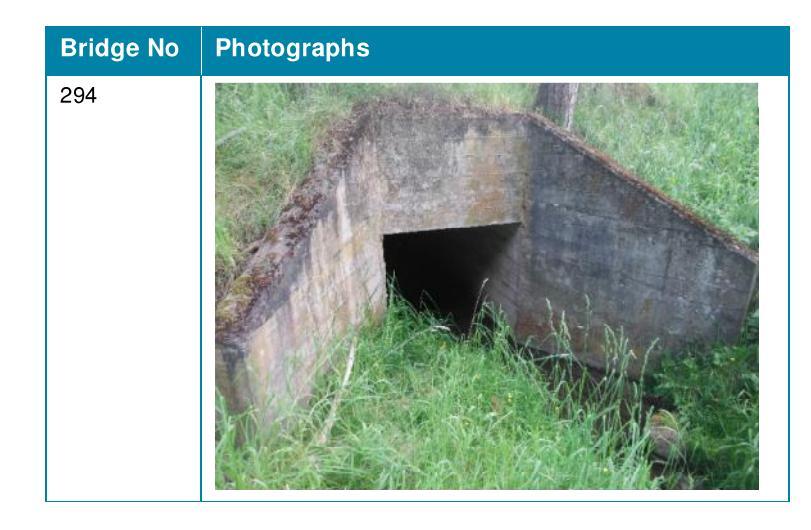
The following structures were identified as having a waterway area less than 3.4 square metres.

It is recommended that bridges 180 and 294 are removed from the bridge inspection programme and added to the road maintenance drainage database.
