Rangitikei District Council

**GEOTECHNICAL ASSESSMENT REPORT
FOR RESIDENTIAL LAND-USE CHANGES**

Bulls, Marton & Mangaweka High Level Planning

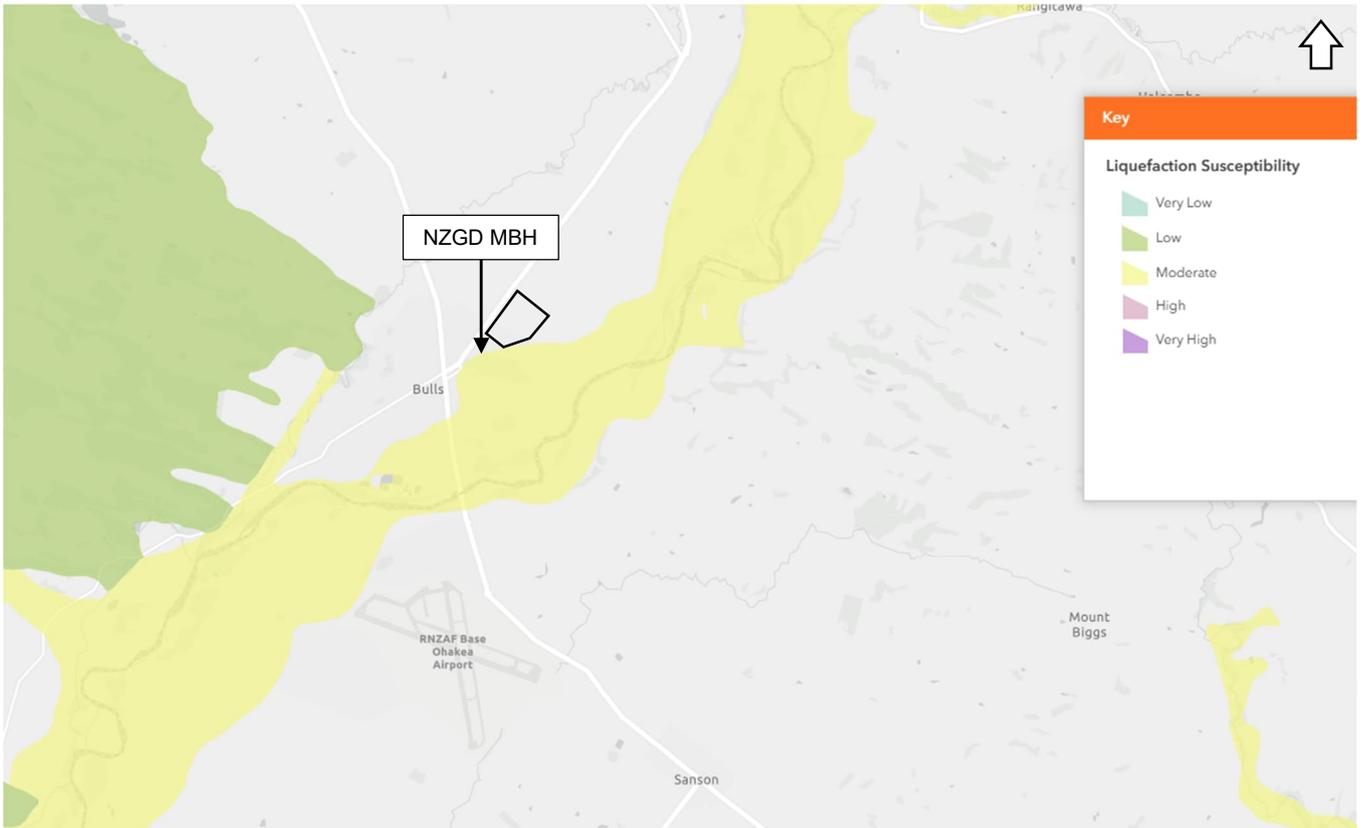
GNS Science Consultancy Report 2016/40⁹, with the “moderate” zone comprising the lower terrace levels adjacent to the Rangitikei River flowing to the southeast of the Bulls township (Figure 5 below). We further note that some of the mapped ‘low’ zones in the greater region (particularly the Horowhenua region & coast) have since been / had sites assessed and proven to be susceptible to liquefaction while conversely areas in the ‘moderate’ have been found to be underlain by thick expanses of gravels not susceptible to liquefaction. Therefore this map should be considered for guidance as a potential liquefaction susceptibility map and not solely relied upon even at a regional scale.

Figure 5: Horizons regional liquefaction map showing 'moderate' susceptibility within the lower alluvial terrace / channel of the Rangitikei River, and 'low' susceptibility to the west of Bulls (Source: HRC Natural Hazard Viewer). Annotated Bul02 area approximately shown.

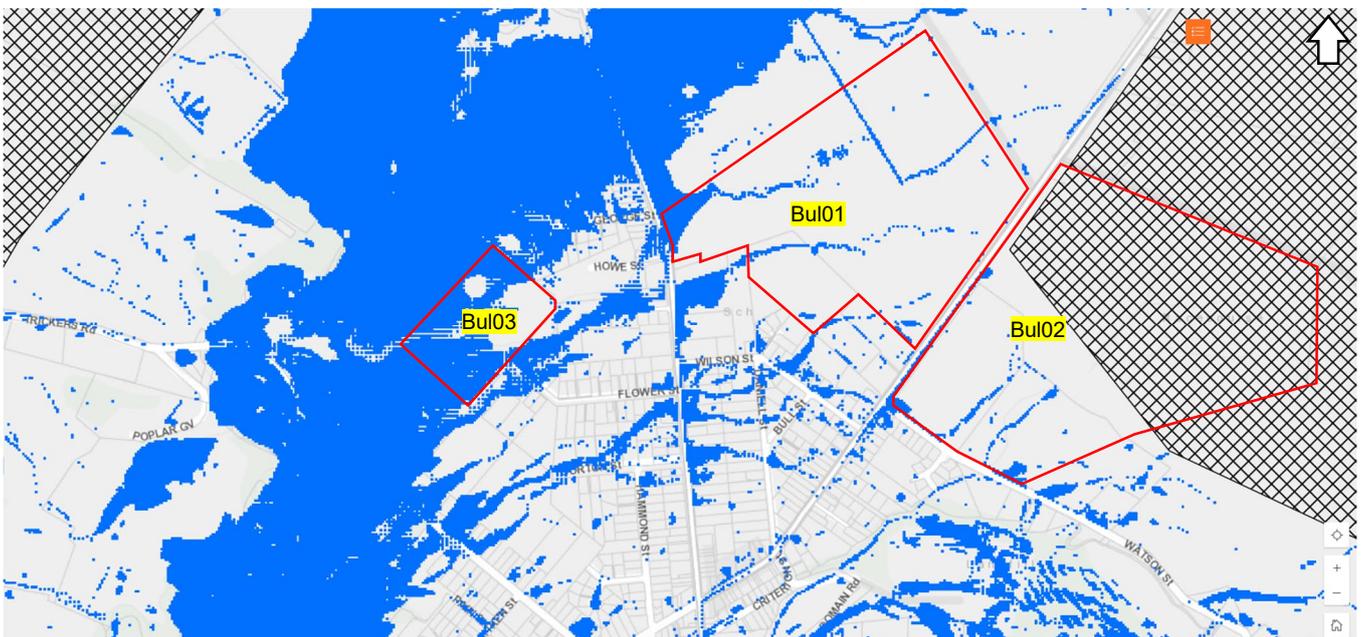
- Bul01 and Bul02 are generally shown to have minimal ‘modelled wet extents’ as mapped under the HRC Flood Hazard 200yr (Bul02 includes an area not modelled). Bul03 is shown to be predominately mapped within a modelled wet extent (Figure 6 below).

Figure 6: Mapped modelled wet extents for 200yr event for Bulls (Source: HRC Natural Hazard Viewer).

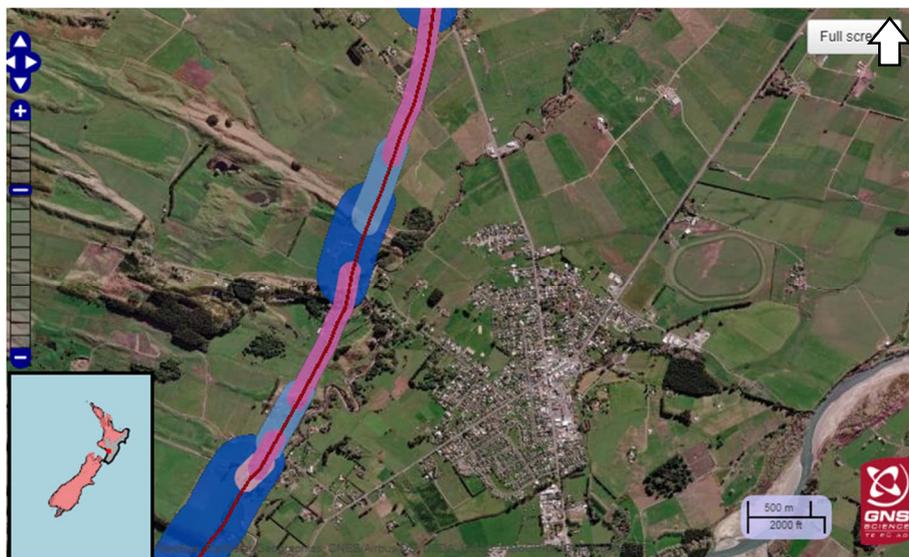
The Leedstown active fault is mapped approximately 500m to the west of the western extent of Bul03. No Fault Avoidance Zone (FAZ) / Fault Awareness Area (FAA) associated with this fault are mapped across any of the sites³ (Figure 8).

Figure 8: Mapped Leedstown Fault to the west of Bulls (Source: GNS Active Fault Database).

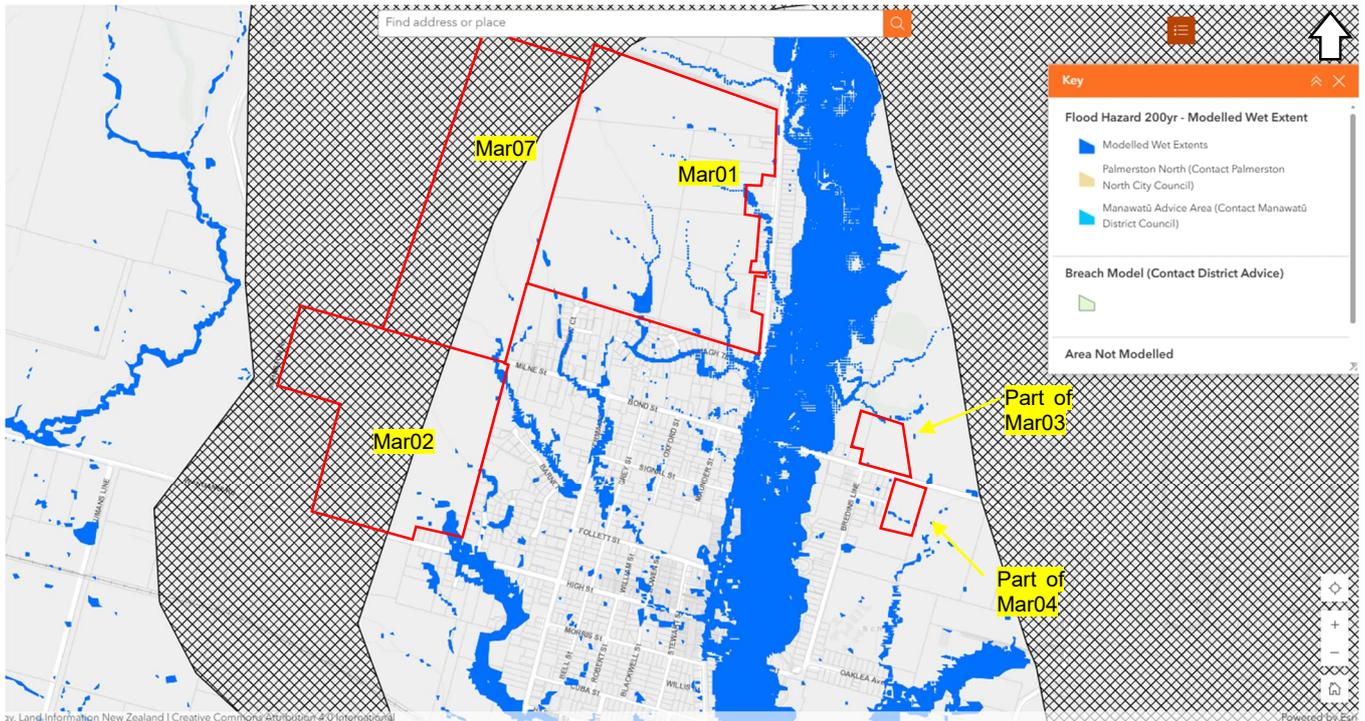
- Mar01, Mar02, Mar07 and Part of Mar03 and Mar04 are generally shown to have minimal 'modelled wet extents' as mapped under the HRC Flood Hazard 200yr. However, the western and eastern extents beyond Marton include areas not modelled (Figure 9). Existing stormwater management and stormwater dam structures have been constructed and are present within / near areas Mar 01, Mar02 and Mar 07. The dams are managed and maintain by Horizons Regional Council (HRC) and are shown on the Marton Site Plan appended.

Figure 9: Mapped modelled wet extents for 200yr event for north Marton (Source: HRC Natural Hazard Viewer).

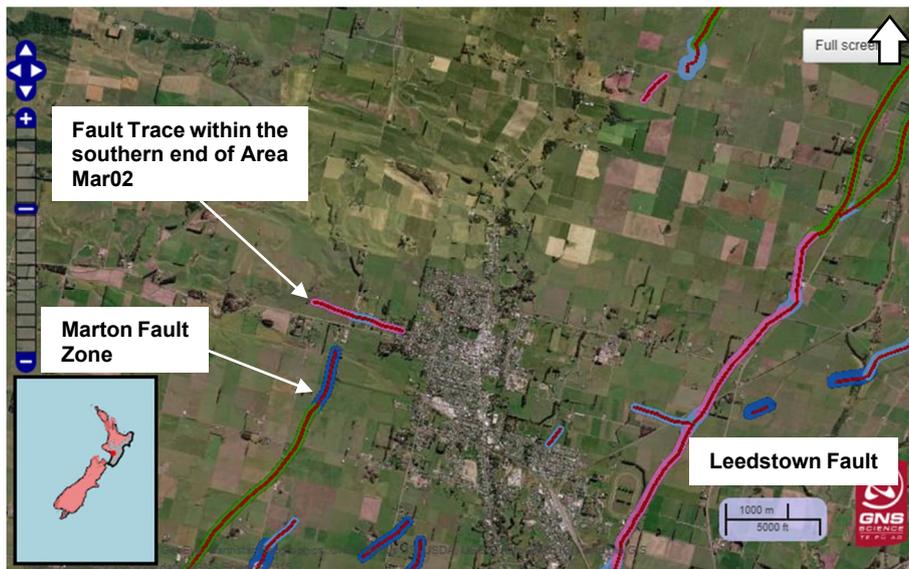
The active Leedstown Fault is mapped to the east of Marton, and the Marton Fault Zone is located to the west / southwest of Marton (Figure 11). A Fault Avoidance Zone (FAZ) associated with the Marton Fault Zone is situated to the south of Mar02 with the fault trace mapped parallel to Wanganui Road³.

Figure 11: Mapped Faults located near Marton as a part of the Marton Fault Zone (Source: GNS Active Fault Database).

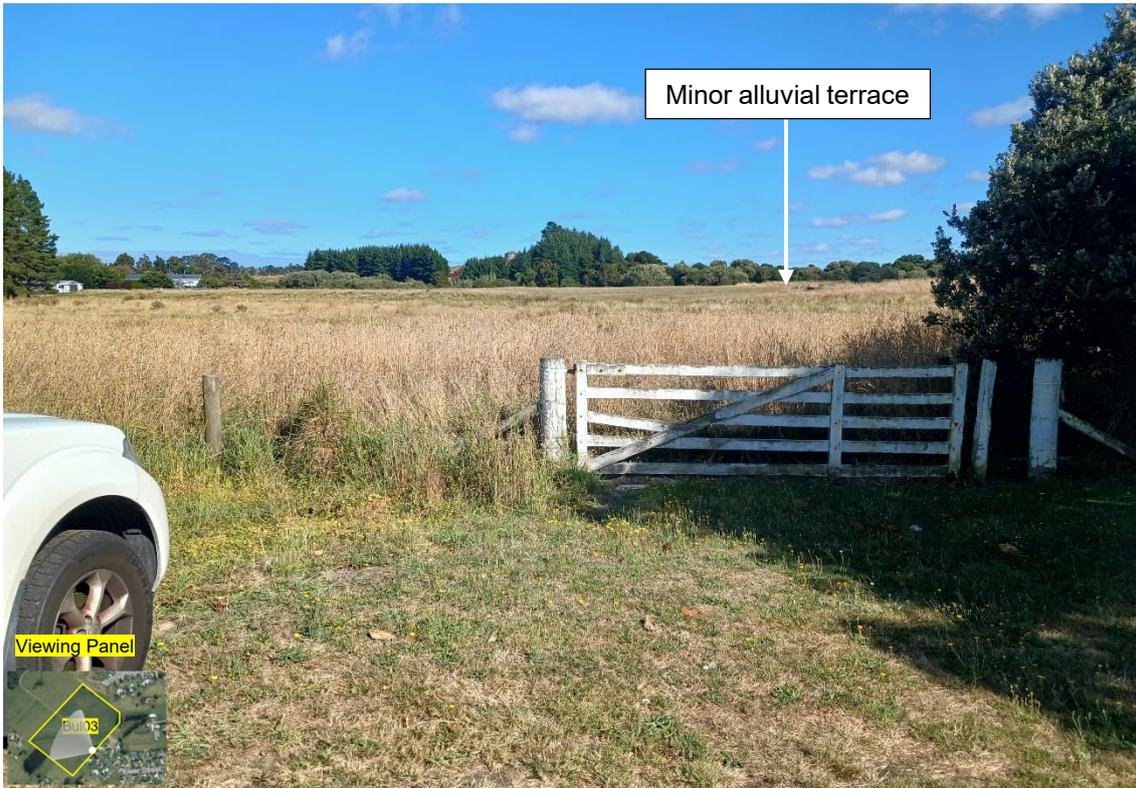
Photograph 1: Area Bul03 viewed from the end of Flower Street, viewed towards the northwest.

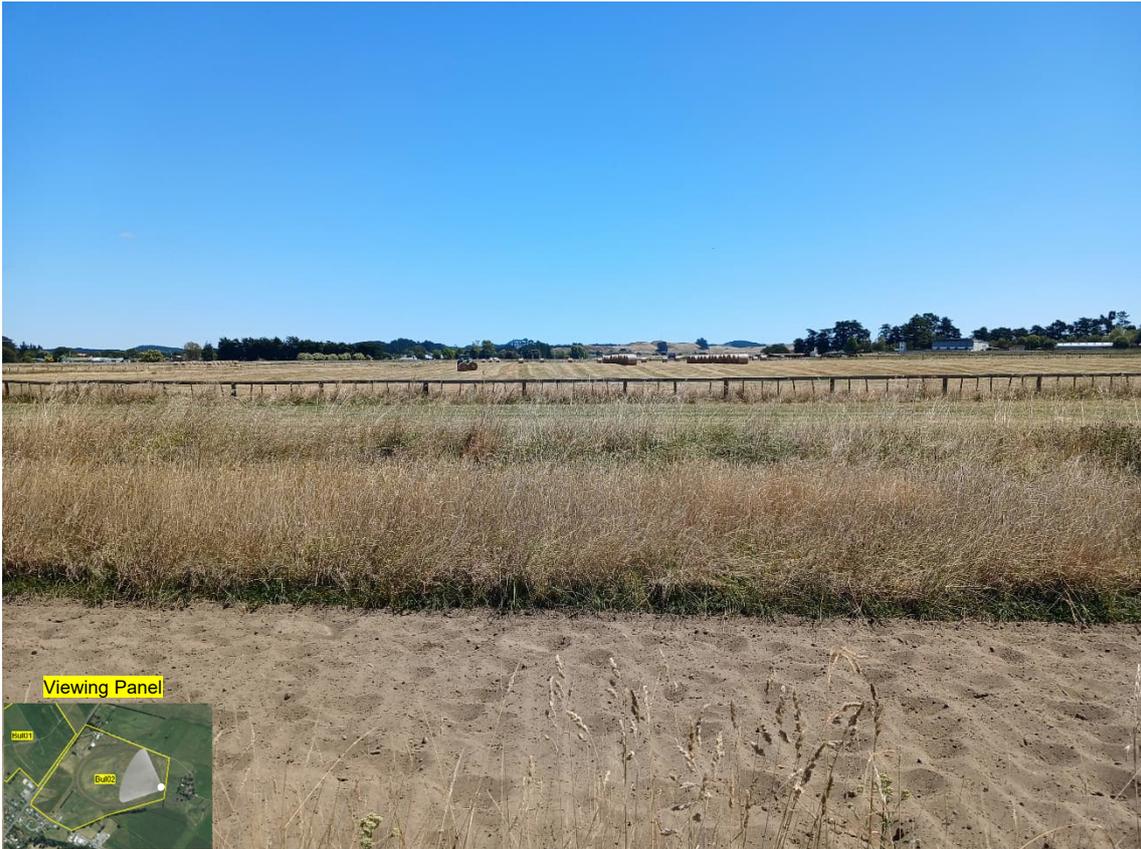
Photograph 7: View of the horse racetrack within Bul02, viewed to the west from within the east most boundary / edge of track within Bul02.

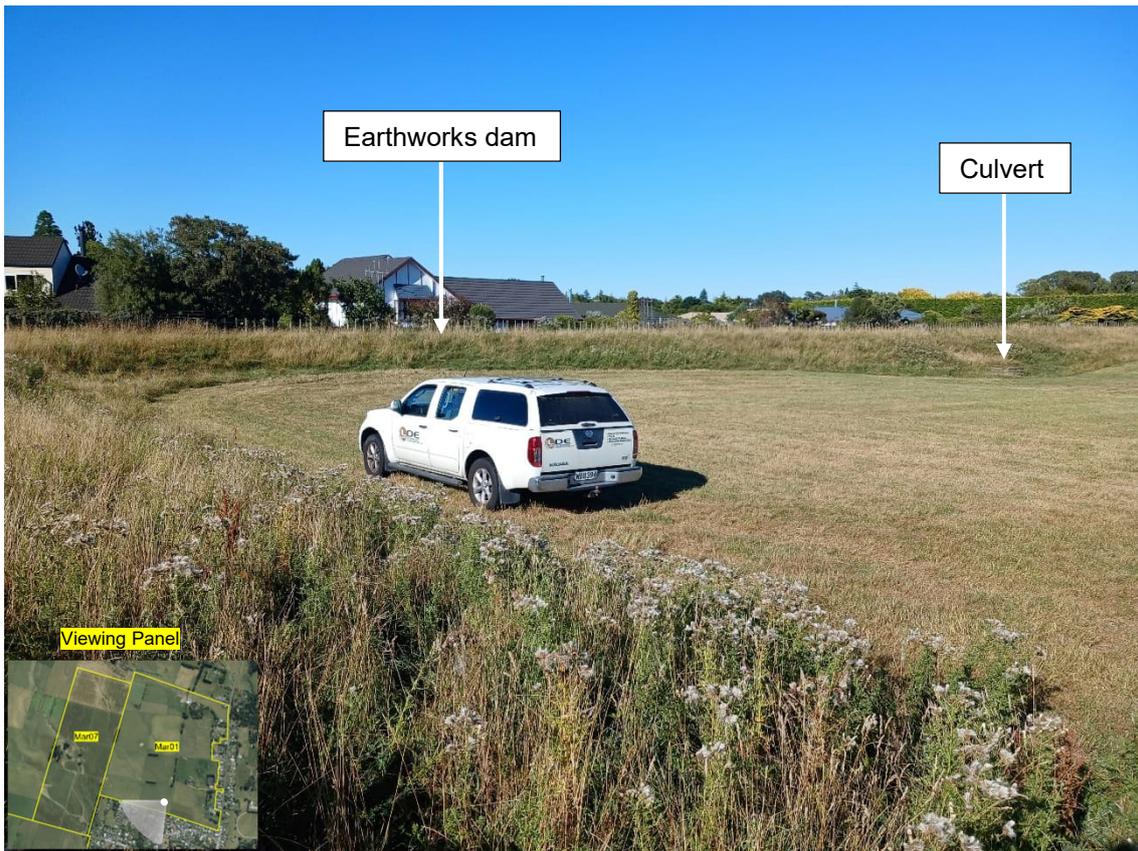
Photograph 13: View of the southern earthworks dam along the southern boundary of Mar01, viewed towards the southwest.

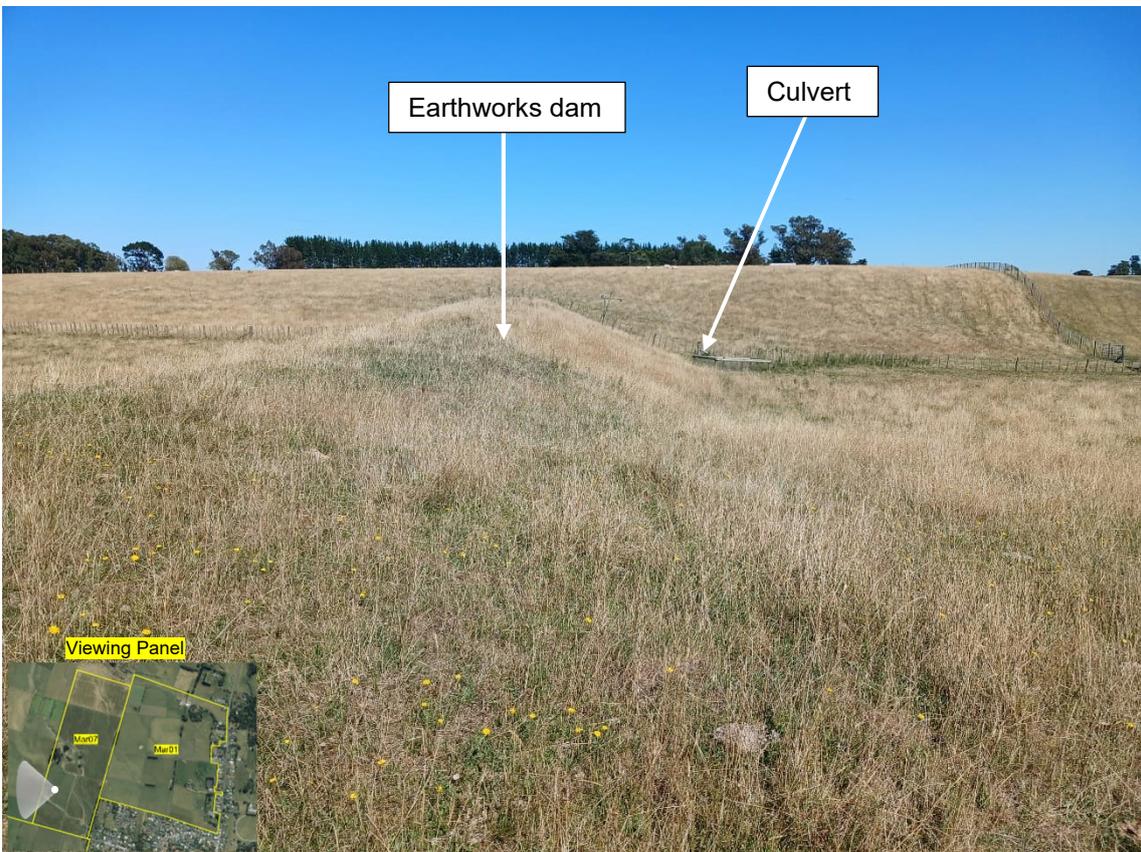
Photograph 16: View of the western earthworks dam along western boundary within the southern half of Mar07, viewed towards the west.

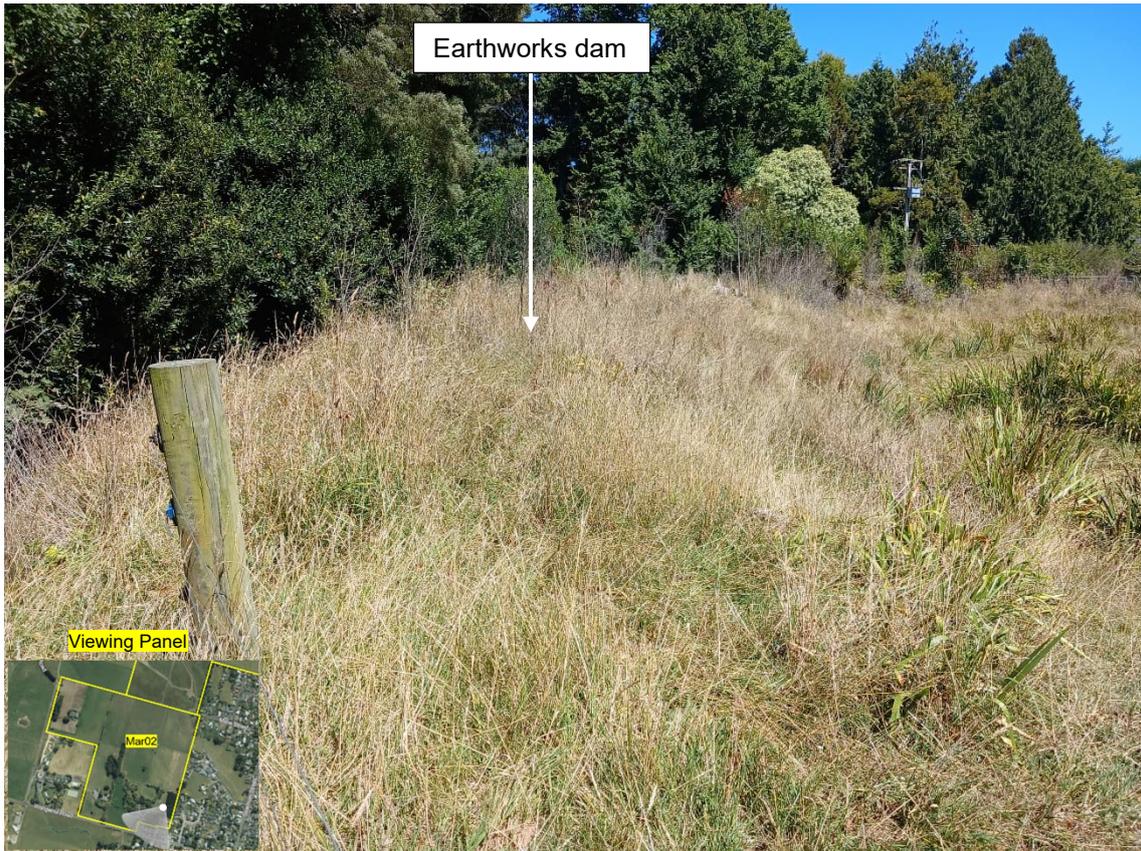
Photograph 19: View of the southern earthworks dam near the southern boundary of Mar02, viewed towards the southwest.

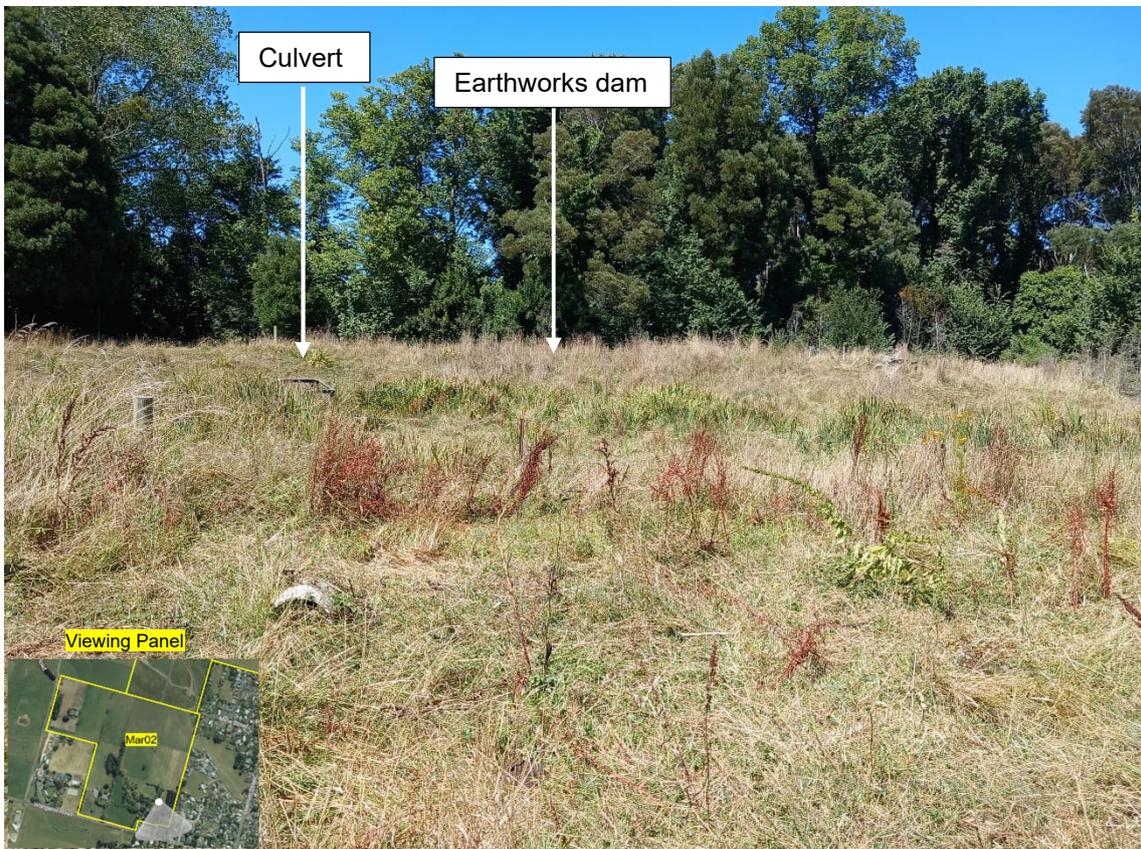
Photograph 20: View of the southern earthworks dam near the southern boundary of Mar02, viewed towards the south.

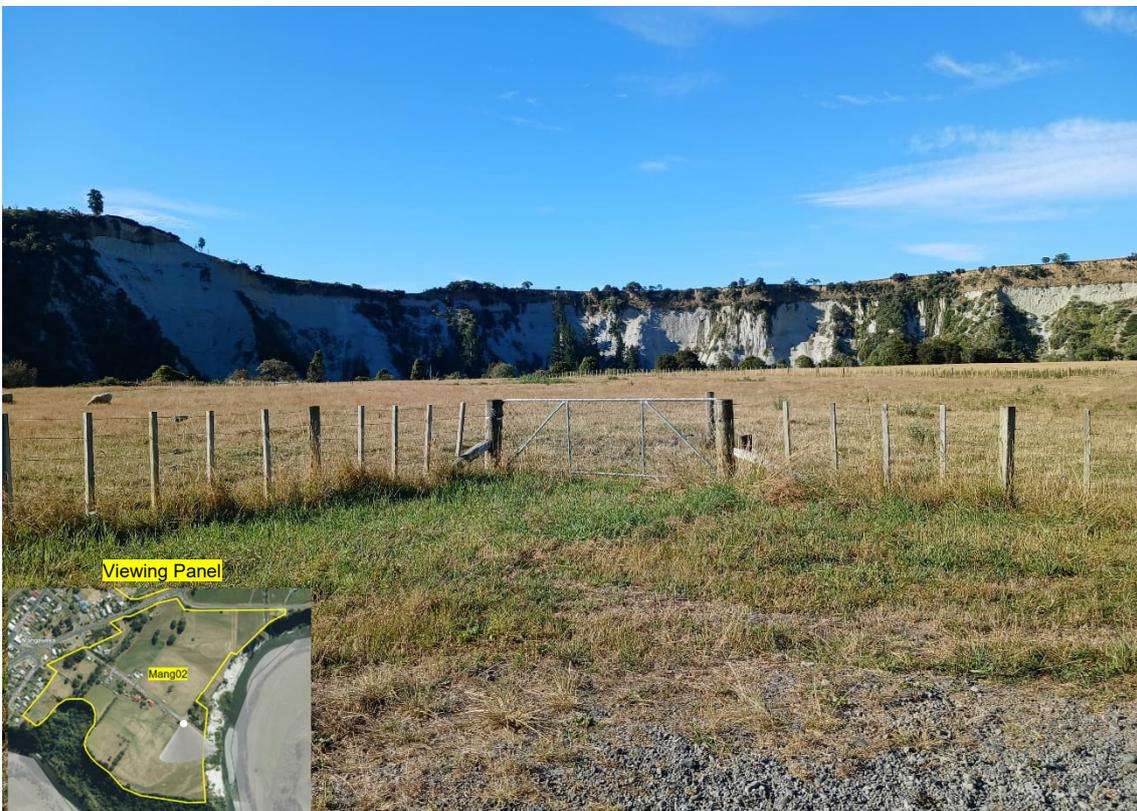
Photograph 22: View of the generally level area within Mang02, viewed towards the sedimentary bedrock cliffs which bound the eastern and southern boundaries of Mang02. Viewed towards the southeast from the end of Raumaewa Road.

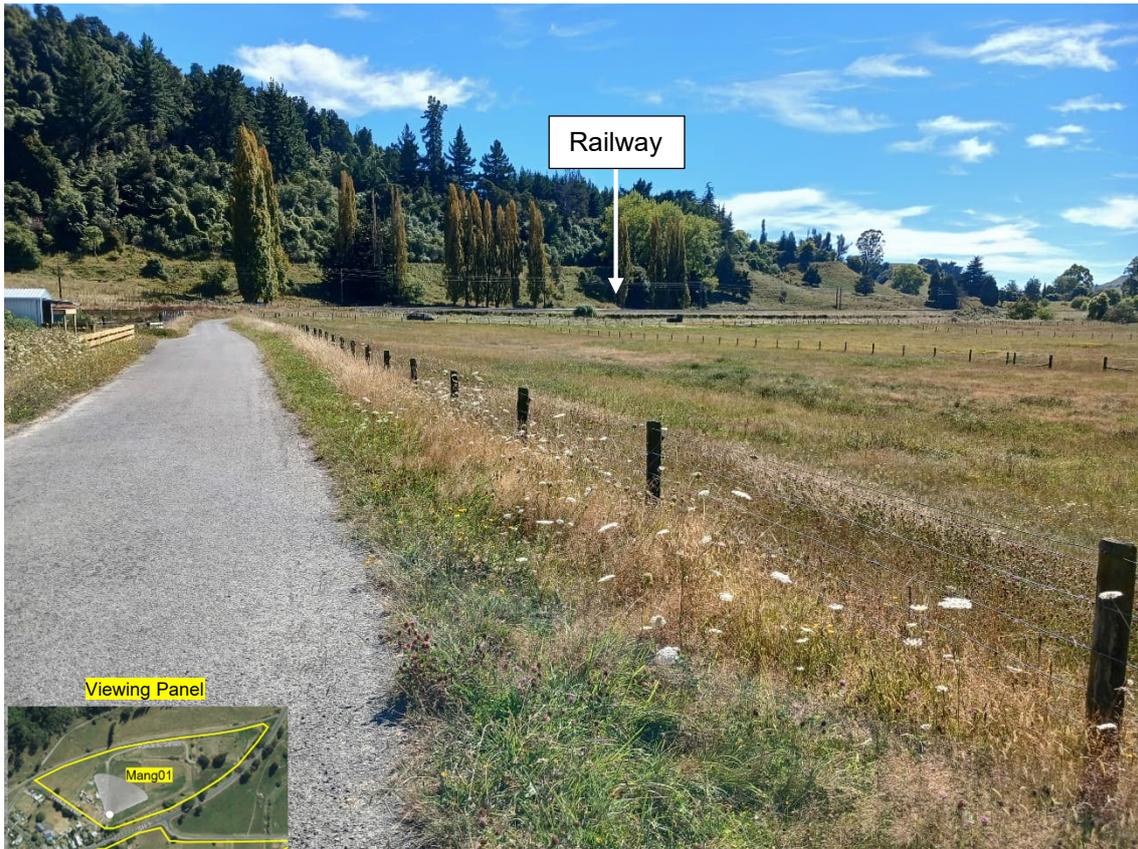
Photograph 28: View of the generally level area within Mang01, viewed towards the north from the southern corner. Note the ground is generally lower than the railway along the northern boundary (in the background).

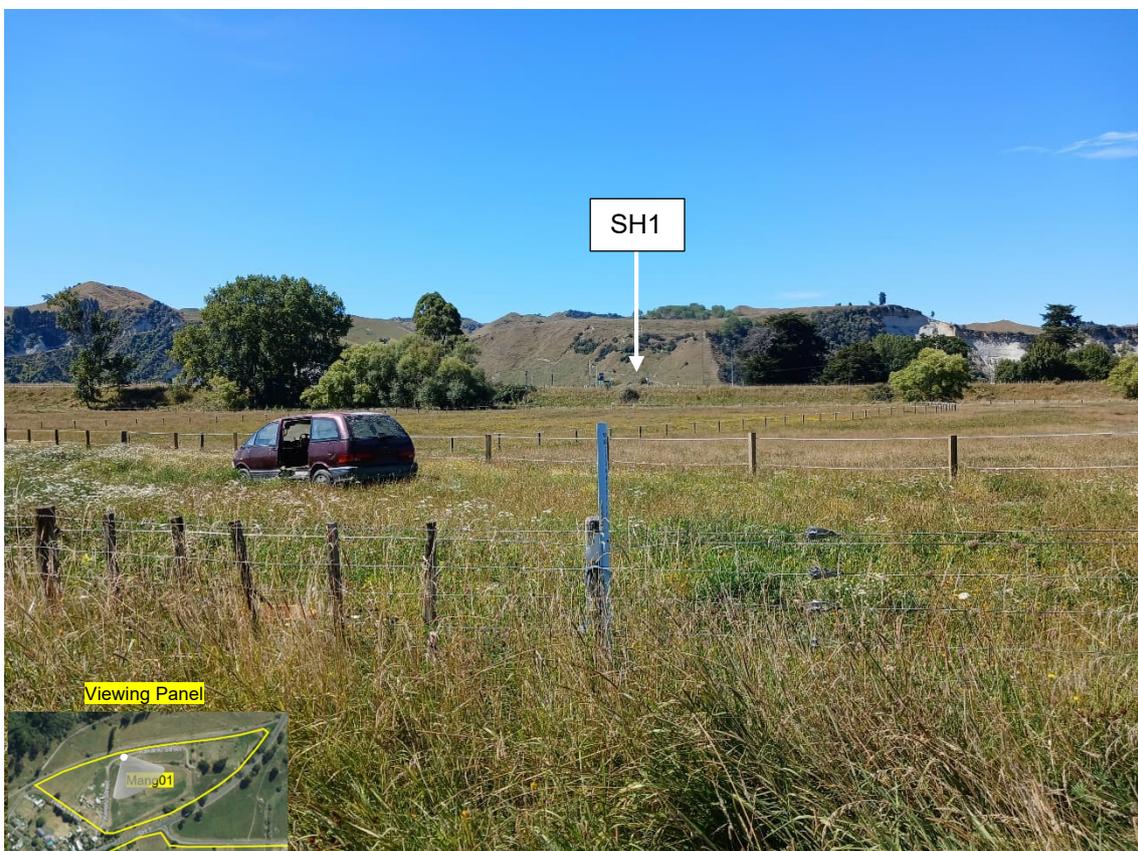
Photograph 29: View of the generally level area within Mang01, viewed towards the south from the northern boundary. Note the ground is generally lower than SH1 along the southern boundary (in the background).
