Rangitikei District Council

DETAILED SEISMIC ASSESSMENT 46 HIGH STREET, MARTON

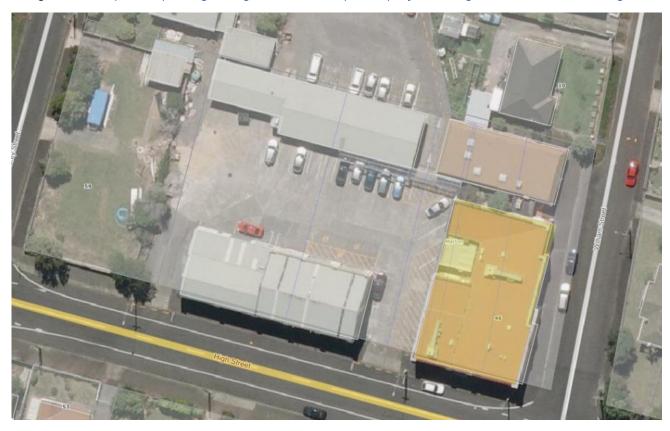
46 High Street, Marton, Manawatu-Whanganui.

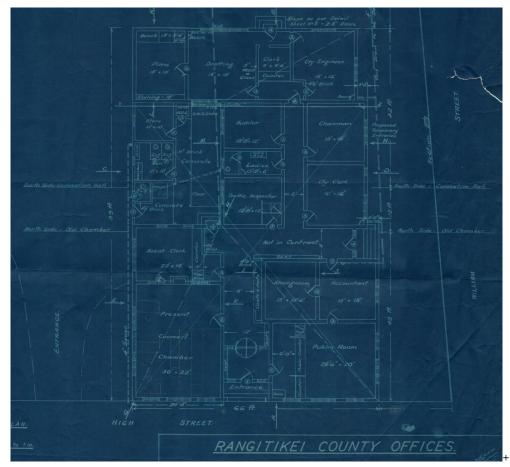
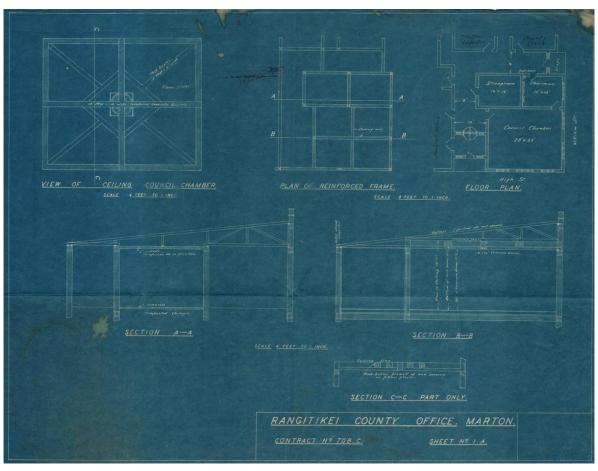
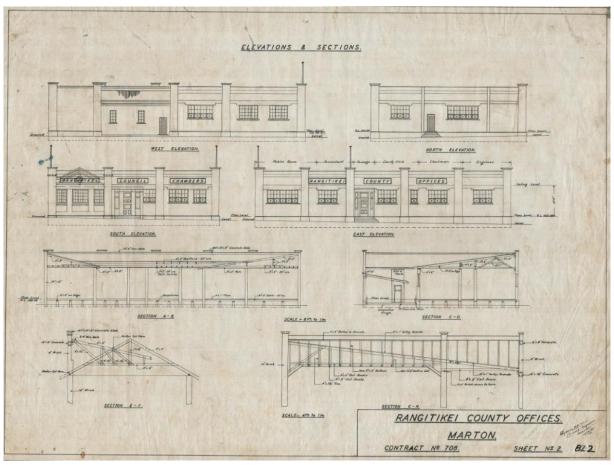
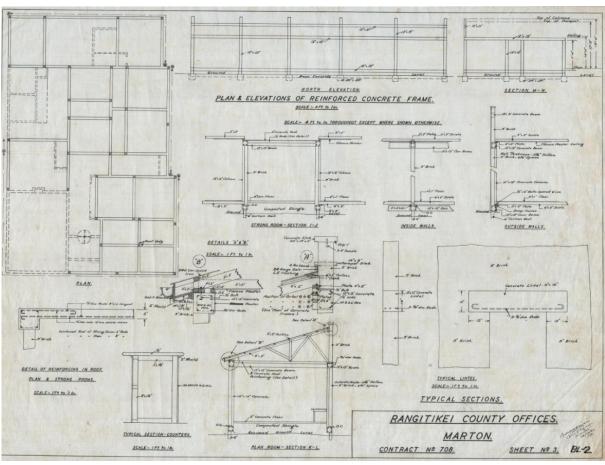
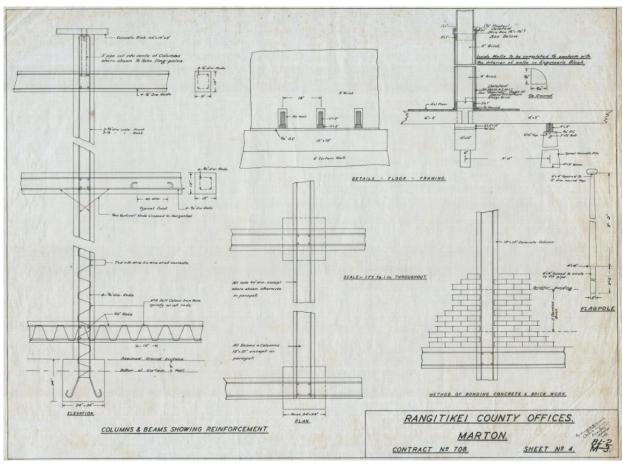
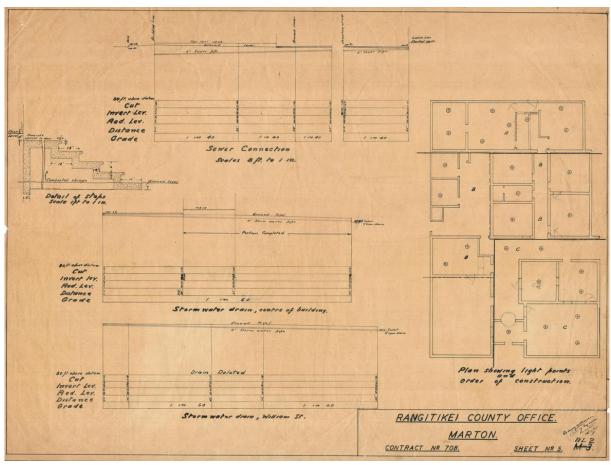
The single storey structure comprises of timber roof trusses supported on reinforced concrete frames with clay masonry infill wall panels. Lateral loads are transferred to reinforced concrete moment frames using timber sarking at roof sheeting level. Reinforced concrete foundations beams assist the frames in flexural capacity and localised pad foundations support the gravity component of the column loads.

The Administration building was designed in the mid-1950s. The structure comprises of timber roof trusses supported on reinforced concrete frames with clay masonry infill wall panels. Lateral loads are transferred to reinforced concrete moment frames using timber sarking at roof sheeting level. Reinforced concrete foundations beams assist the frames in flexural capacity and localised pad foundations support the gravity component of the column loads.
