Rangitikei District Council

DETAILED SEISMIC ASSESSMENT 31 HIGH STREET, MARTON

3 DECEMBER 2021

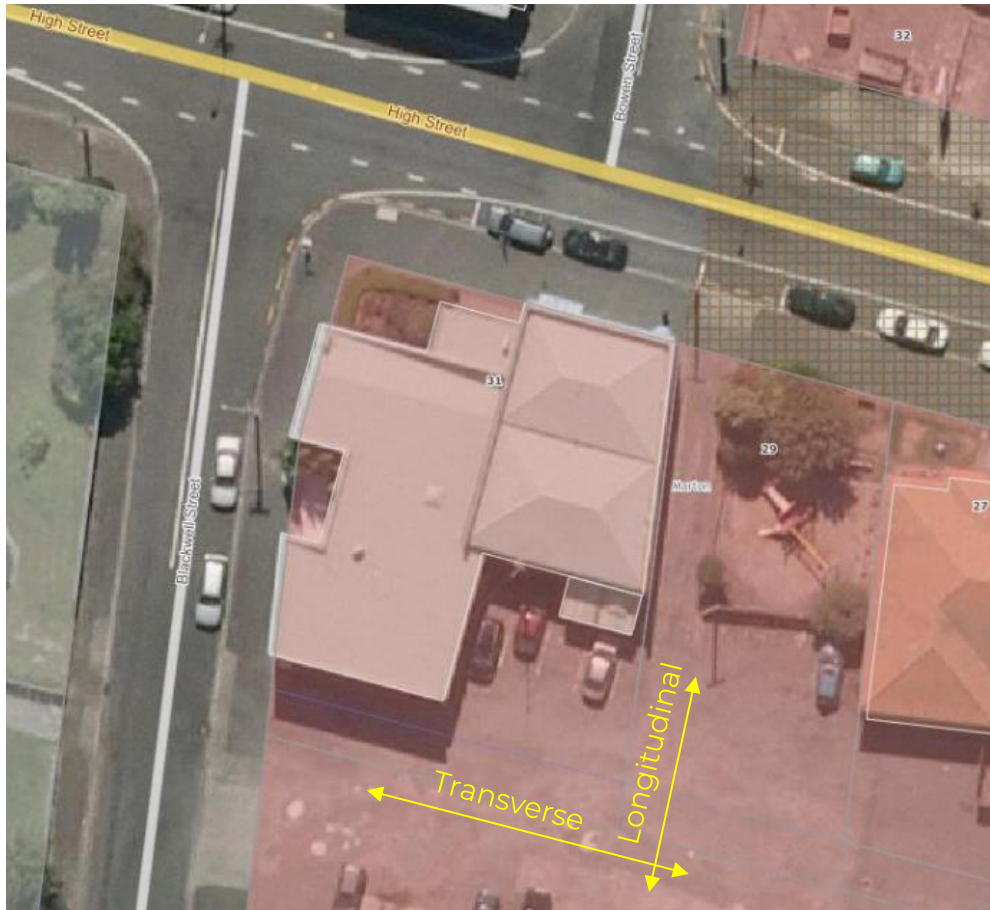
3.1 SITE

31 High Street, Marton, Manawatu-Whanganui.
