Rangitikei District Council

Asset Management Plan

3 Waters – 2017-2018

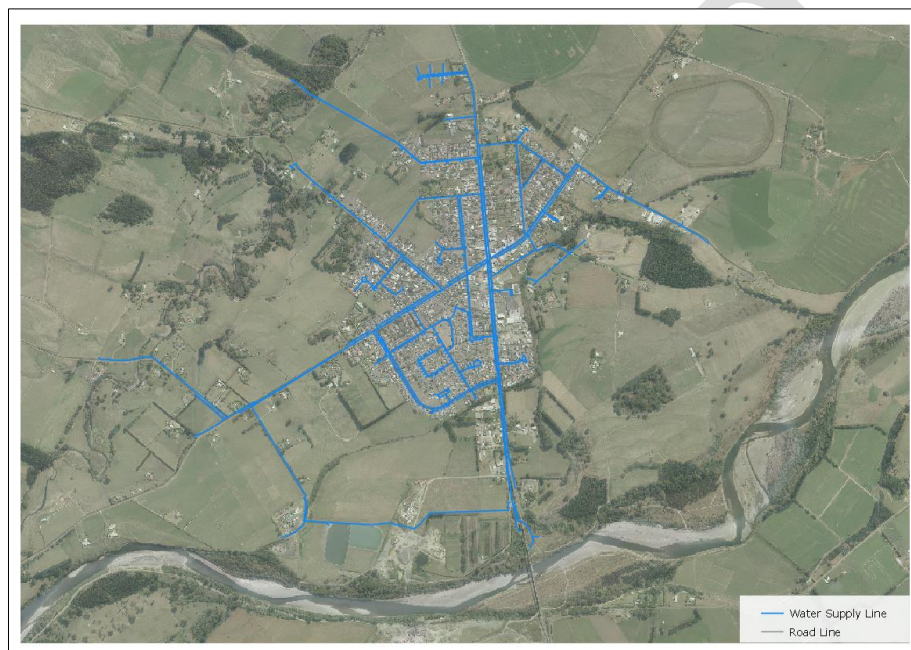
Figure 17: Bulls Water Supply

The Bulls water network is depicted in Figure 17.

The Bulls water network comprises pressure mains ranging up to 200 mm diameter. Approximately two-thirds of all the pipes are Asbestos Cement pipes laid in the late 1960s and 1970s. This material was superseded in the late 1970s by MDPE and PVC, which now account for 30% of the network. There is a small portion of the network built from copper which is known to be in poor condition.

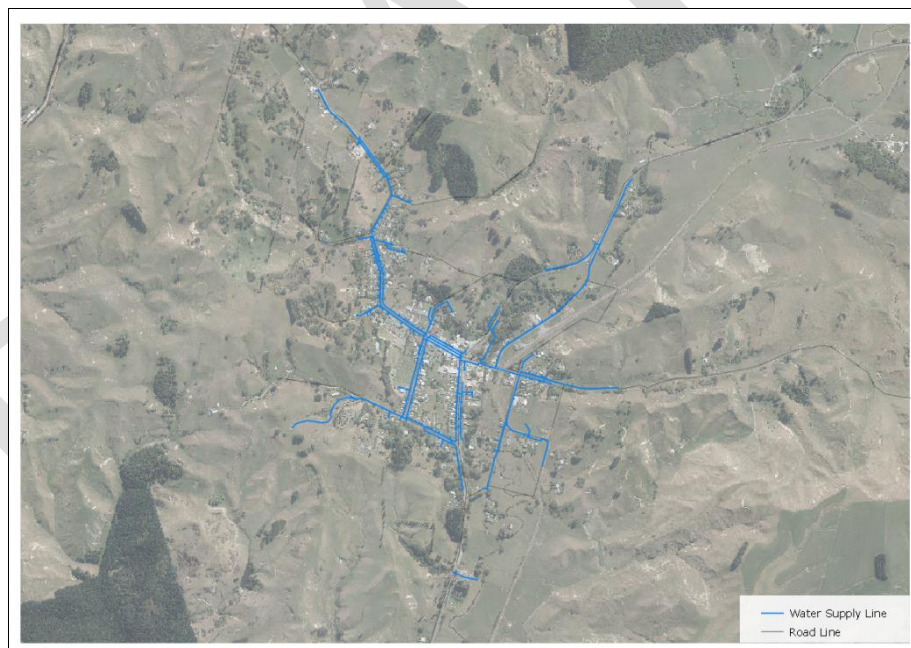
Figure 19: Hunterville Urban Water Supply

Figure 19 shows the extent of the Hunterville Urban water supply.

The Hunterville Water Network comprises pressure mains ranging up to 150 mm diameter. The network is relatively new, with no pipes listed as being older than 30 years, and 30% being less than 10 years old.

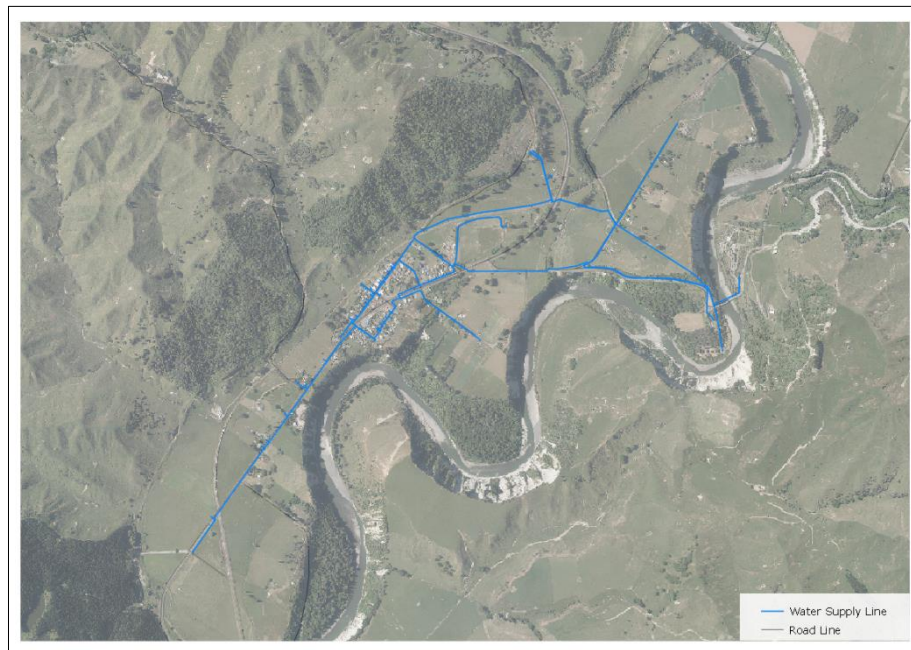
Figure 21: Mangaweka Water Supply

The layout of the Mangaweka water supply is shown in Figure 21.

The Mangaweka water network comprises pressure mains ranging up to 200 mm diameter. Approximately half of the network was replaced during the 1990s and many service connections renewed as part of the consumption meters installed in the 2000s. Asbestos pipes from the 1960s and original steel pipes from the 1910s make up the remainder of the network.

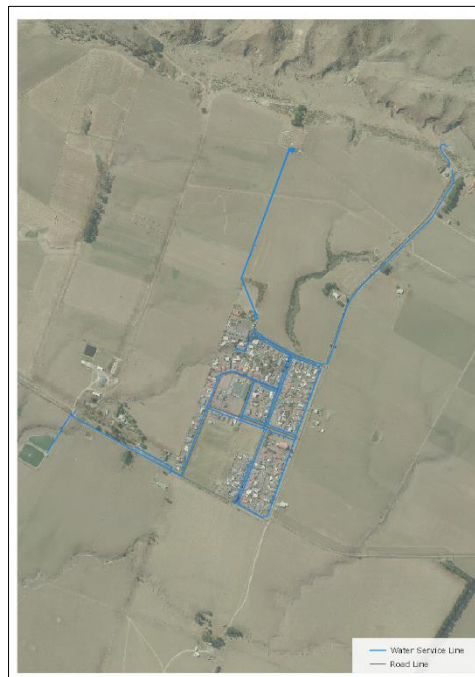
Figure 25: Rātana Water Supply

The Rātana water supply is shown in Figure 25.

The Rātana water network comprises pressure mains ranging up to 150 mm diameter. More than half of all the pipes are Asbestos Cement pipes laid in the late 1970s. The network was progressively extended in the 1980s-1990s with MDPE and PVC, accounting for 43% of the network.

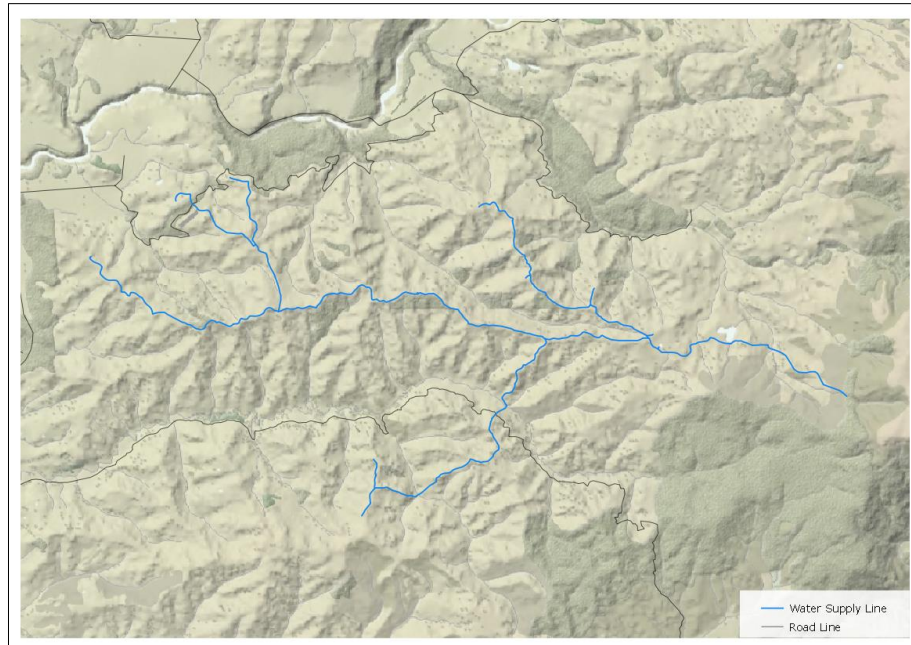
Figure 33: Omatane Rural Water

The extent of the Omatane scheme is shown in Figure 33.

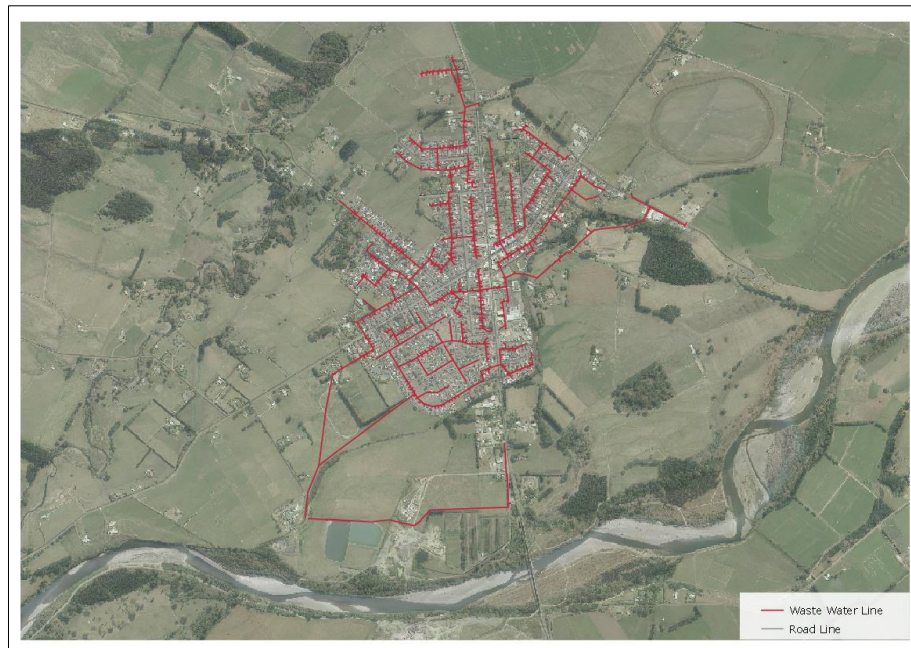
Figure 39: Bulls Wastewater

The extent of the Bulls network can be seen in Figure 39.

The Bulls wastewater network comprises pipelines ranging from 100 to 375 mm in diameter. The network is relatively young with an age of less than 40 years. The majority pipe material is Asbestos Cement, which has exhibited accelerated deterioration in other communities. However, there is very little industrial waste in the township and the expected remaining life for this material is expected to be longer than elsewhere.

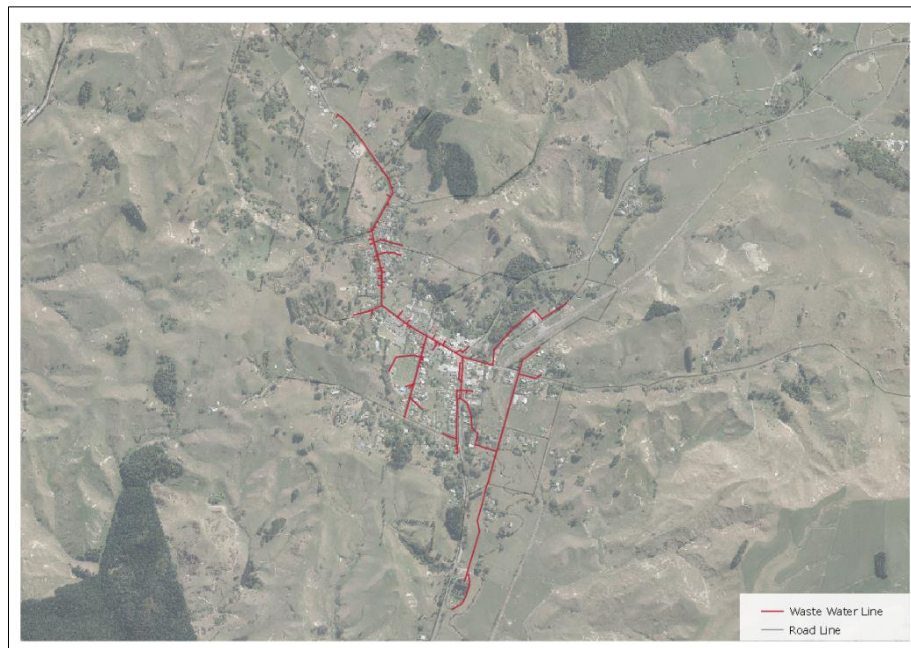
Figure 42: Hunterville Wastewater

Wastewater from Hunterville is treated in primary and secondary oxidation ponds that are located between State Highway 1 and the Porewa Stream, approximately 500 m south of Hunterville. Treated effluent is discharged via an open drain to the Porewa Stream under conditions set by resource consent.

The extent of the area served by the Hunterville wastewater network can be seen in Figure 42.

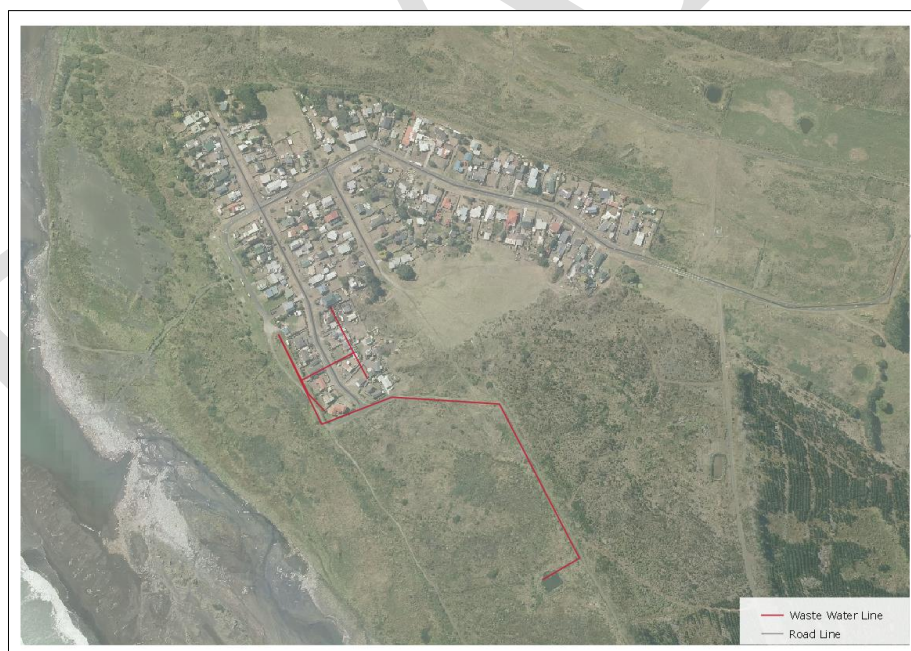
Figure 45: Koitiata Wastewater

Figure 45 shows the extent of the Koitiata wastewater network.

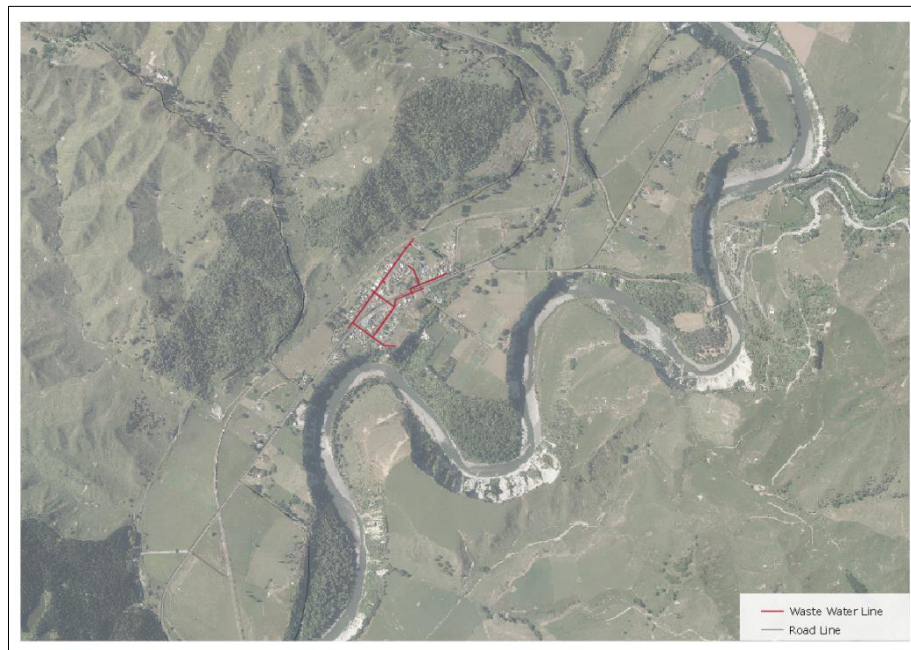
Figure 48: Mangaweka Wastewater

The extent of the Mangaweka wastewater system is shown in Figure 48.

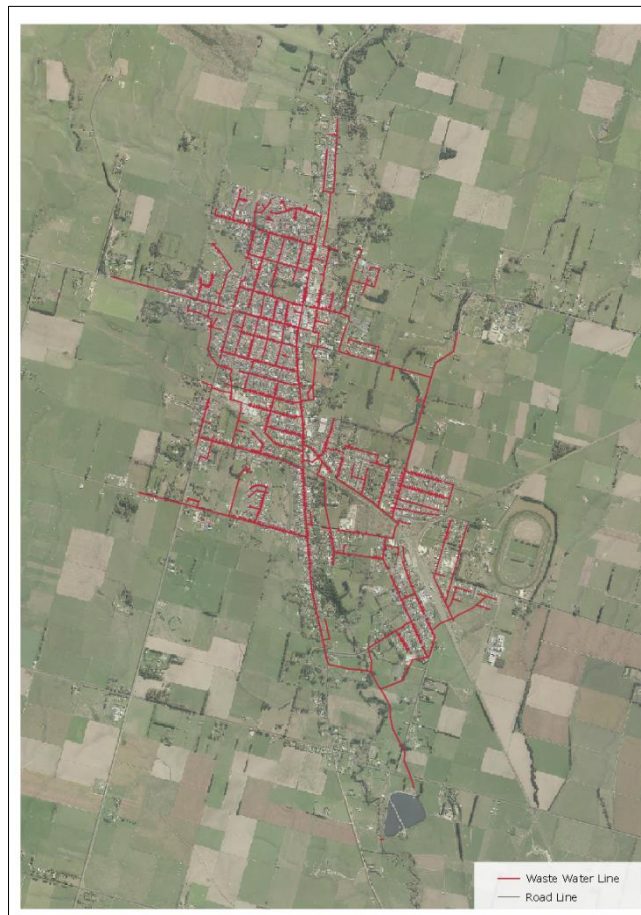
Figure 51: Marton Wastewater

The extent of the Marton wastewater network can be seen in Figure 51.

The Marton wastewater network comprises pipelines ranging from 100 to 500 mm in diameter.

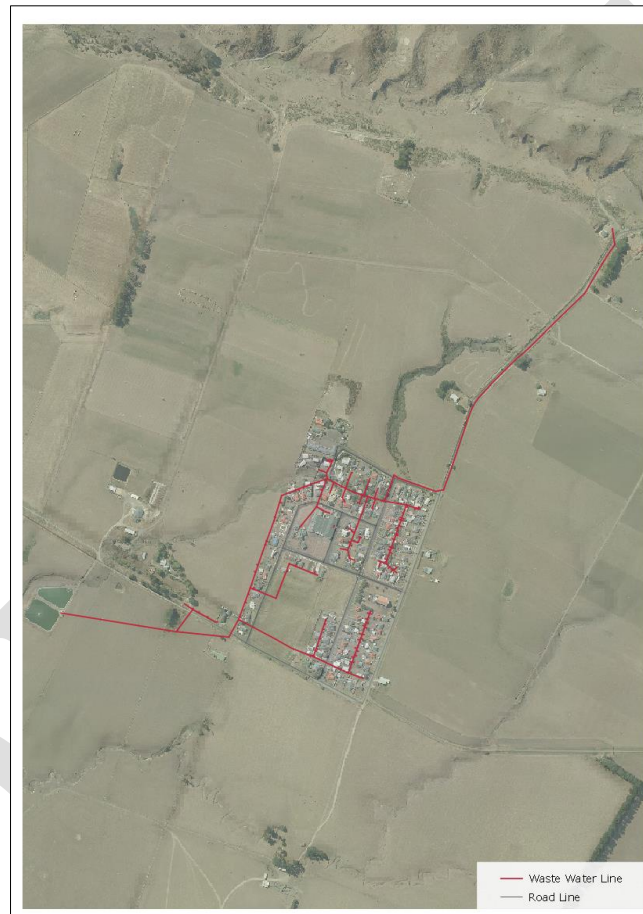
Figure 54: Rātana Wastewater

The extent of the Rātana network is shown in Figure 54.

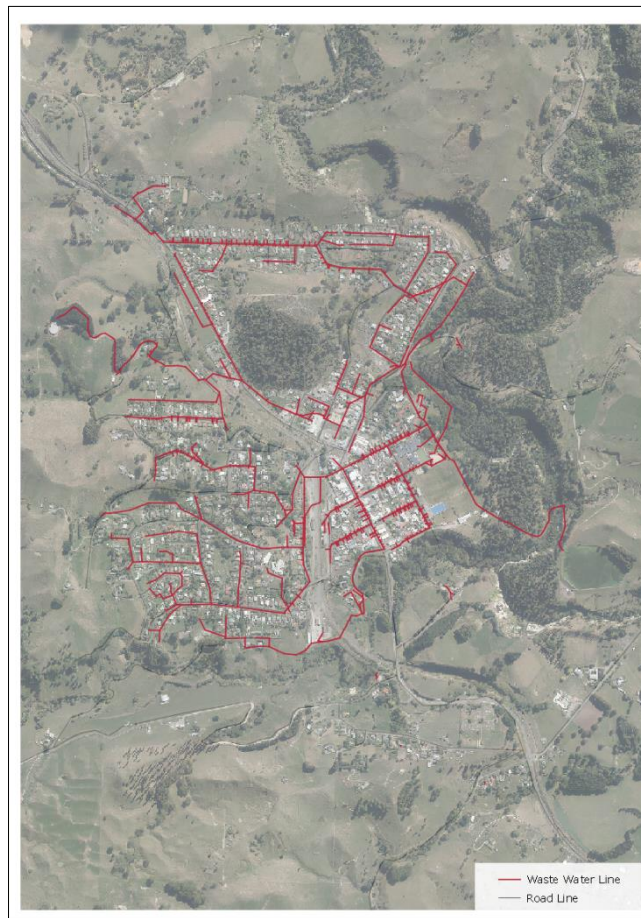
Figure 57: Taihape Wastewater

Figure 57 shows the extent of the Taihape wastewater network.

The Taihape wastewater network comprises pipelines ranging from 100 to 375 mm in diameter. Approximately 70% of the network is thought to be glazed earthenware pipes over 90 years old.

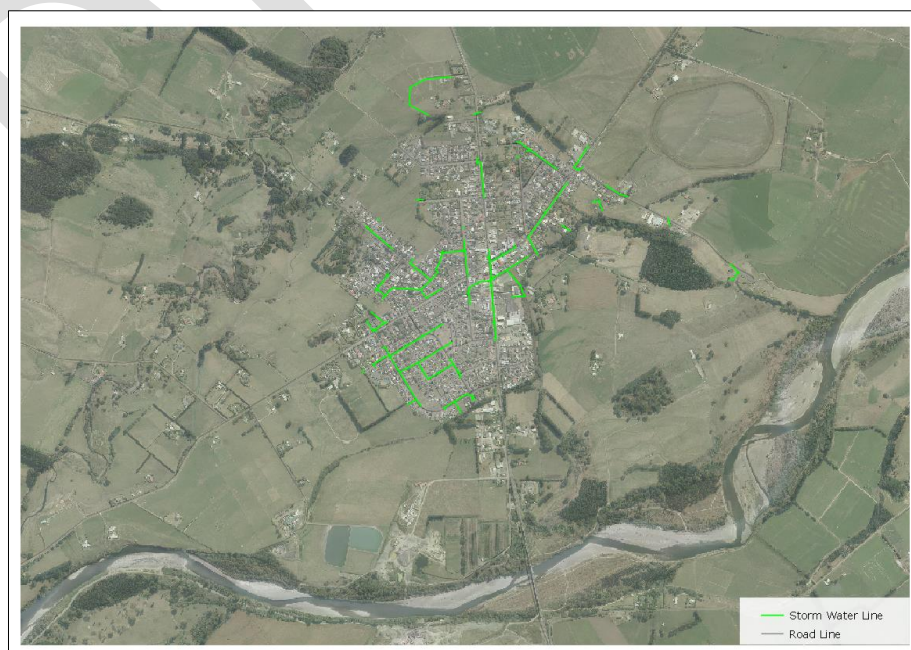
Figure 63: Bulls Stormwater

The Bulls urban stormwater network is characterised by a flat river plain on two distinct levels, serviced by public and private drains feeding into key catchments serviced by open unlined drains. These drains feed into the Rangitikei River and the Tutaenui Stream. The Bulls stormwater network is a mixture of mainly open drains with some short sections of piped reticulation.

The extent of the stormwater system for Bulls is shown in Figure 63.

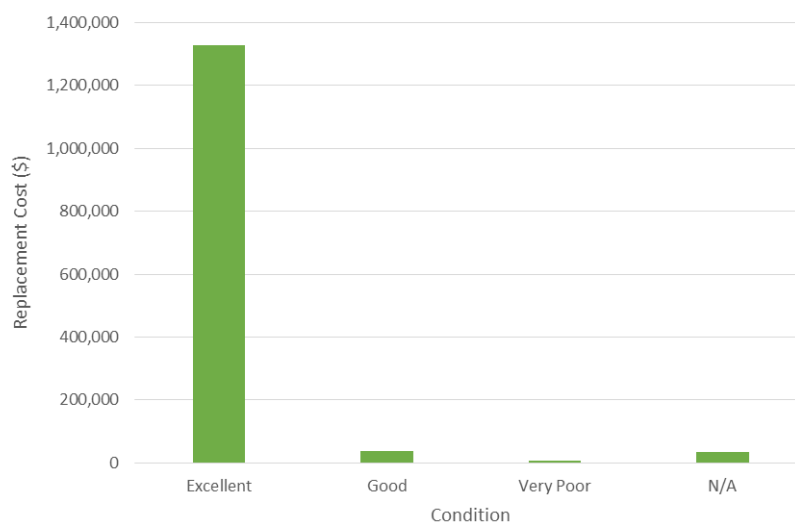
Figure 68: Asset Condition - Hunterville Stormwater

The condition of stormwater assets in Hunterville has generally been assessed as “Excellent”, as seen in Figure 68. There are some gaps in information for this network, however. Condition grading following CCTV inspections and more accurate dates of installation will allow the Council to improve our asset information.

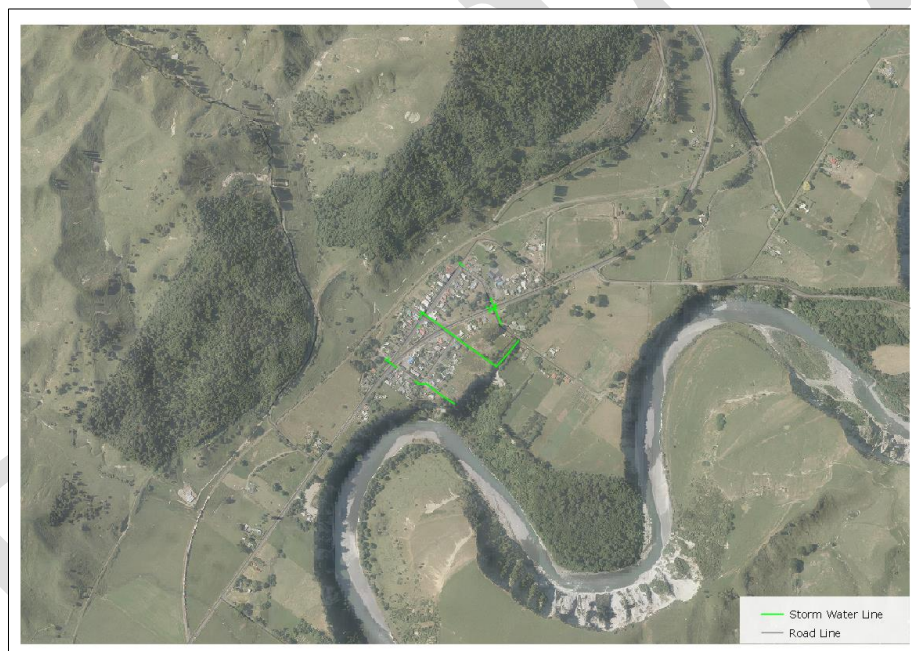
Figure 69: Mangaweka Stormwater

The extent of the stormwater network for Mangaweka is shown by Figure 69.

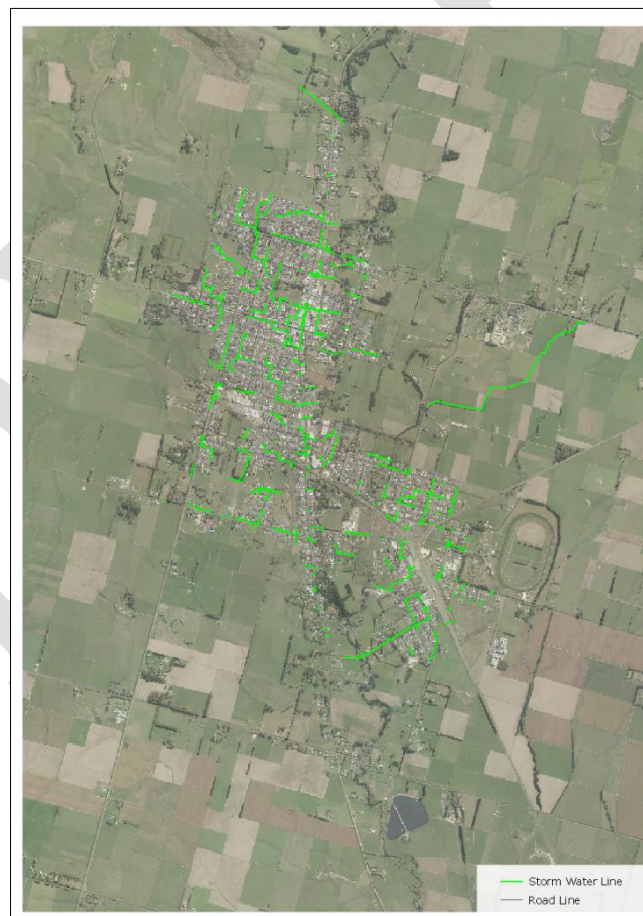
Figure 72: Marton Stormwater

The Marton stormwater system catchment is shown in Figure 72.

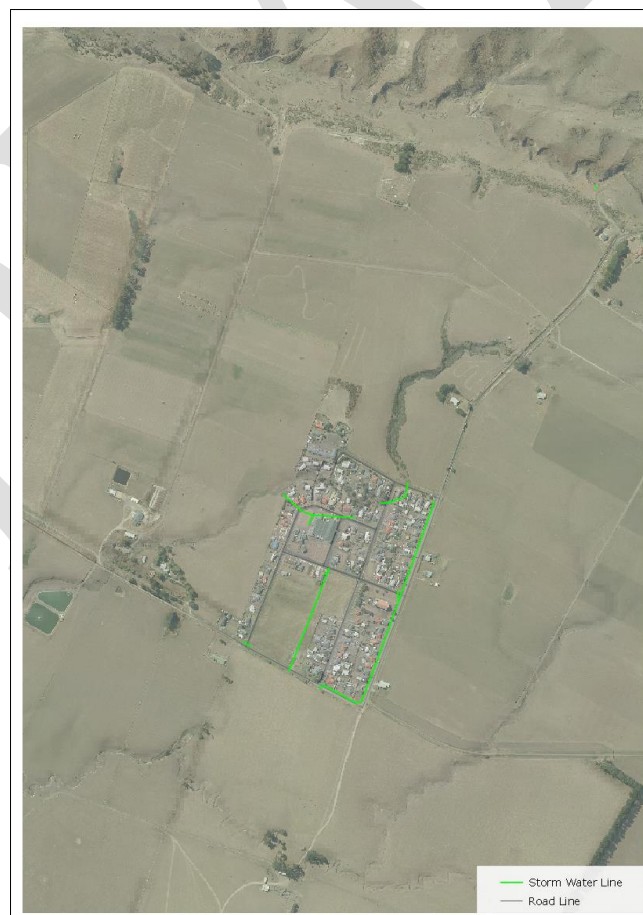
Figure 75: Rātana Stormwater

The Rātana stormwater system is shown in Figure 75.
