# Heritage Assessment

# Mangaweka Bridge, Mangaweka May 2015

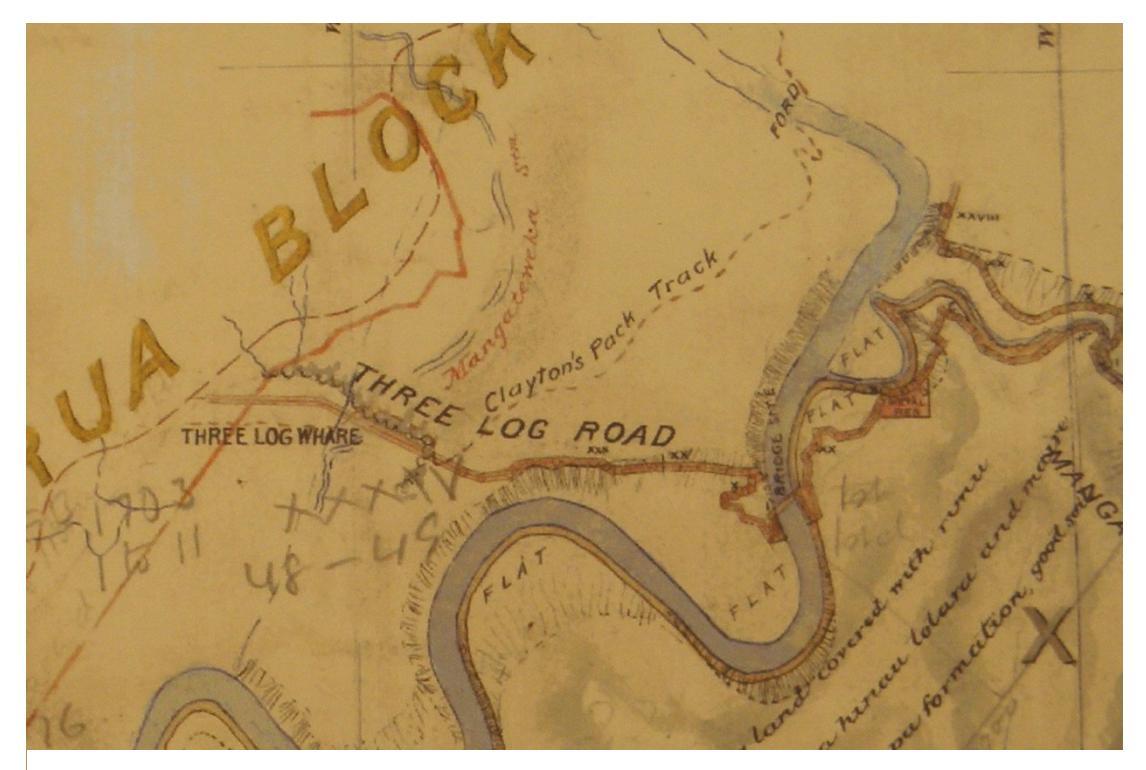
Figure 1 A section of Plan 13472, Otamakopua-Rangitikei Block, dated 1893, showing the proposed bridge site on 'Three Log Road'. (Source: A copy of the plan on display at the official opening of the bridge, 7 March 2015)

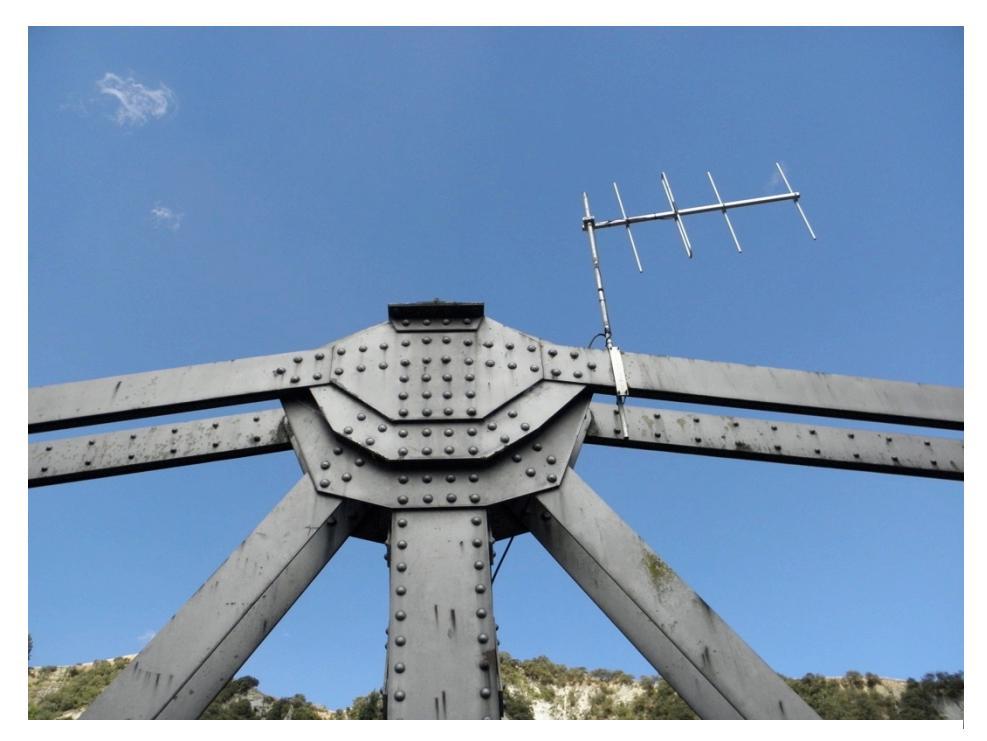
Figure 3 Not a TV aerial for an under-bridge-dwelling troll while he awaits some unsuspecting Billy-Goats Gruff, but rather the aerial connected to the river level recorder attached to the bridge, 7 March 2015 (Photo: Val Burr)

A pencilled note on the November 1899 plan of the bridge, PWD 18543, records that during the construction of the Rangitikei Catchment Board's water level recorder tower at the bridge site in late 1953, it was found that the largest abutment in the Mangaweka side of the river (built 1896), was by this time only between 2ft 6ins to 3ft 6ins into the papa.<sup>84</sup>

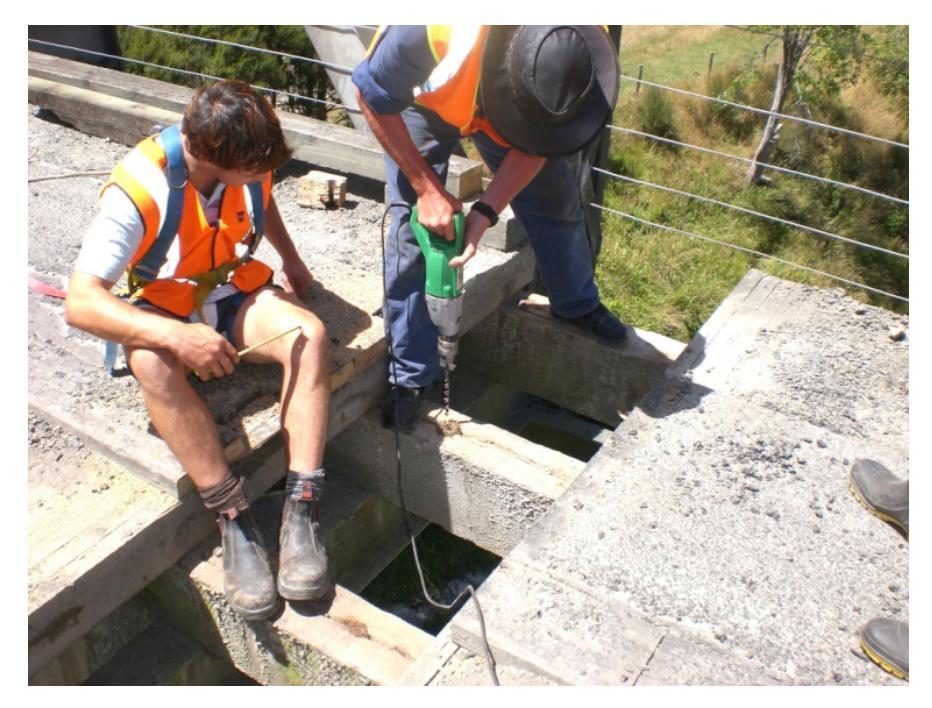
Figure 4 Testing the bridge's timberwork on 30 January 2009 (Photo: Manawatu District Council)

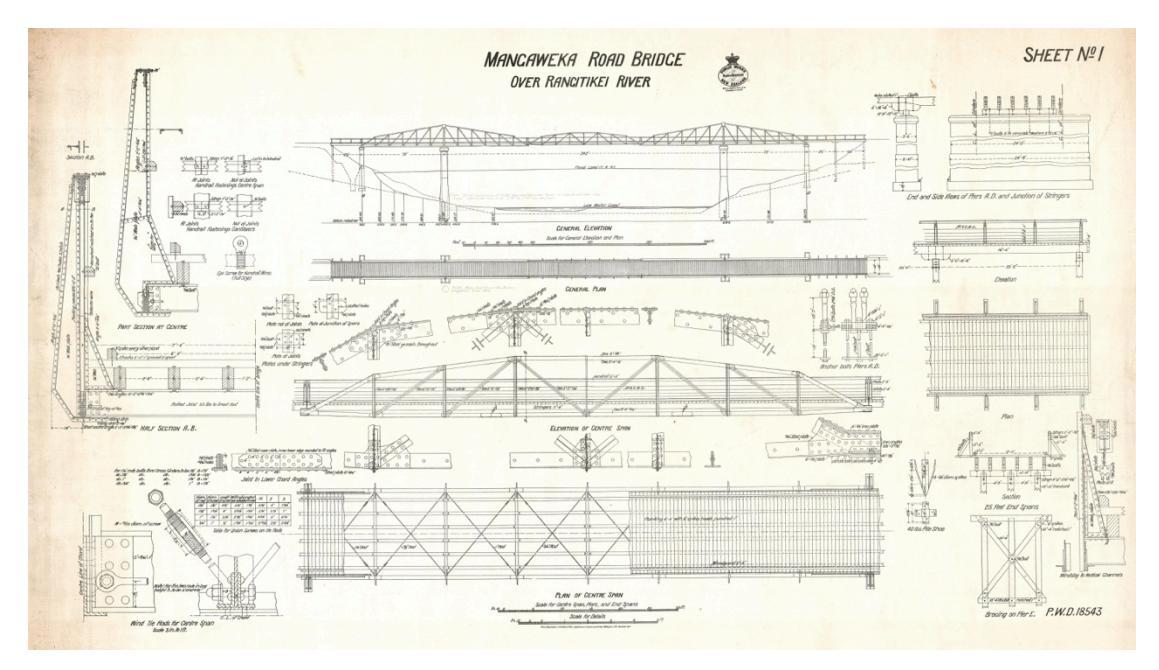
Figure 6 Bridge plans, 1899, MDC archives

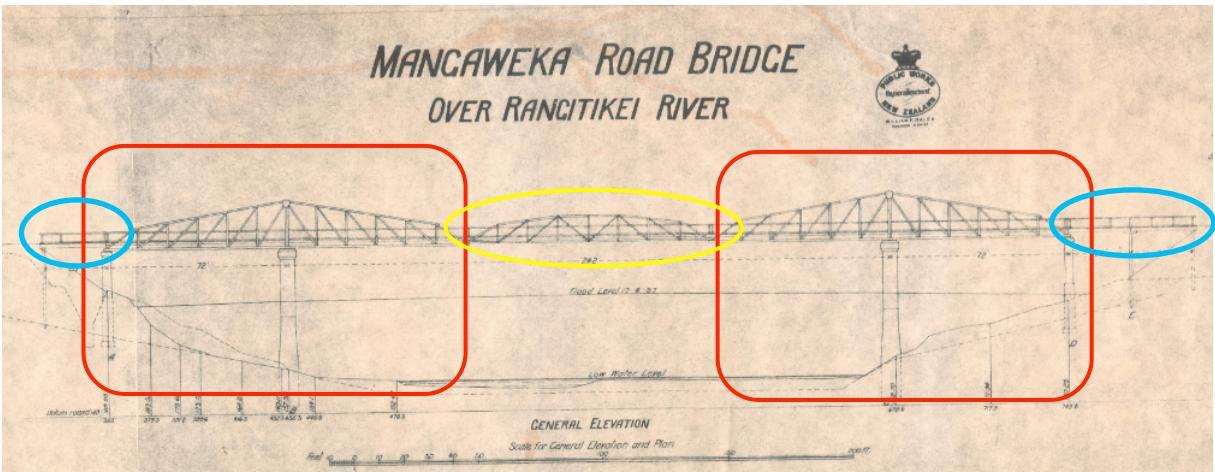
The two short spans at either end of the bridge are simply-supported approach spans for which truss support was not needed – refer to figure 7 highlighted in blue.

Figure 7 Cantilever bridge elements
