Subject: **Rātana Community Housing Condition Report**

To: Rātana Community Board

Date: 10 February 2020

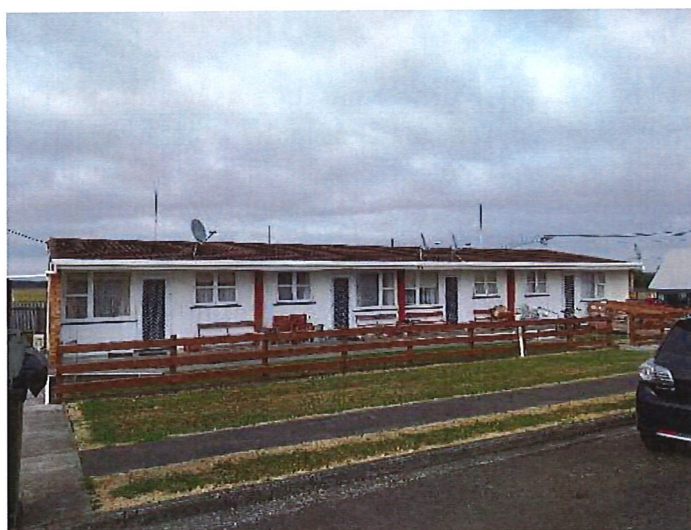
- 2.1 The flats located on Taihauauru Street enjoy a high occupancy. There are three single units and one double unit. All flats have been well looked after by their tenants and are clean and tidy.

- 2.2 Exterior - The units are clad with a narrow profile vertical weatherboard. These are in generally good condition, however some areas are showing a deterioration of the paintwork. There are some areas of the boards, particularly at the bottom (along the porch area) that are showing signs of deterioration. The timber would benefit from being prepared and repainted to increase the lifespan of the cladding. The windows need to be sanded back and re-painted to maintain the timber. Quotes will be obtained to undertake this work.
- 2.3 The brick cladding at either end is in good condition.
